Westport No.1 Water Tunnel Repairs Option 2d (Stabilising + Piping)

Feasibility Study

October 2017

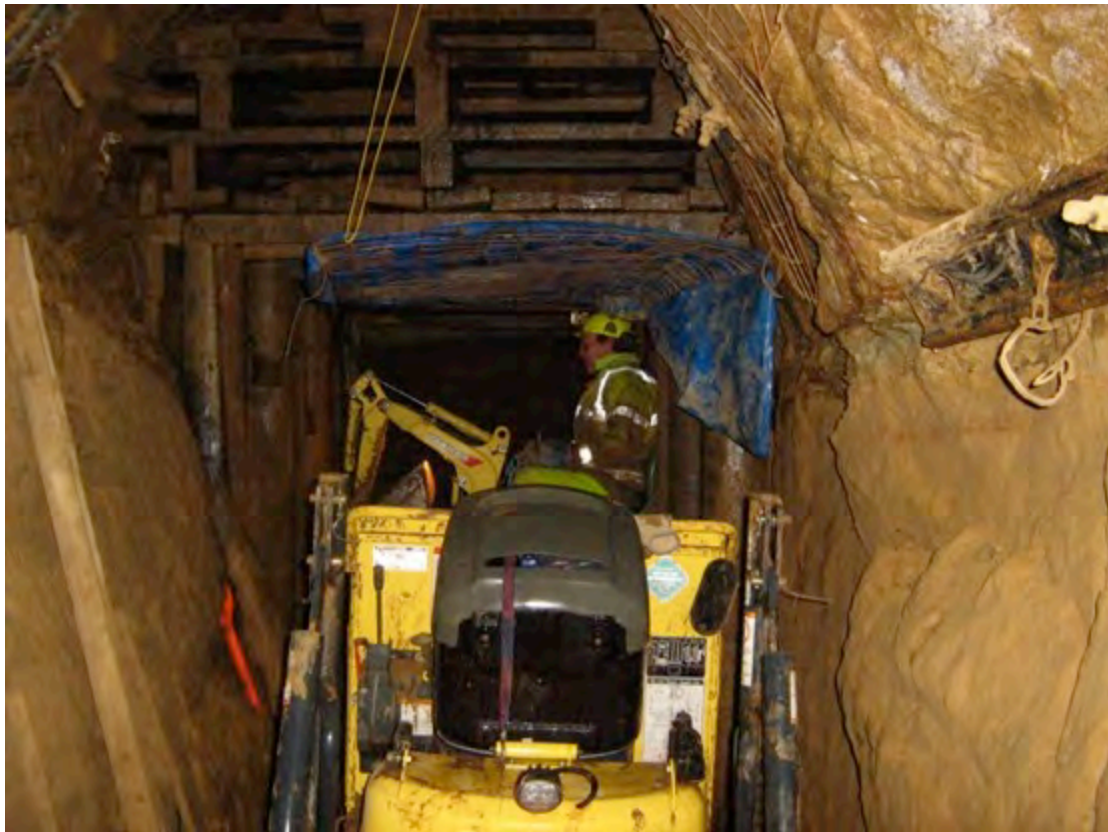
Figure 6. Geotech Ltd removing timber using modern bolts, mesh and 'W' strap in Westport water tunnel - Tunnel No. 4.

Resin encapsulated rock bolts, mesh and “W” straps were installed (Figure 6). 1.8 metre by 20mm bolts were installed in the roof with resin anchors in 27mm diameter holes at one metre spacing. Due to width/space considerations 1.2m bolts were installed in the rib at 1m centres. These bolts held “W” straps to the rib and provided immediate and effective confinement, which is a key to ground stabilization in the O’Keefe lithology.

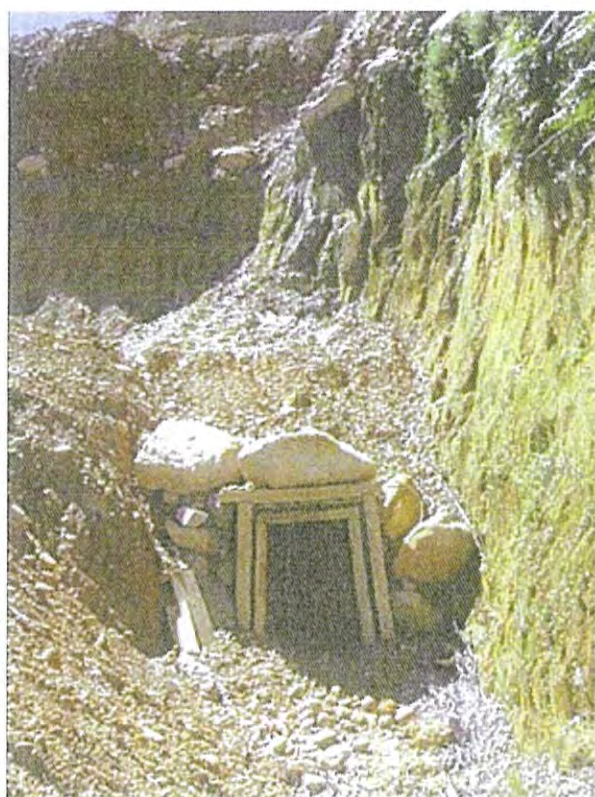
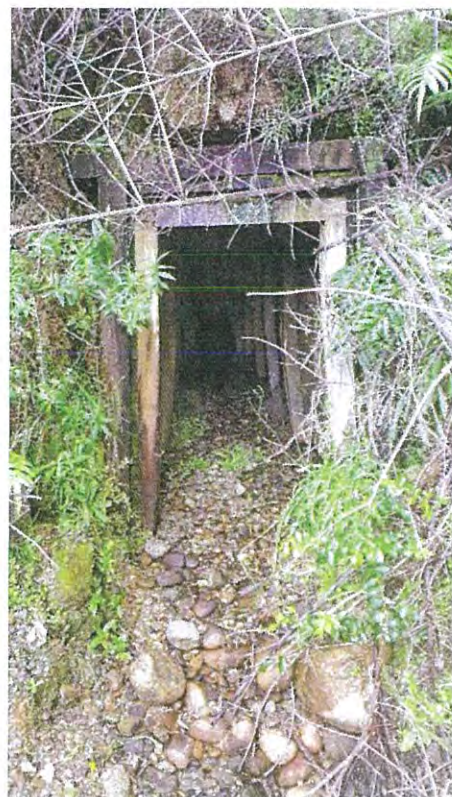
The risk of further instability has the potential to limit or block access to the portal location. Comparison of photos (Figure 5) taken in 2009 and 2016 highlight significant levels of additional loading and deformation particularly on the left-hand side of the wooden tunnel supports at the portal. New rockfall material near the tunnel entrance was also observed.

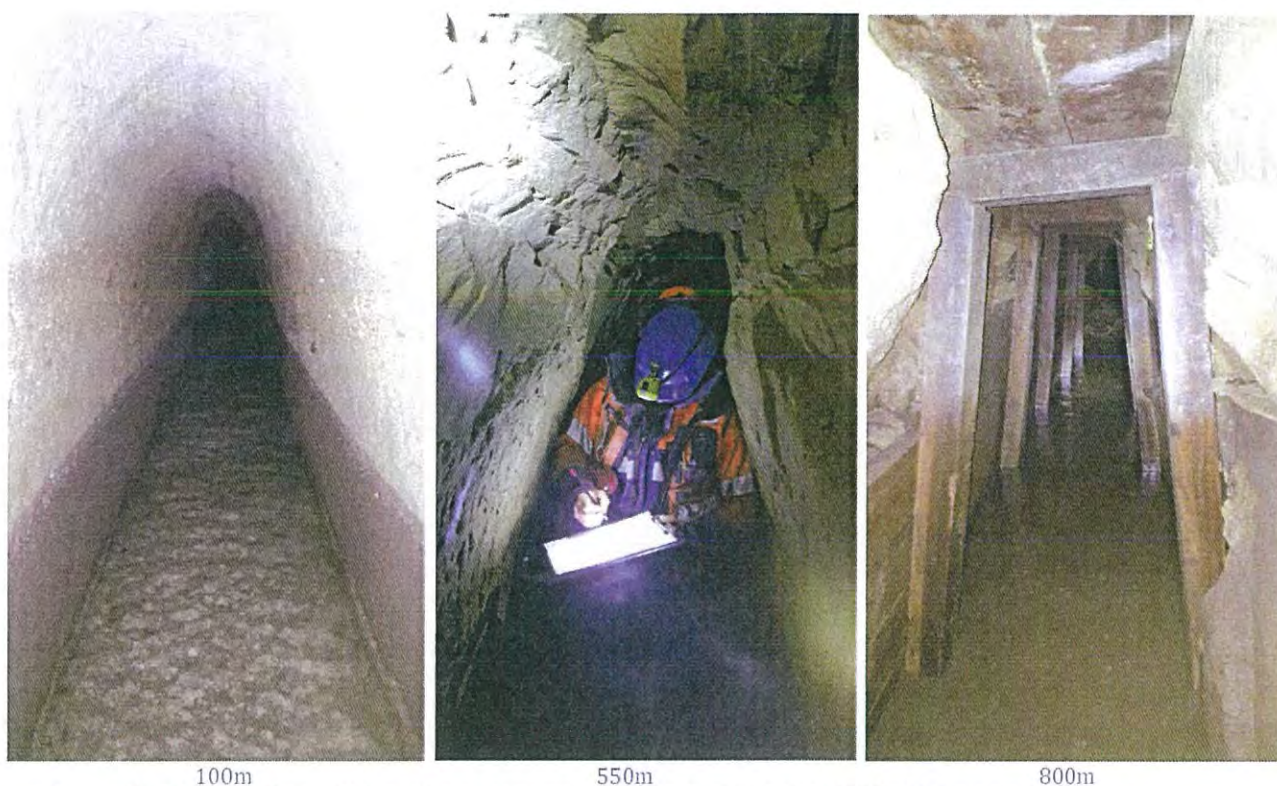
Figure 7 - Range of conditions from very good (100m), moderate (550m) to poor (800m)

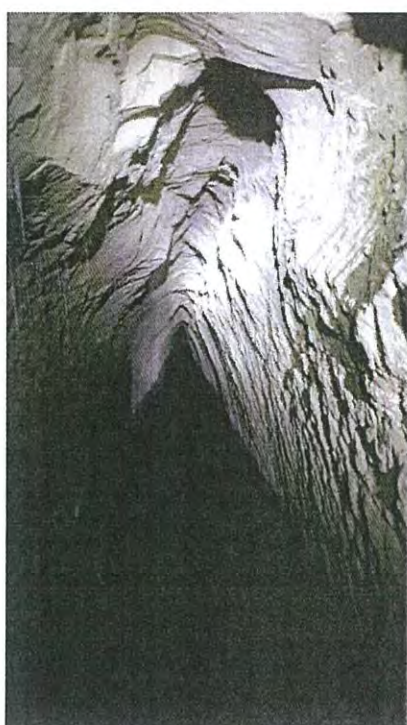
Guttering at 350m

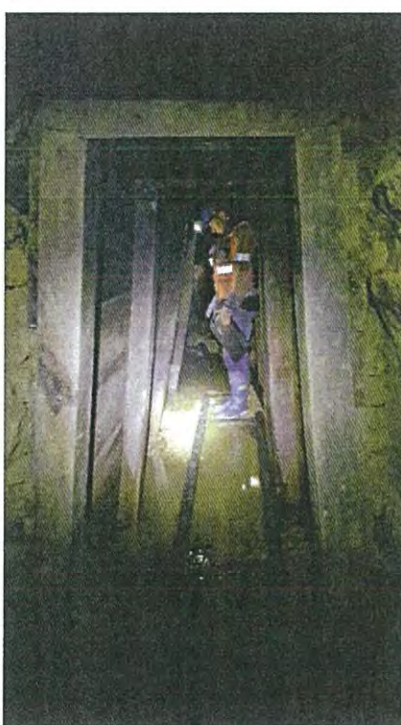
Wooden sets at 885m collapse

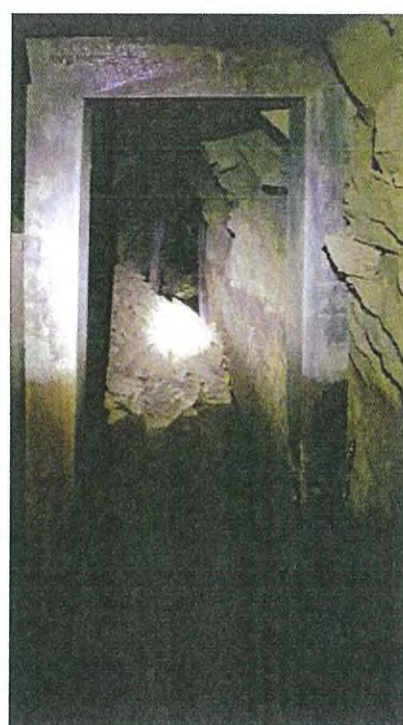
Partial sidewall / roof failure & blockage at 815m

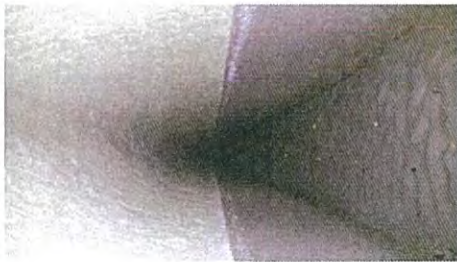
Tunnel at ~200m showing very good conditions

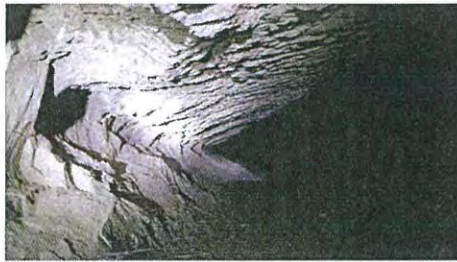
Tunnel at ~350m showing onset of guttering in roof

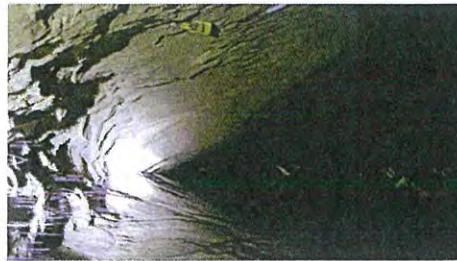
Tunnel at 600m showing good conditions with roof fretting

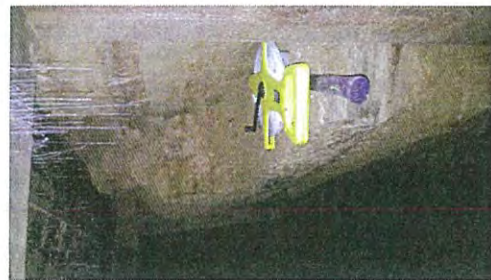
Tunnel ~660m showing sidewall Spalling & timber supports

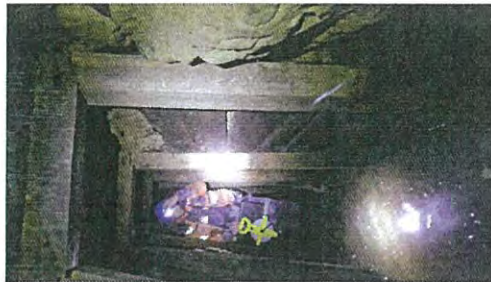
Tunnel at ~750m showing poor conditions and rotten timber lagging

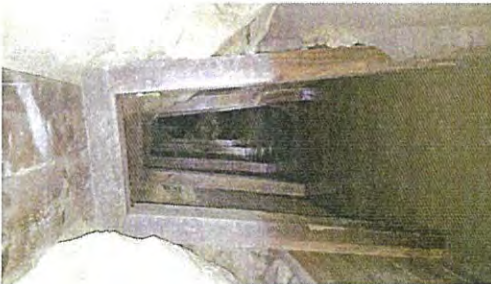
Tunnel at 800m showing sidewall failure (81.5m), blockage and increased water level

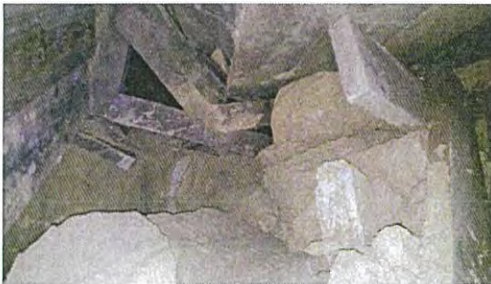
Tunnel at 885m showing collapse

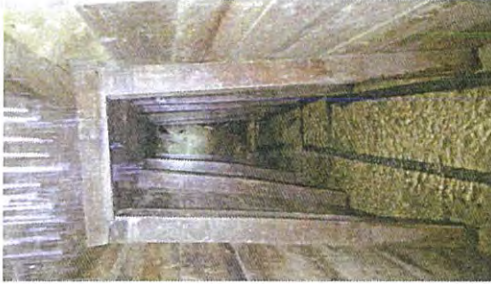
Tunnel at ~870m showing deformation of timber sets leading into collapse

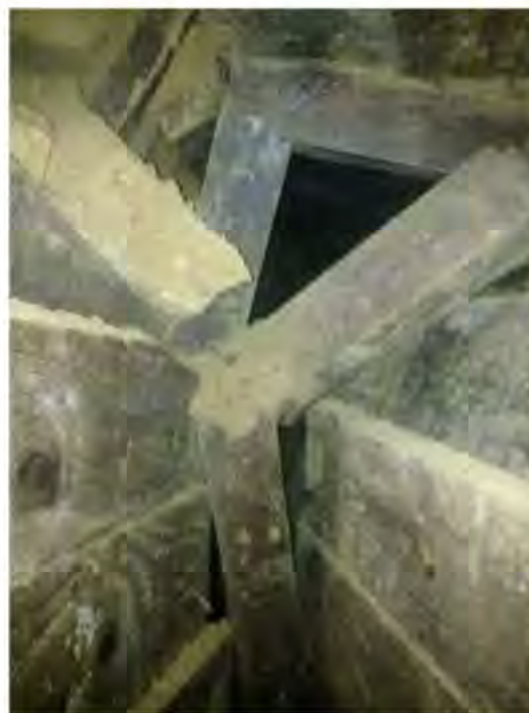
Photo 1: Collapsed section of tunnel No 1

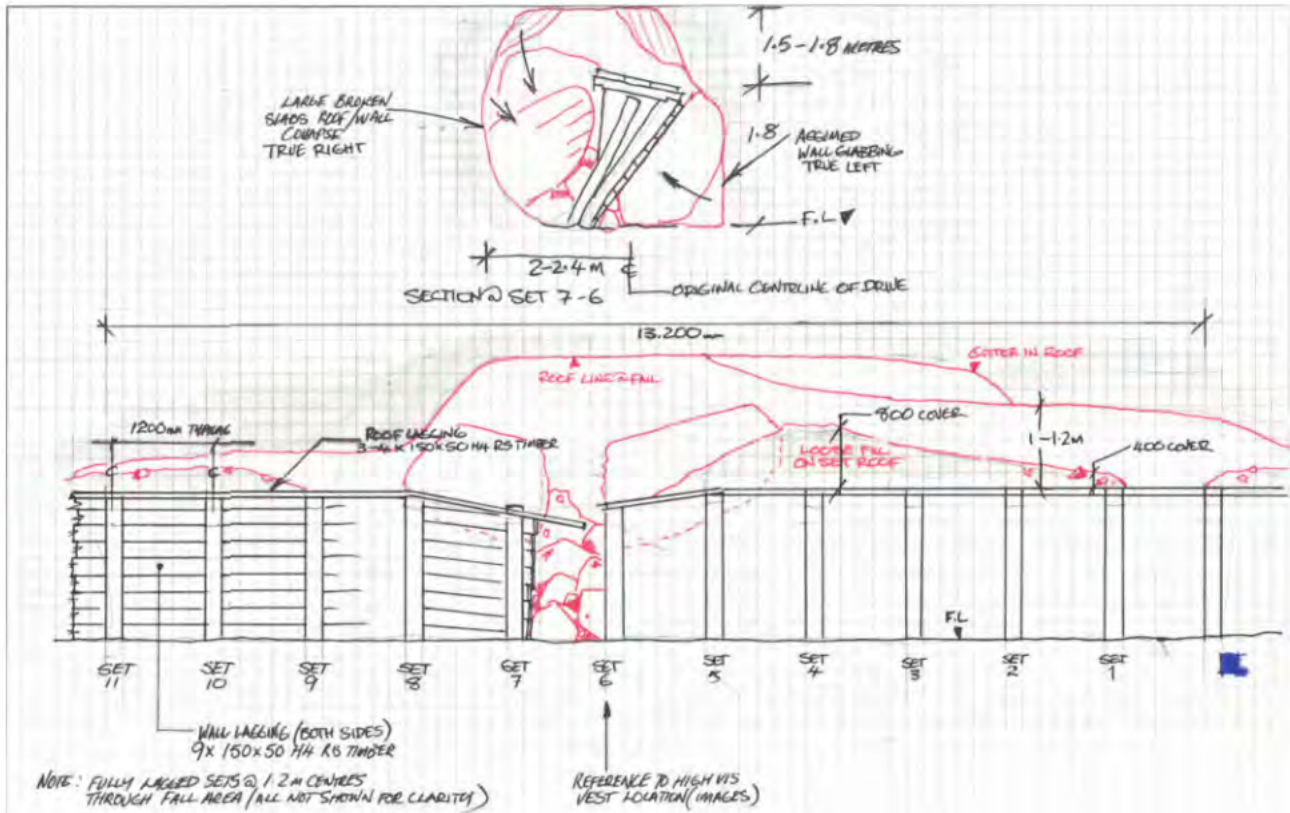
Figure 3: Long section sketch along the fall section of Tunnel 1, showing timber sets and cavity above roof of timbers.

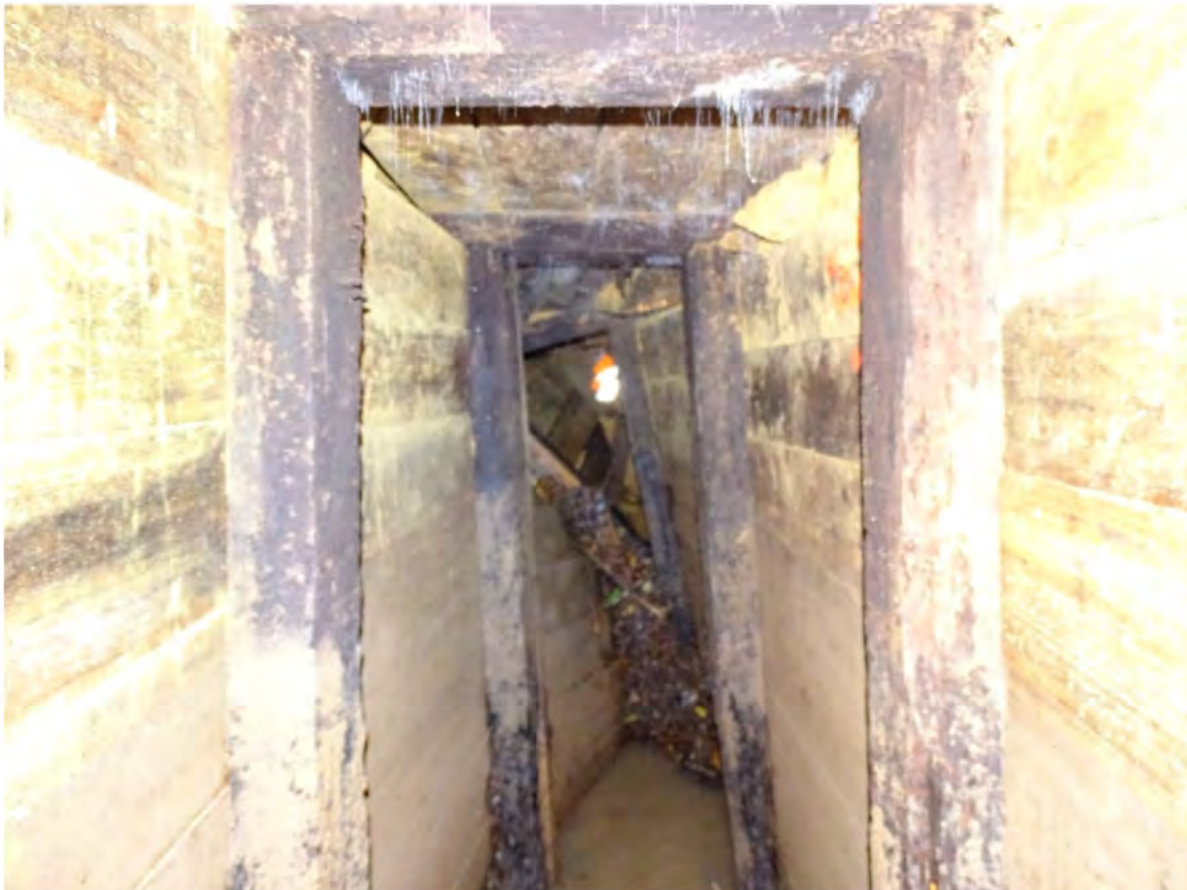
Photograph 2: Collapse section at 870m view looking downstream. Hi-vis item positioned in hole was visible from both directions indicating the tunnel was not fully closed.

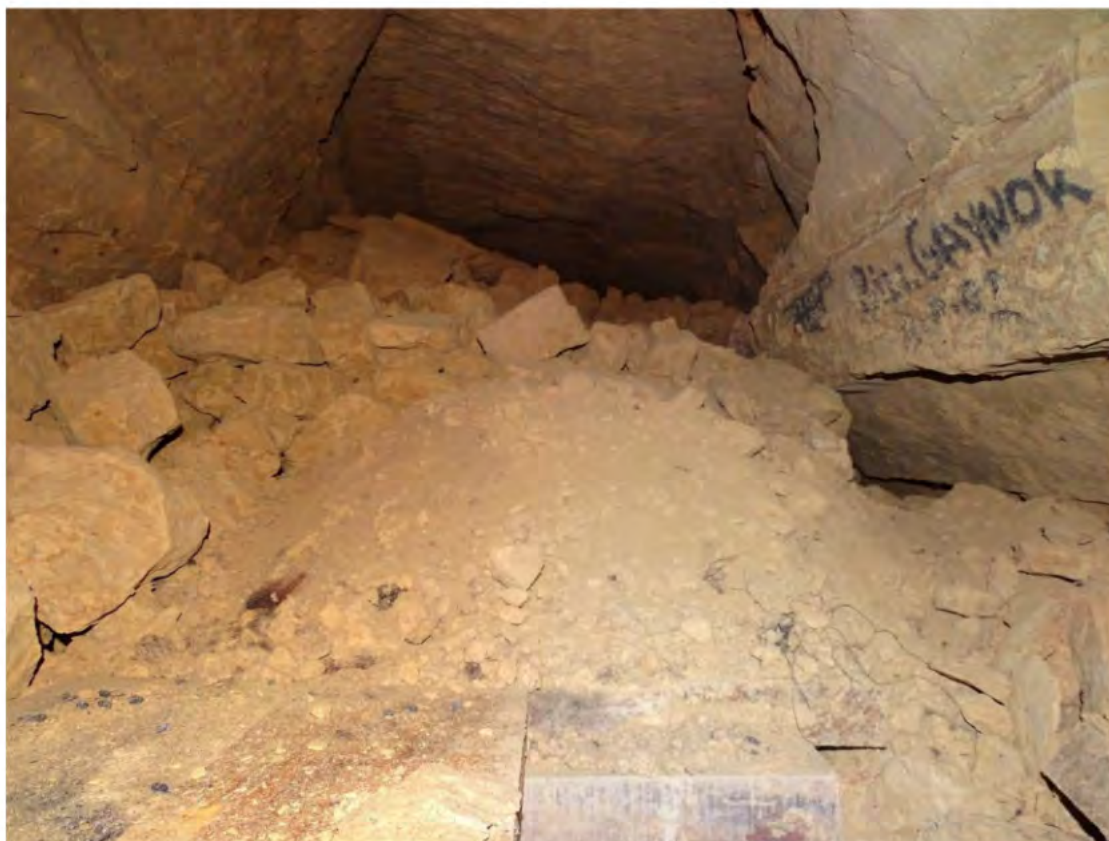
Photograph 3: Void above tunnel roof timbers (visible at base) looking towards collapse area at approximately 870m.
