Perpendicular Point

Natural Hazard
Desktop Assessment
Version 2

24 March 2025

ACG Properties Limited

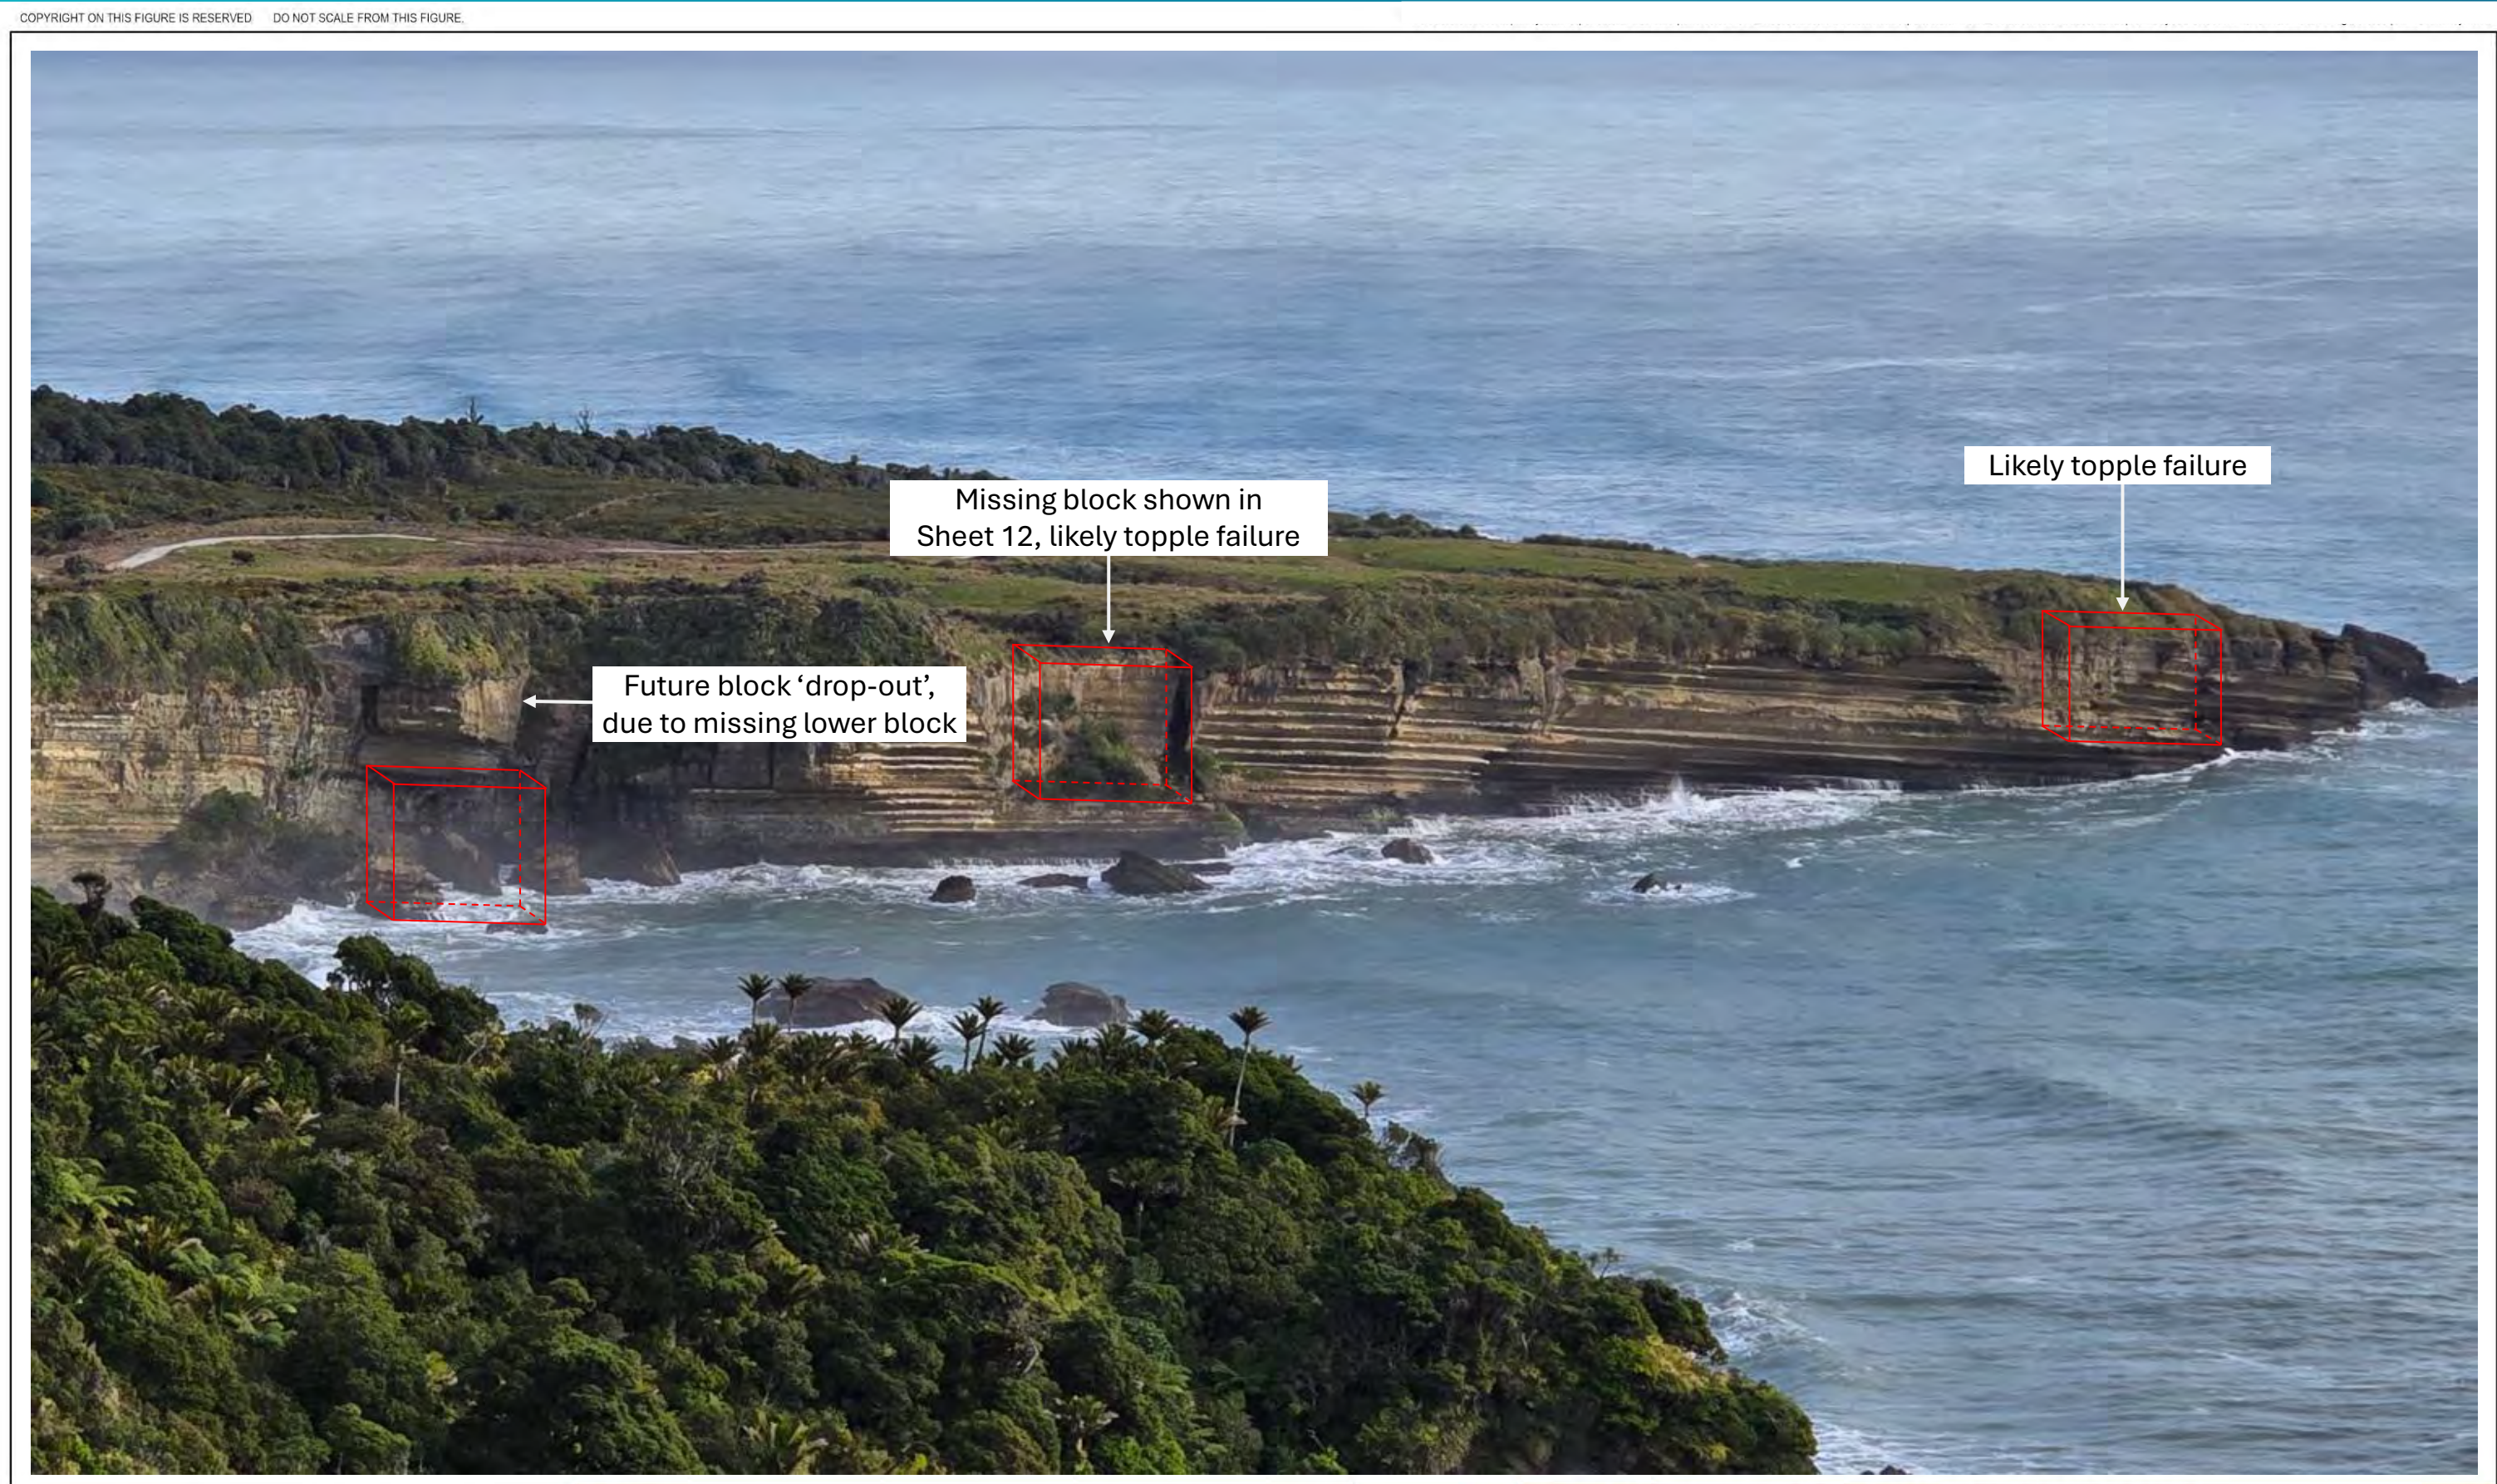
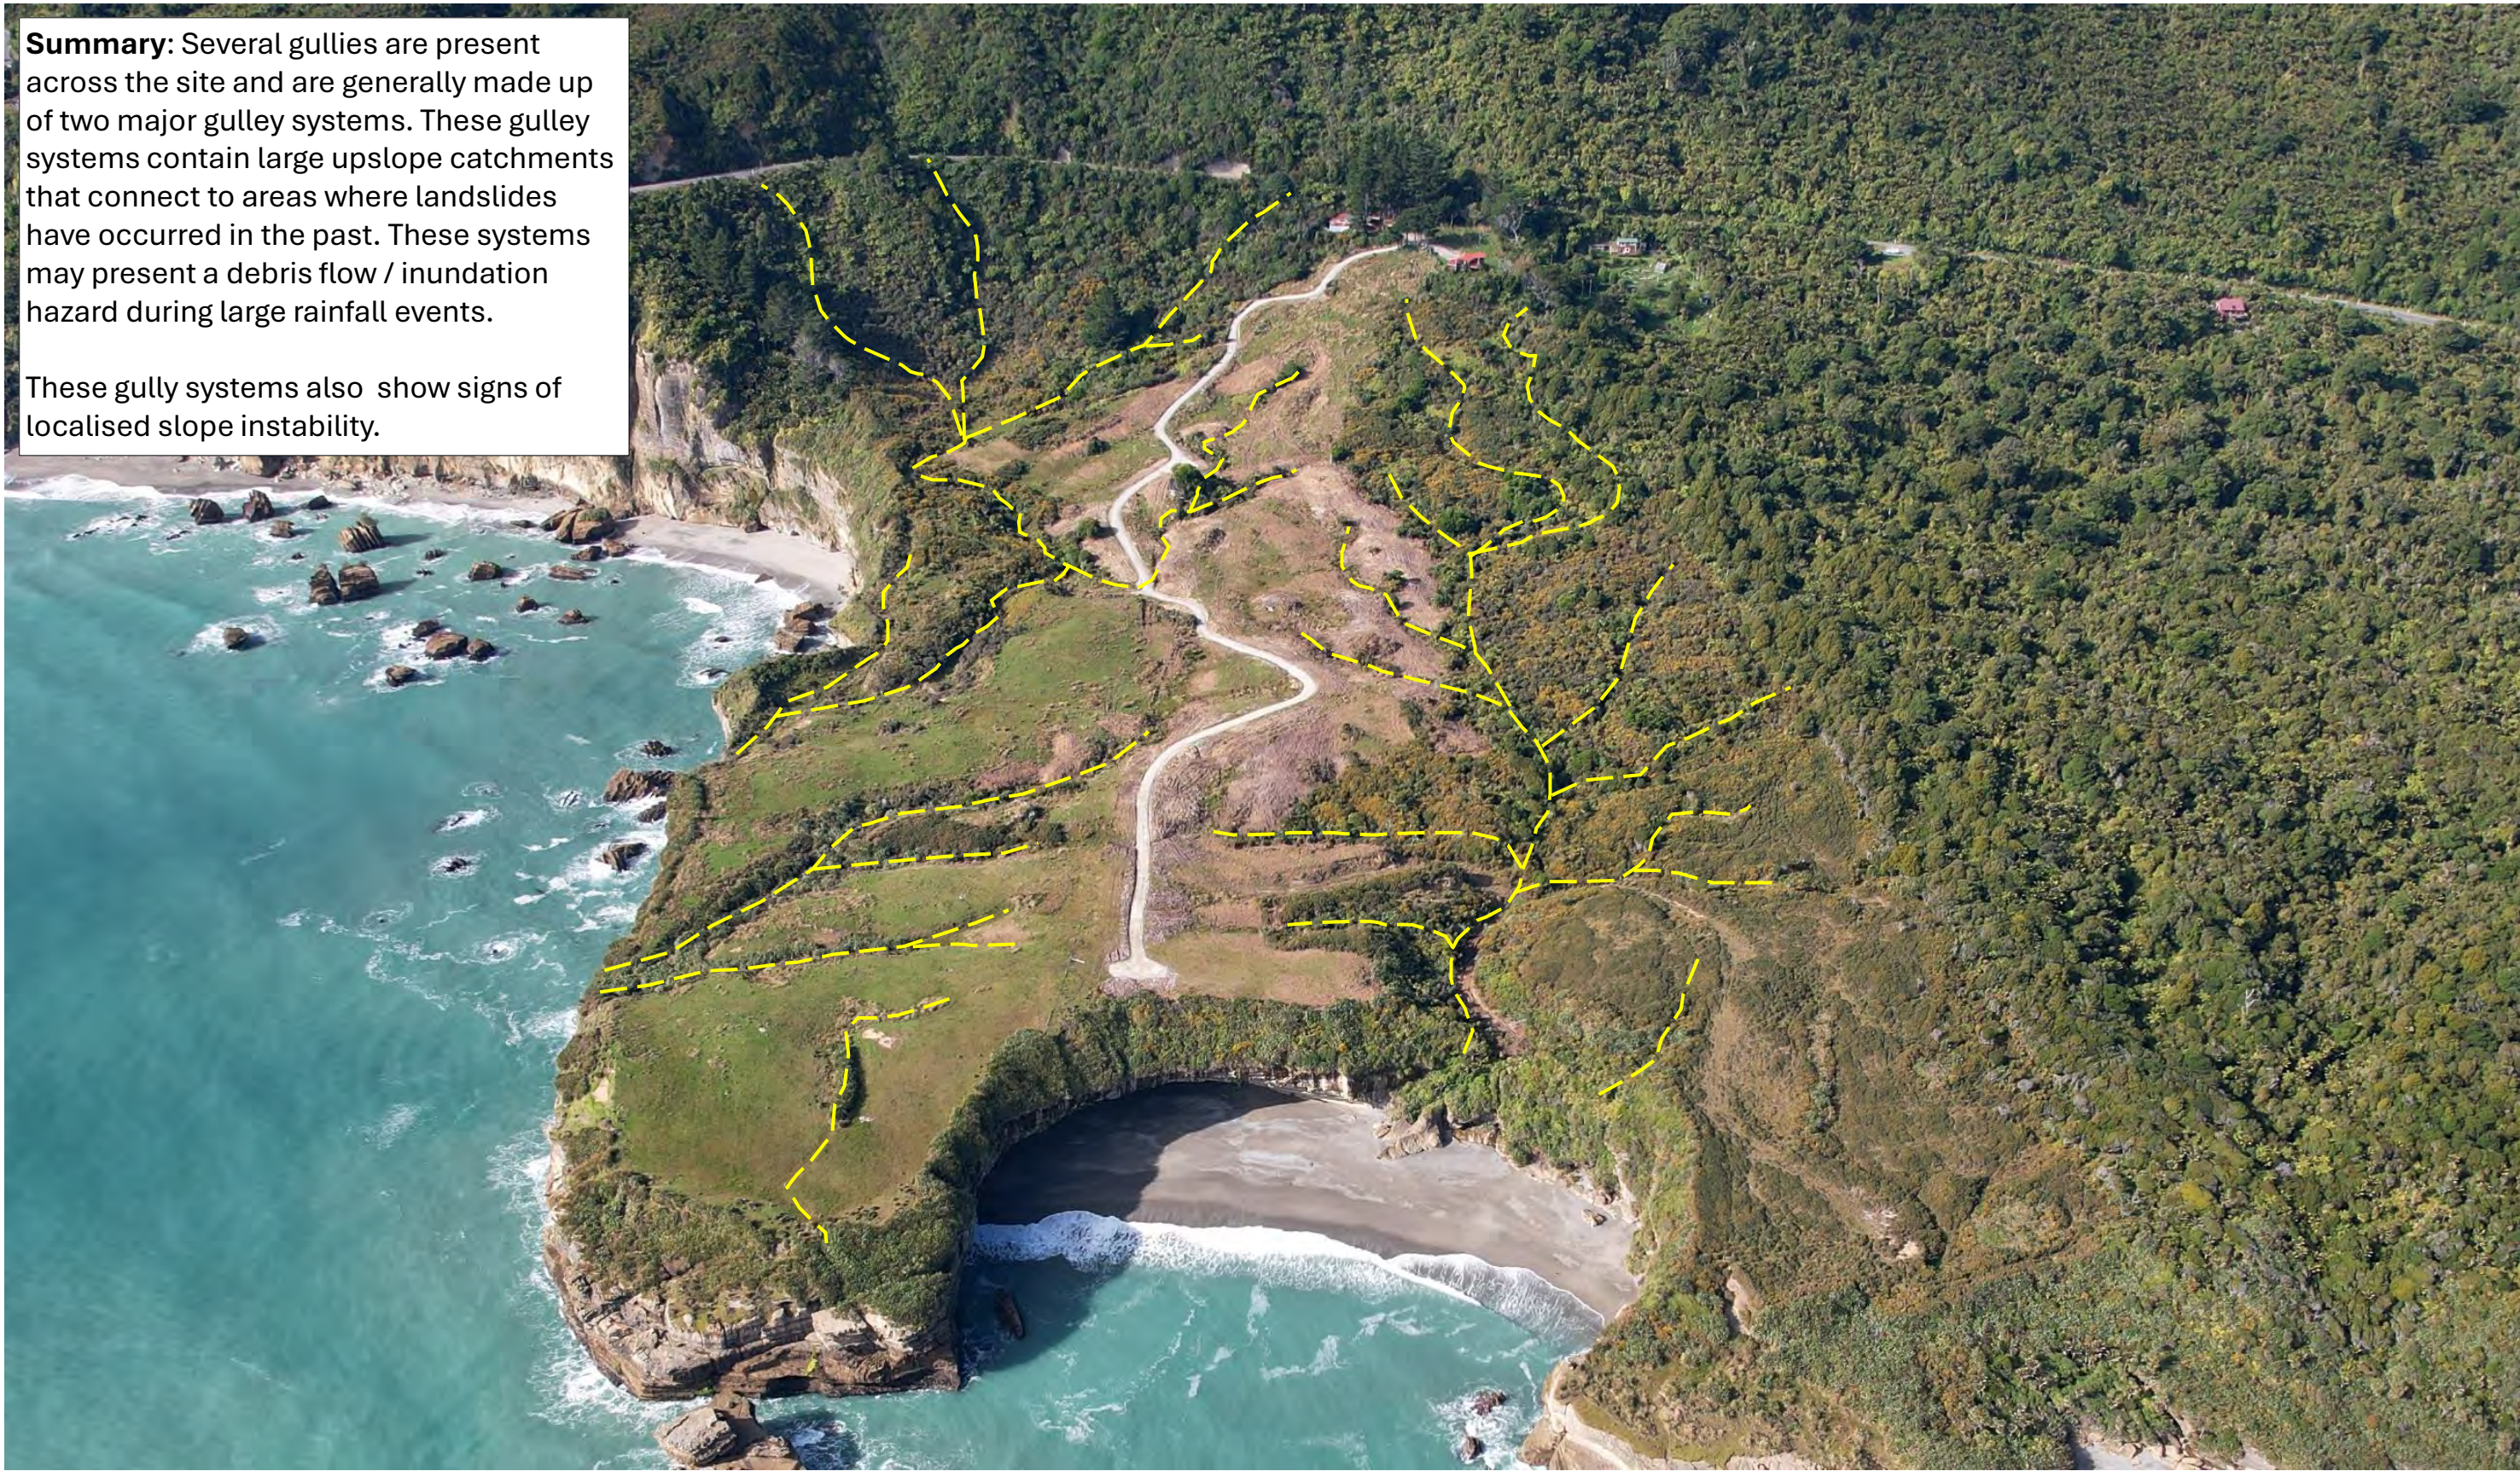
CLIENT	ACG PROPERTIES LIMITED
PROJECT	PERPENDICULAR POINT
TITLE	GULLY HAZARDS JULY 2024 DRONE FLYOVER
FIG No. SHEET 15.	
REV	0

Summary: Several gullies are present across the site and are generally made up of two major gully systems. These gully systems contain large upslope catchments that connect to areas where landslides have occurred in the past. These systems may present a debris flow / inundation hazard during large rainfall events.

These gully systems also show signs of localised slope instability.

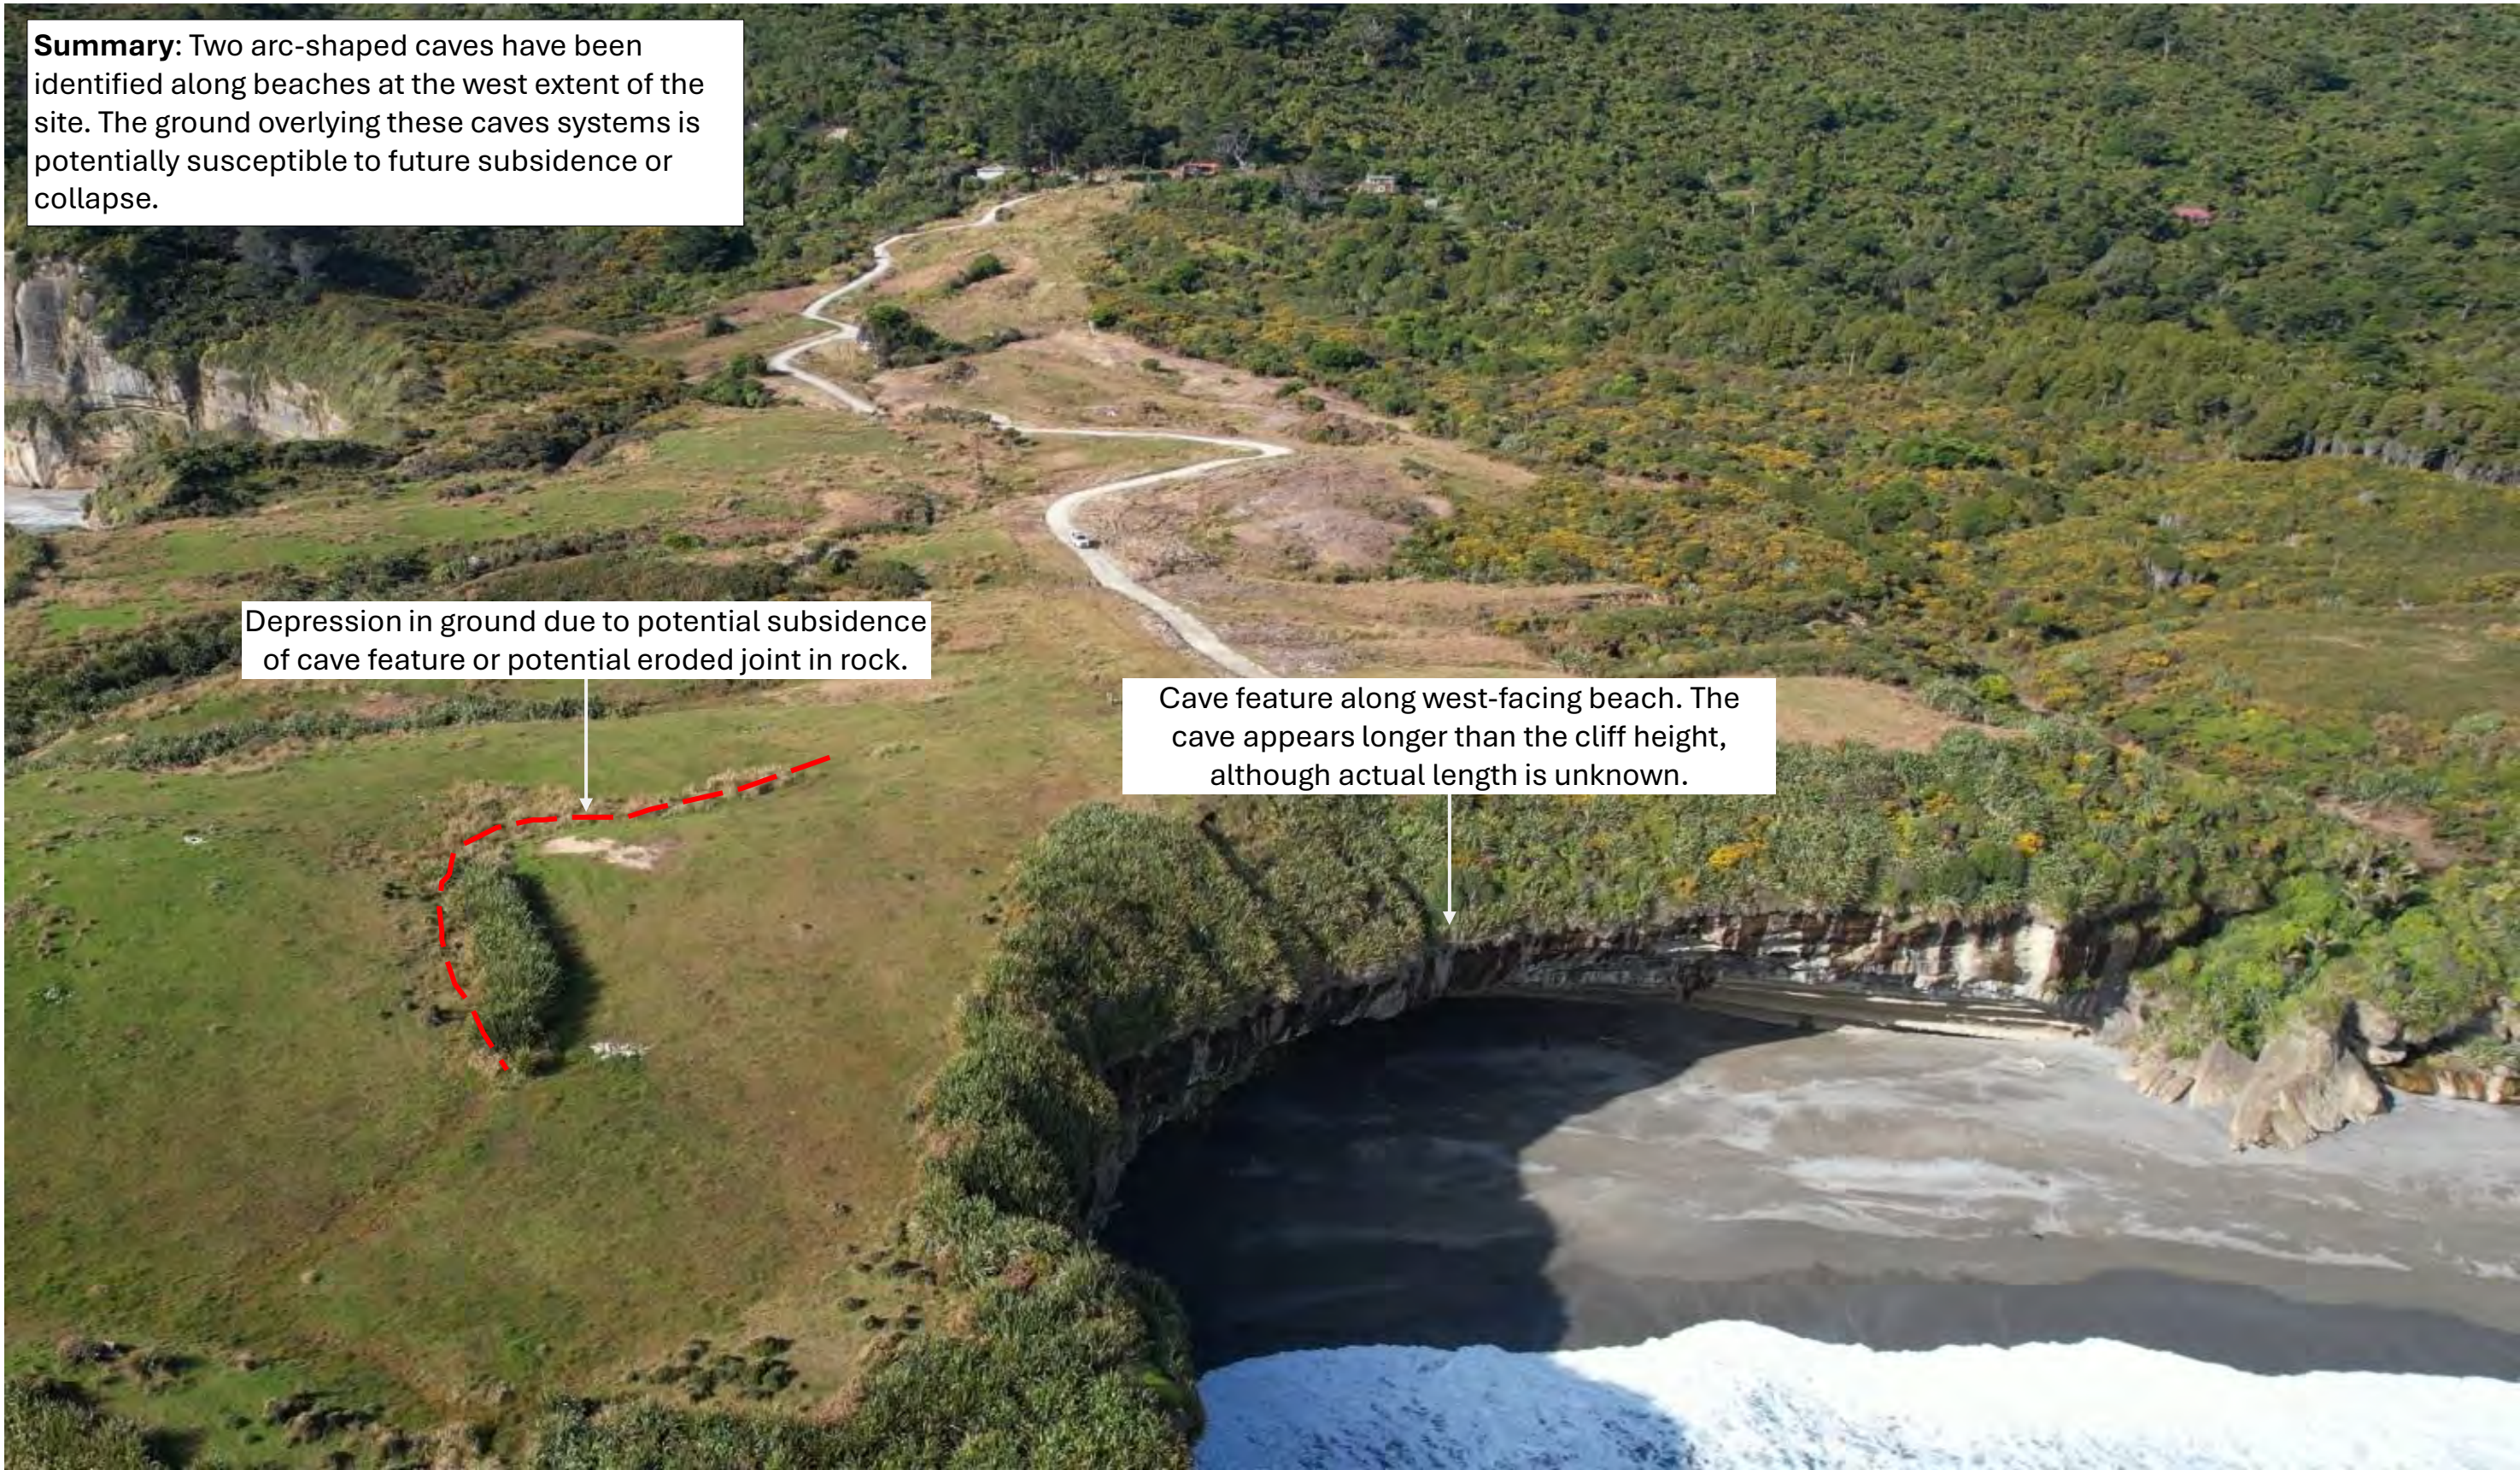
CLIENT	ACG PROPERTIES LIMITED
PROJECT	PERPENDICULAR POINT
TITLE	UNDERMINED CLIFF HAZARD JULY 2024 DRONE FLYOVER [1 OF 2]

Summary: Two arc-shaped caves have been identified along beaches at the west extent of the site. The ground overlying these caves systems is potentially susceptible to future subsidence or collapse.

Depression in ground due to potential subsidence of cave feature or potential eroded joint in rock.

Cave feature along west-facing beach. The cave appears longer than the cliff height, although actual length is unknown.
