GEOTECHNICAL REPORT FOR SUBDIVISION

44214 / LOT 3 DP 360520, STATE HIGHWAY 6 (SH6),
WESTPORT / JOHN RAYMOND MCLAUGHLIN

Title: Geotechnical Report for Subdivision – Lot 3 DP 360520, SH6, Westport

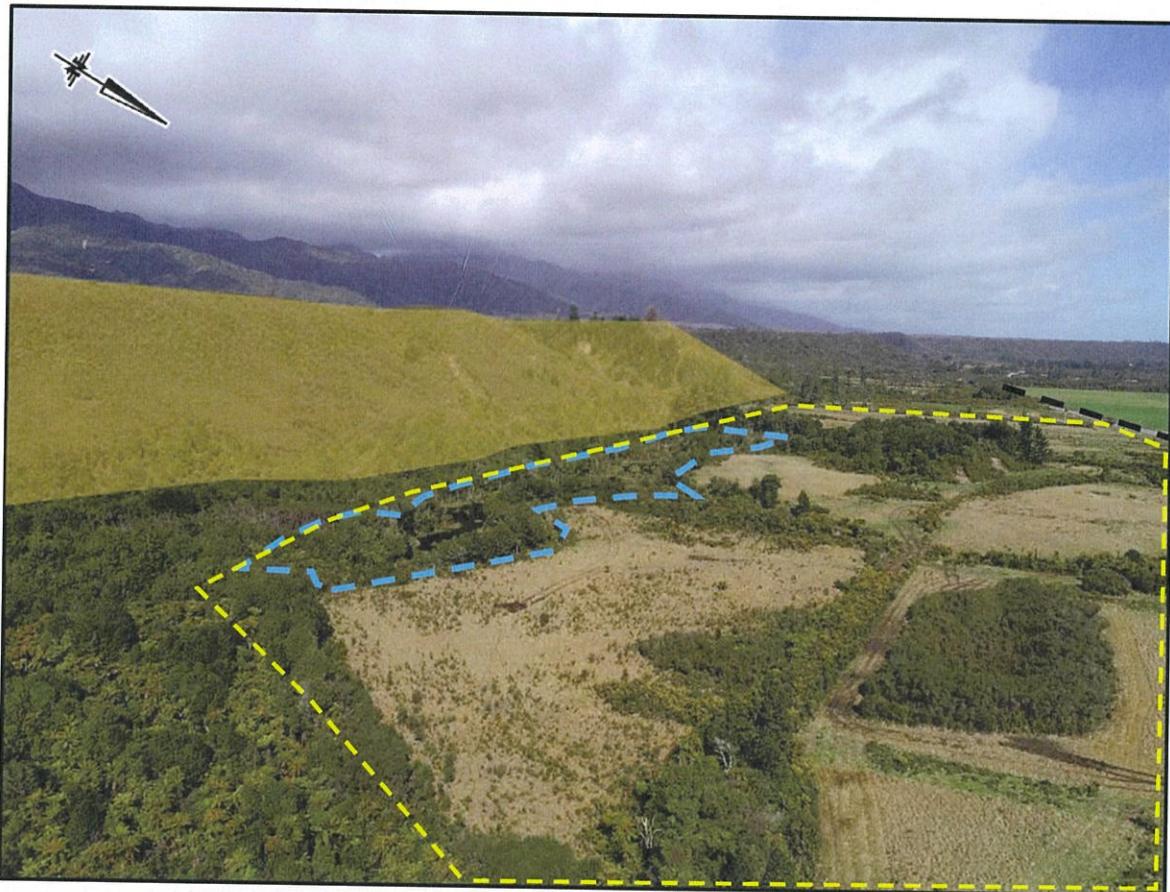
Figure 3: Photo of the site from the north looking southward. State highway 6 on right (black dashed line) and terrace on left (shaded orange). Anthropogenic ponds are visible centrally (blue dashed line). Yellow dashed line indicates approximate area for subdivision. Photo source: Davis Ogilvie, September 2024.

Man-made drainage channels are evident across the southern portion of the site (proposed Lots 7 – 12), oriented west-east to allow for surface water drainage in a westward direction. The site has been predominantly cleared of vegetation and utilised for farming purposes. A currently unsealed access road crosscuts the central part of proposed Lot 13. A large mound of uncontrolled fill material resides across the intersection of proposed Lots 6 and 7, on the western end. This fill pile has become overgrown with large trees and shrubs.

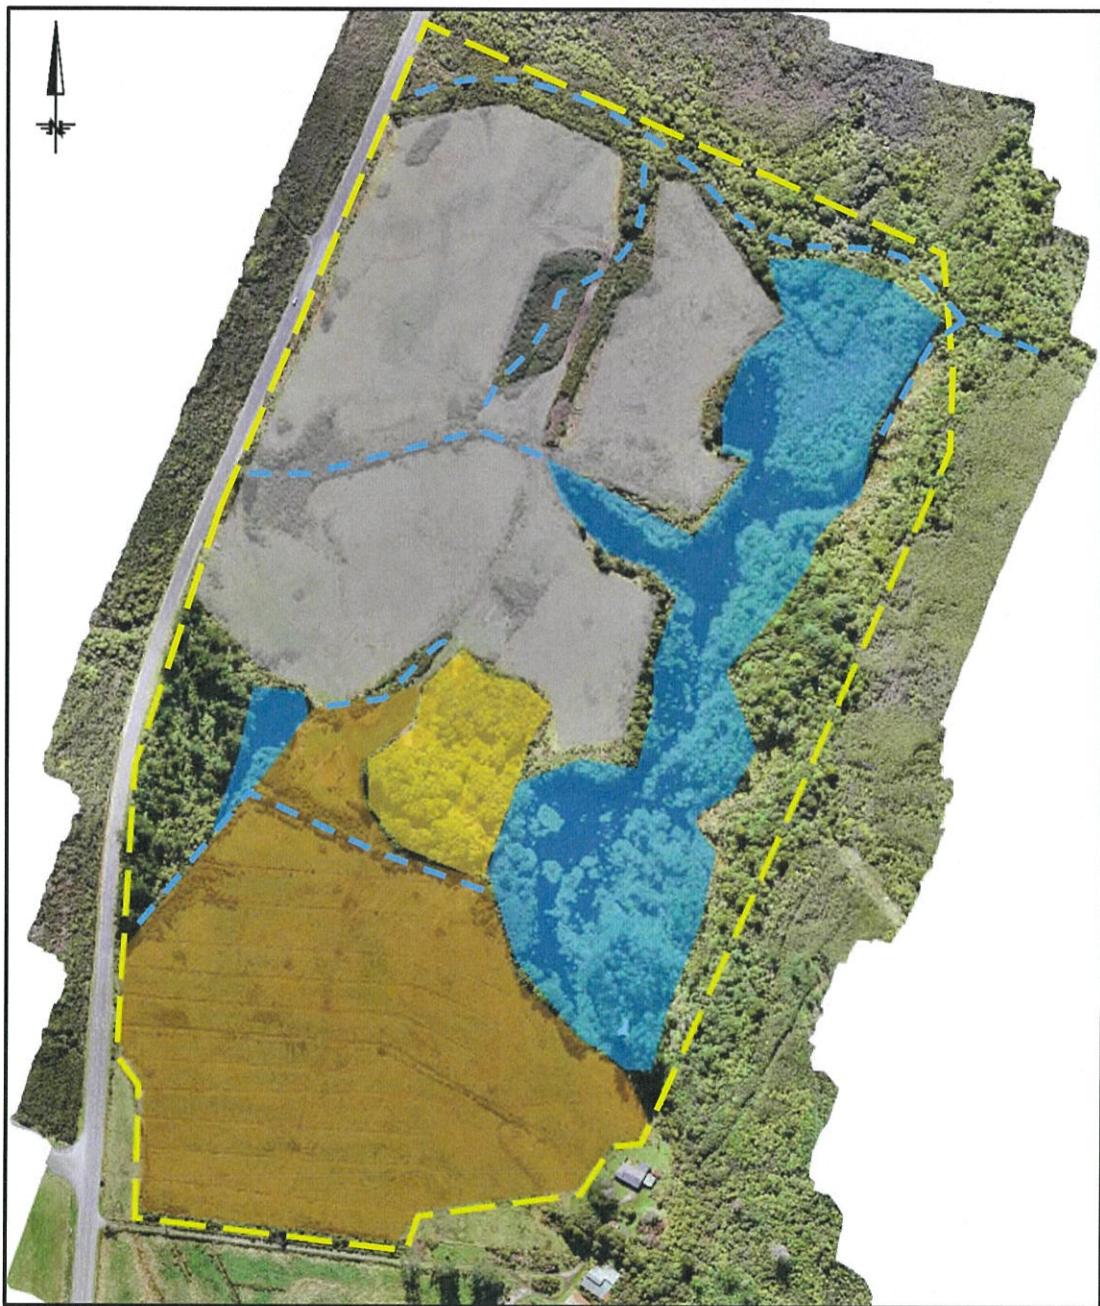
The soil profile indicated by the shallow testing is summarised in Table 2. The surficial soil conditions generally consisted of topsoil and / or organic silt from the ground surface to depths of 0.1 to 0.8 m below EGL. Some variability was encountered below these surficial soils across the site (shown in Figures 4 and 5). Generally, dense granular soils (typically cemented) were encountered at shallow depths ranging from 0.1 to 1.8 m below ground level. These are interpreted to be the cemented marine sands and gravels indicated by the published geology. Some areas encountered softer, more organic units varying in thickness from 0.3 to 1.2 m, generally overlying denser soils. In some places cemented soils were underlain by dense sandy / granular soils to a maximum depth of 4.5 m. There is evidence the upper layers of soil towards the south have been flipped in order to promote drainage, accompanying the incised drainage channels (shown on Figure 4).

Figure 4: Image showing indicative site boundary (yellow dotted line). Blue shaded areas indicate standing groundwater (ponds), and blue dashed lines indicate natural drainage channels (creeks). Yellow shaded area indicates old gravelly fill stockpile. Areas of shallow cemented sand indicated in grey, and more recent deposits and / or "flipped" soil in brown. Drone imagery provided by Davis Ogilvie September 2024.

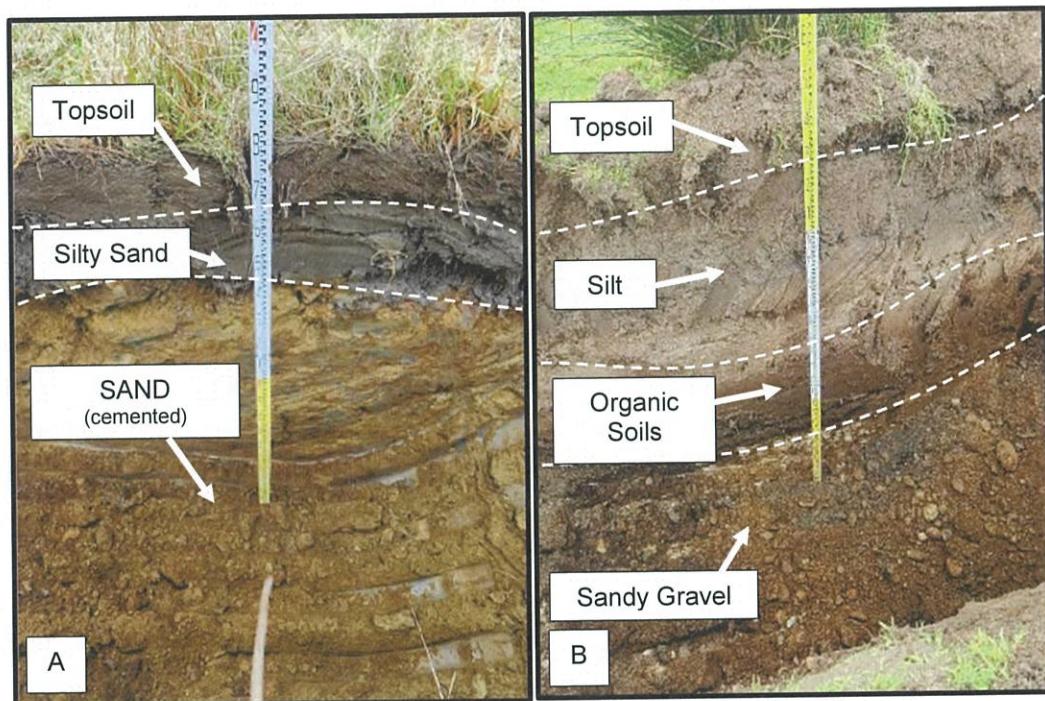
Figure 5: Example of shallow soil profiles encountered on site. Left TP 05 showing shallow granular and cemented soils (A), and right TP 11 showing shallow soft and organic soils with deeper gravelly soils (B). Photos taken September 2024.

Standing groundwater was encountered during the investigation and was generally recorded at depths ranging from 2.4 m to 4.2 m below EGL depending on location, with shallow water seepage from between 0.2 – 0.6 m below EGL. The presence of cemented soils and iron pan layers encountered in several areas across the site has likely led to perched (shallower) groundwater seepage / surface water ponding conditions developing on site following periods of heavy and / or prolonged rainfall, depending on location.

A timber floor option incorporating piles founded in the dense granular soils from between 0.3 – 1.8 m below EGL depending on location is considered a suitable foundation solution. It is noted that the presence of cemented granular soil/iron pan within the shallow soils on some areas of the site may limit the effectiveness of driven piles, therefore bored or cast-in-situ methods may need to be considered. Sufficient embedment into the dense soils will be required to provide lateral support.
