Subdivision Suitability Report

**Section 41 SO 13711, Tauranga Bay
Road, Westport**

Prepared for Tauranga Bay Holdings Ltd
510322

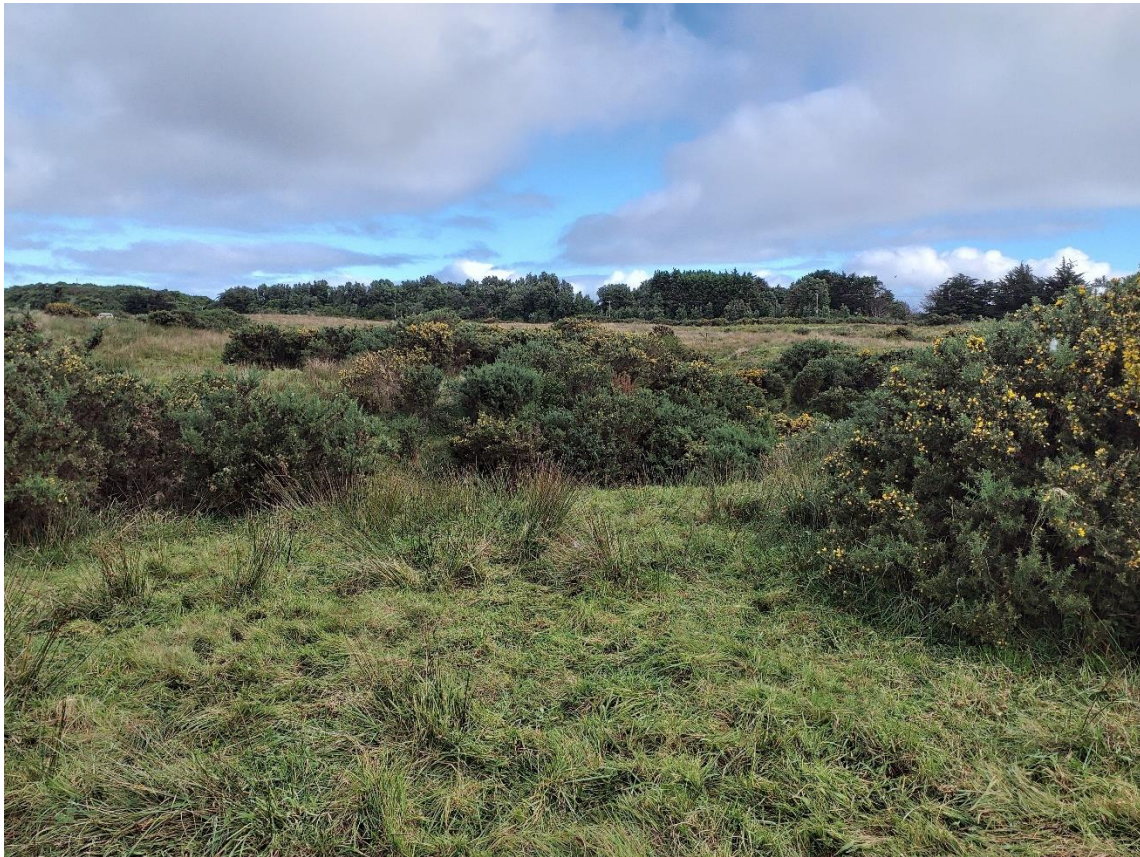
Figure 2. Looking towards Valley B.

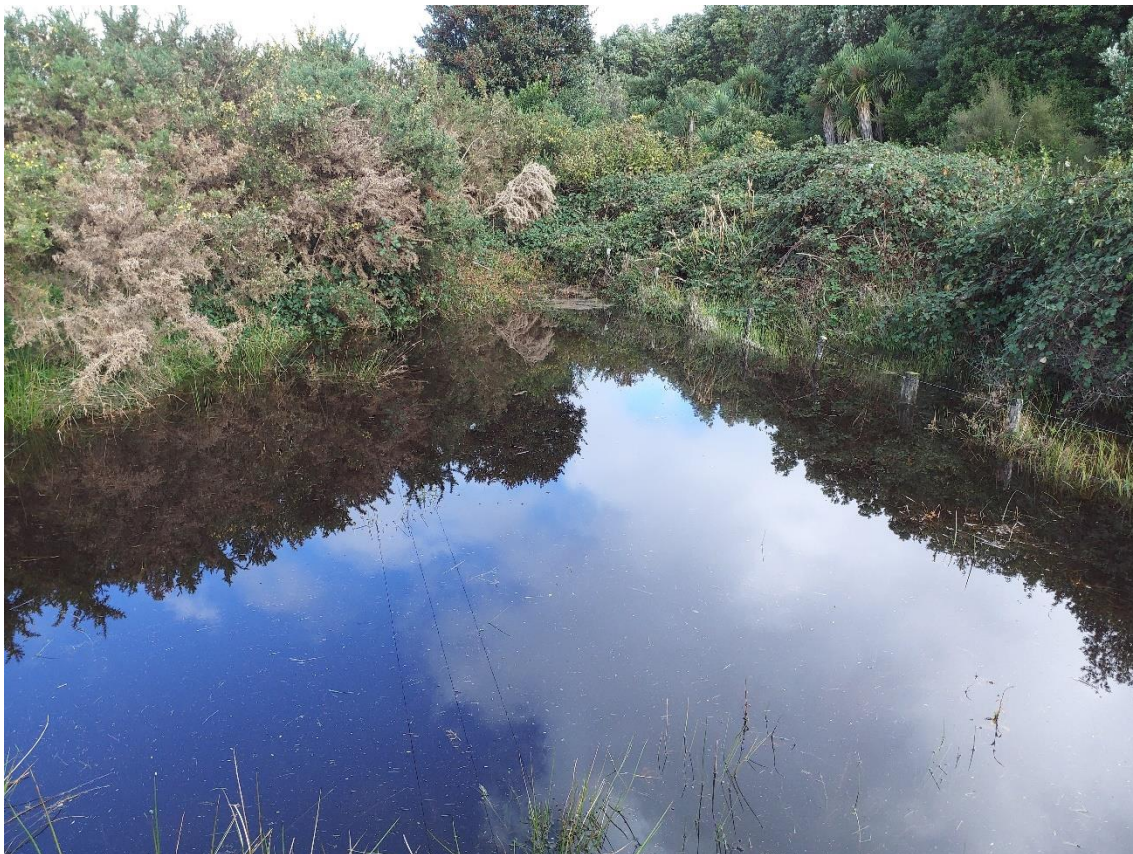
Figure 4. Drainage adjacent to Tauranga Bay Road on western side of site.

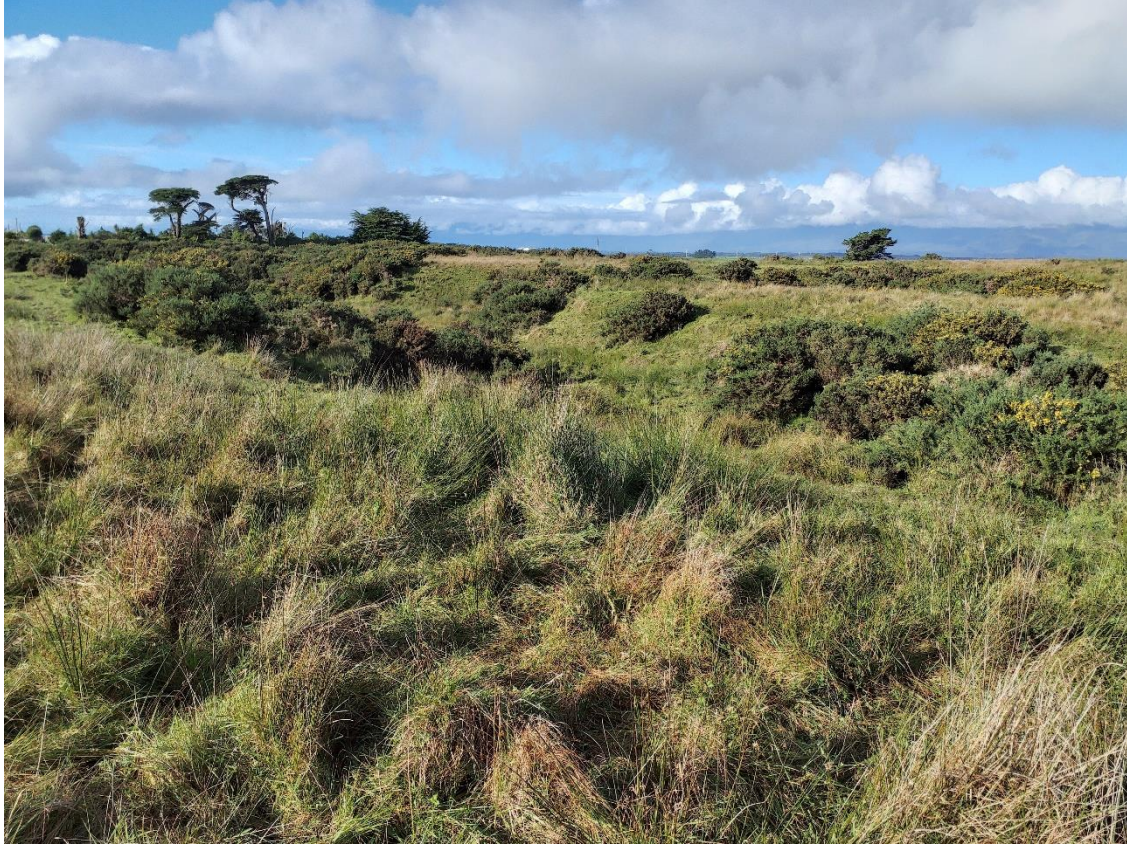
Figure 5. Southern end of Valley B.

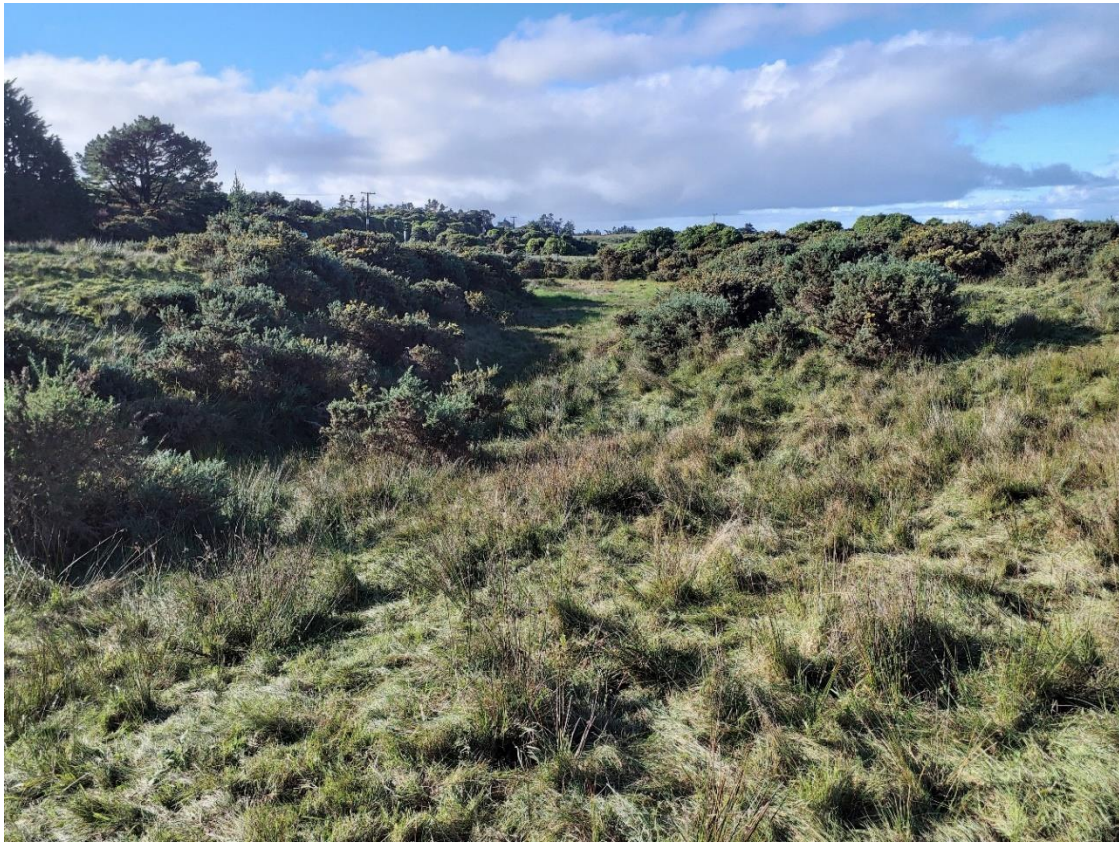
Figure 6. Facing north from looking across a Valley A towards the Wilson Lead Road and Tauranga Bay Rd intersection.

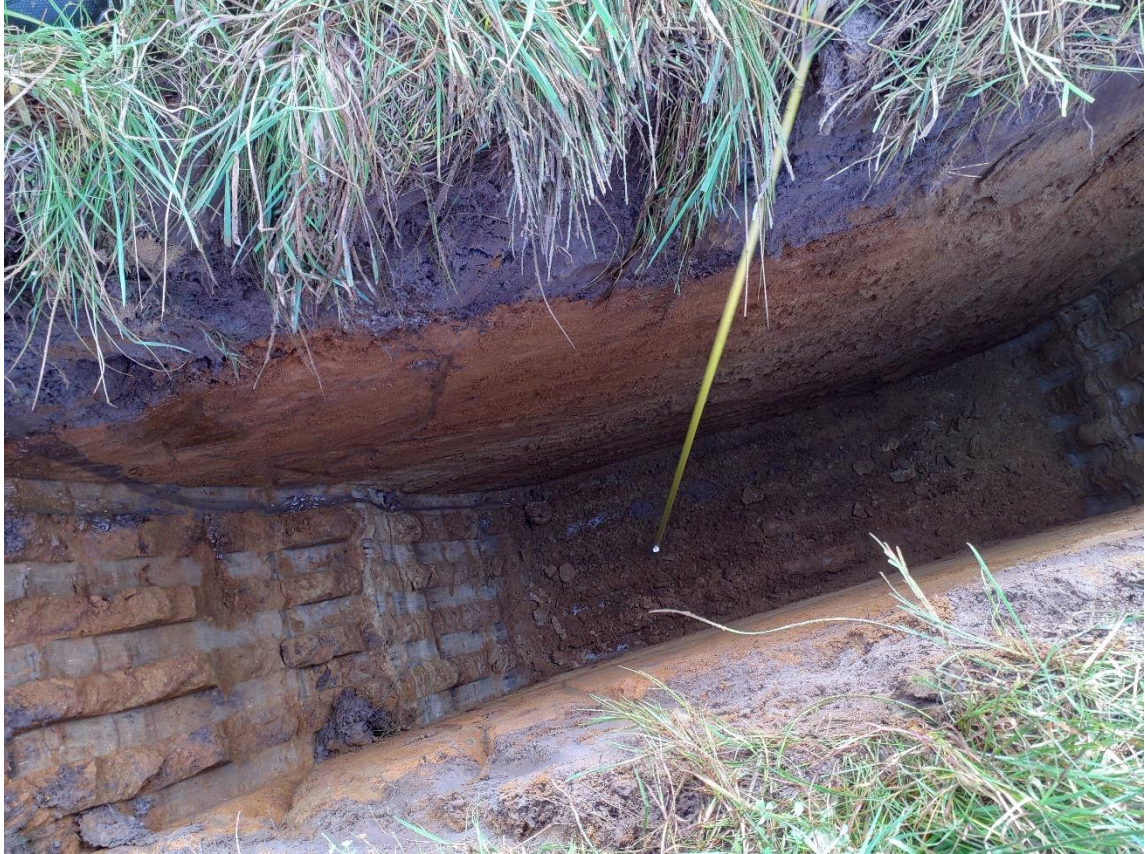
Figure 7. Test pit in area A.

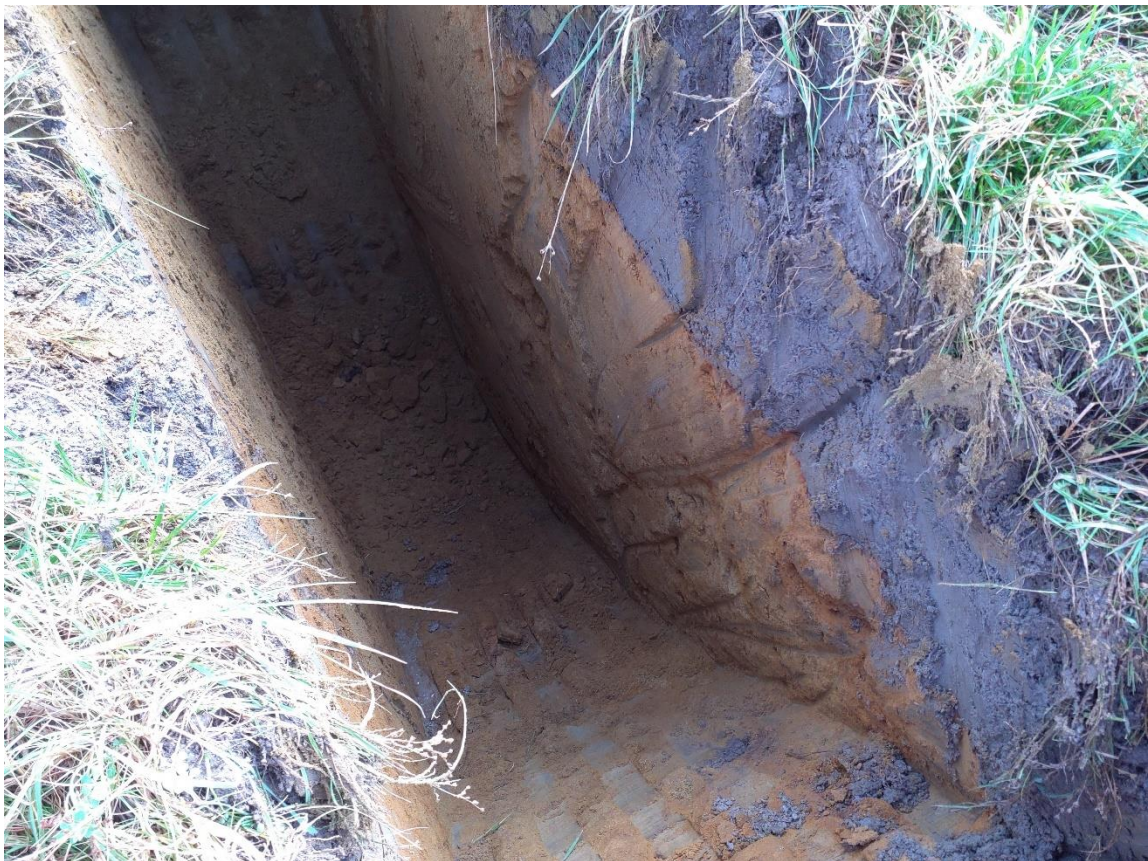
Figure 8. Dense sand encountered at test location 3.

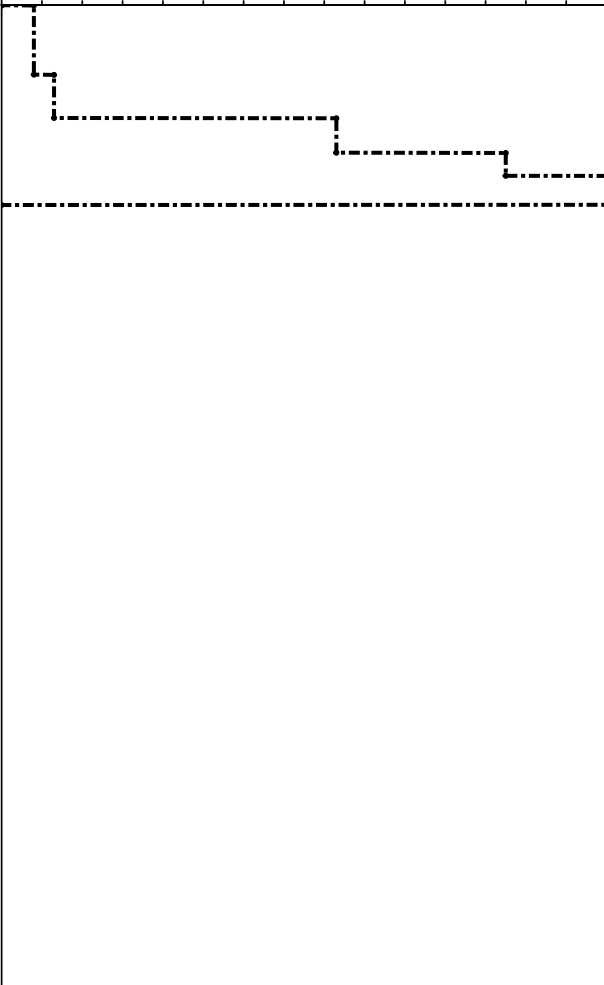
06

0.2	TS	TOPSOIL & SILT, with some sand; brown.	Groundwater Not Encountered
														0.4		SAND; orange. Iron pan. SAND; orange brown.	
														0.6			
														0.8		SAND; greyish brown.	
														1.0			
														1.2			
														1.4			
														1.6			
														1.8			
														2.0			
														2.2		EOH: 2m - Target Depth.	
														2.4			
														2.6			
														2.8			
														3.0			
														3.2
