# Subdivision Suitability Report

**Section 41 SO 13711**

Prepared for Tauranga Bay Holdings Ltd  
510322

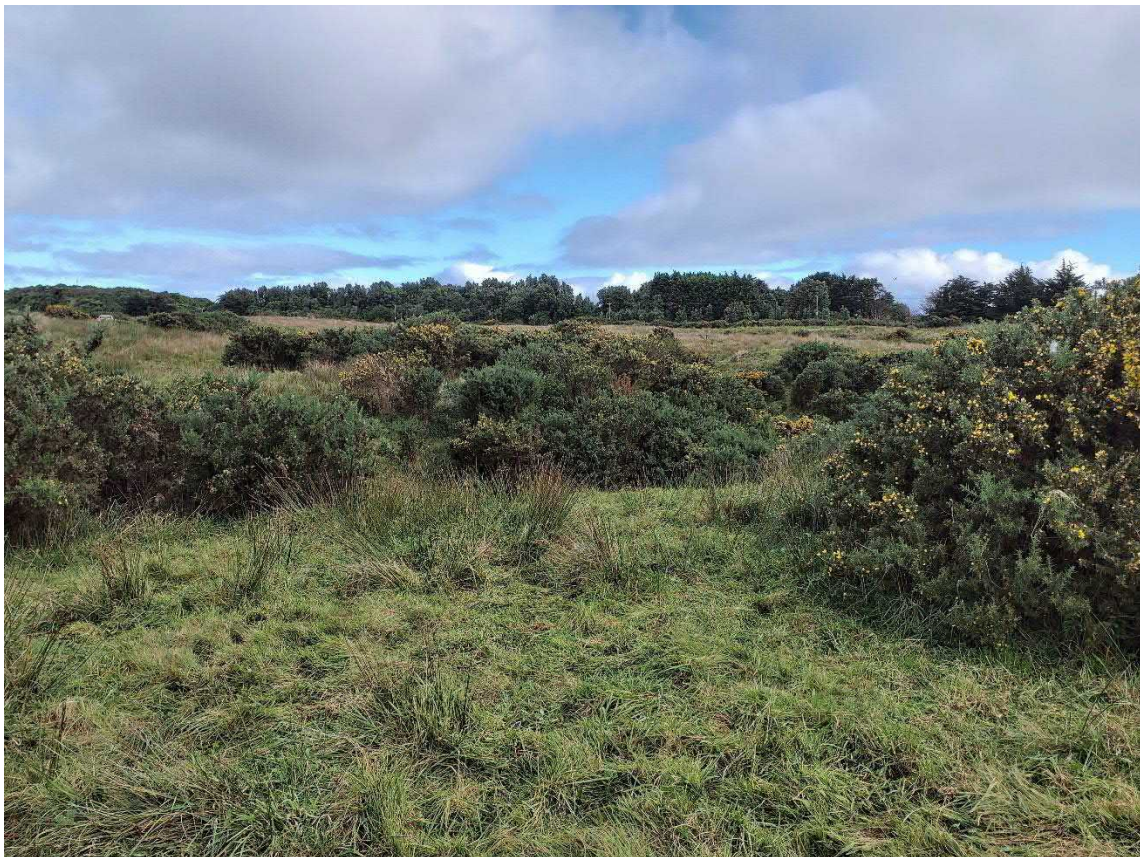
**Figure 2. Gully by area G.**

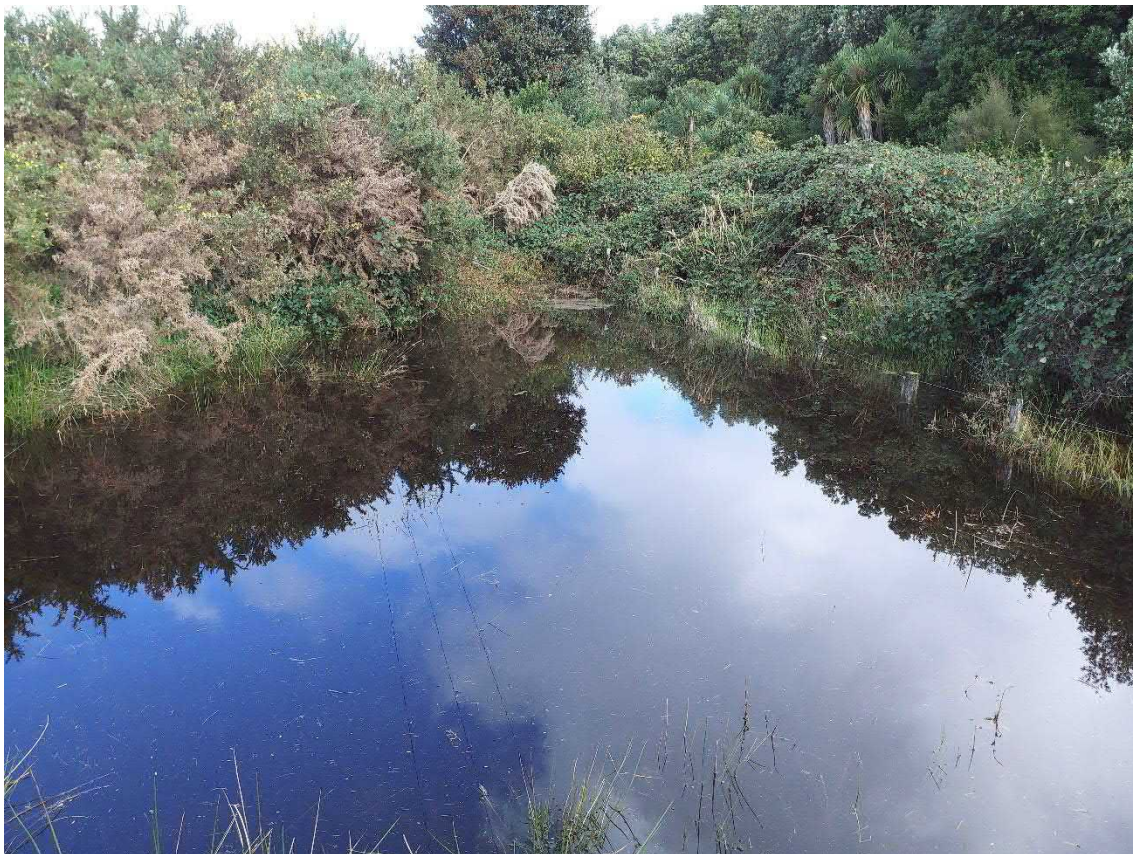
**Figure 4. Drainage adjacent to Tauranga Bay Road by area J**

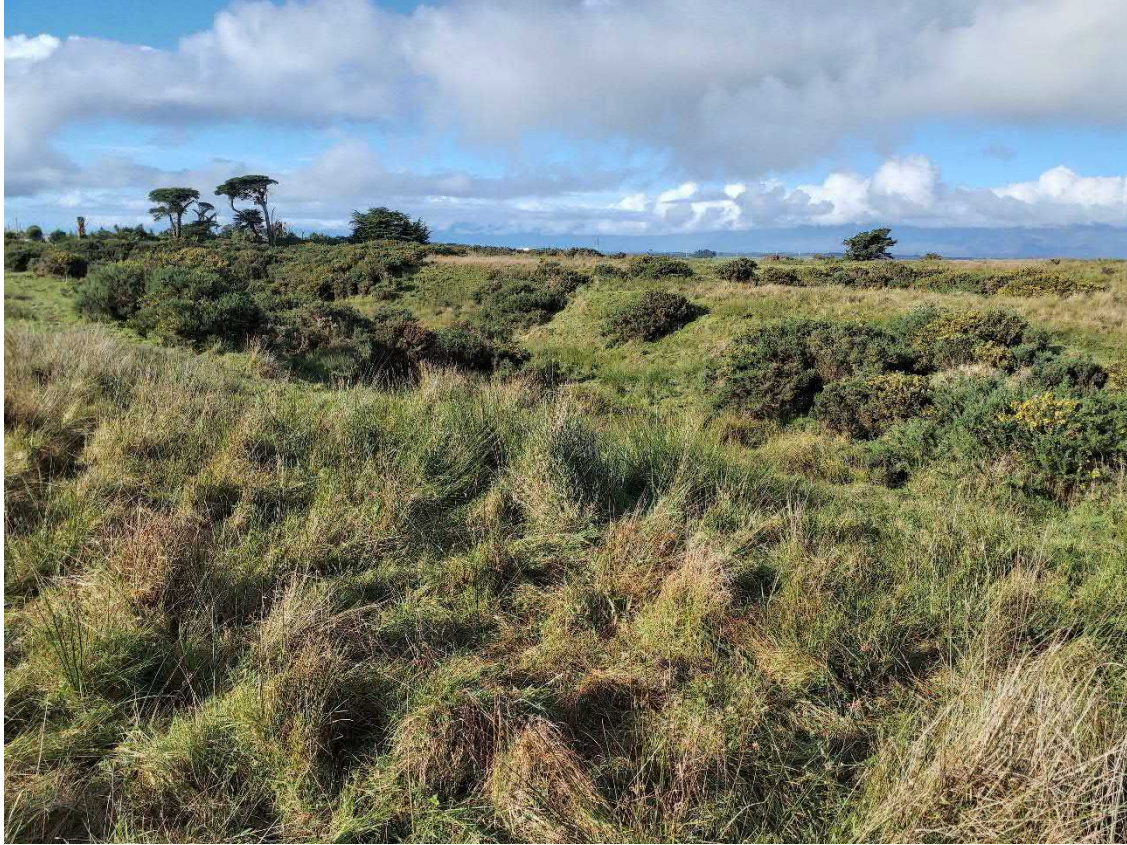
**Figure 5. Gully south-east of area L**

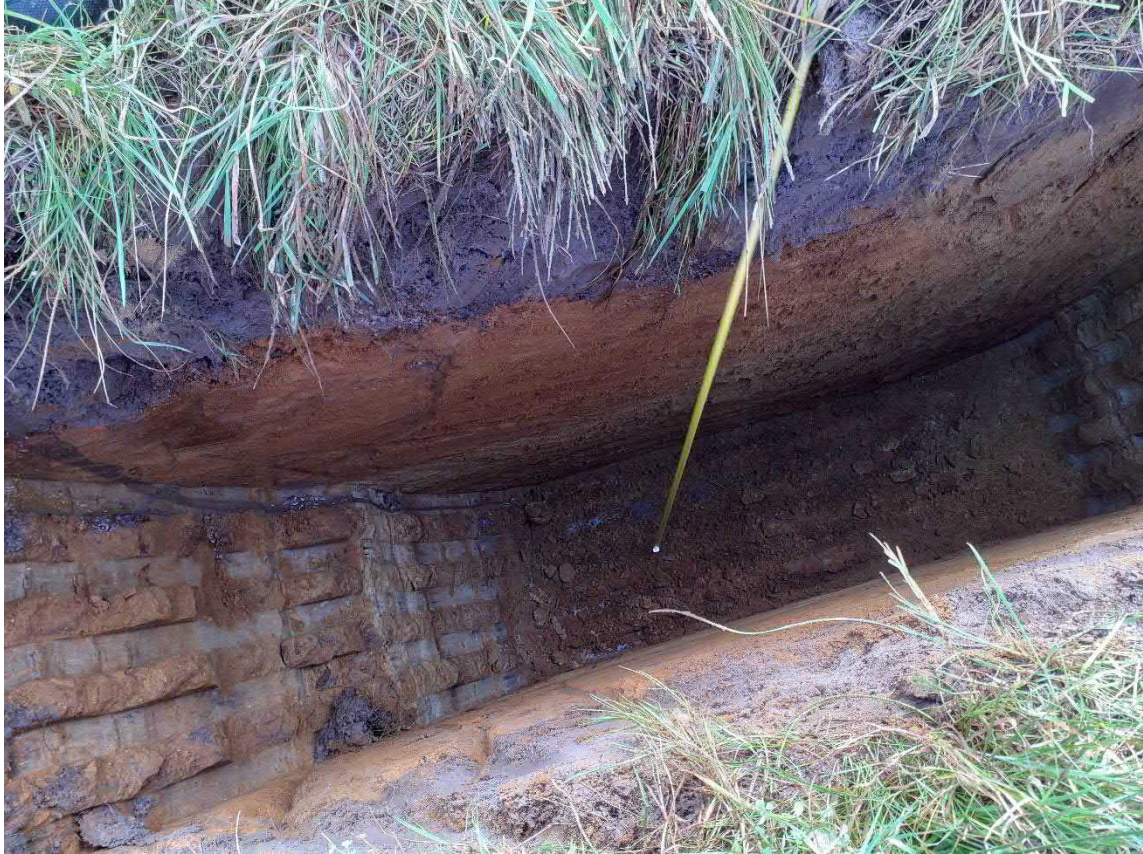
**Figure 7. Test pit in area A.**

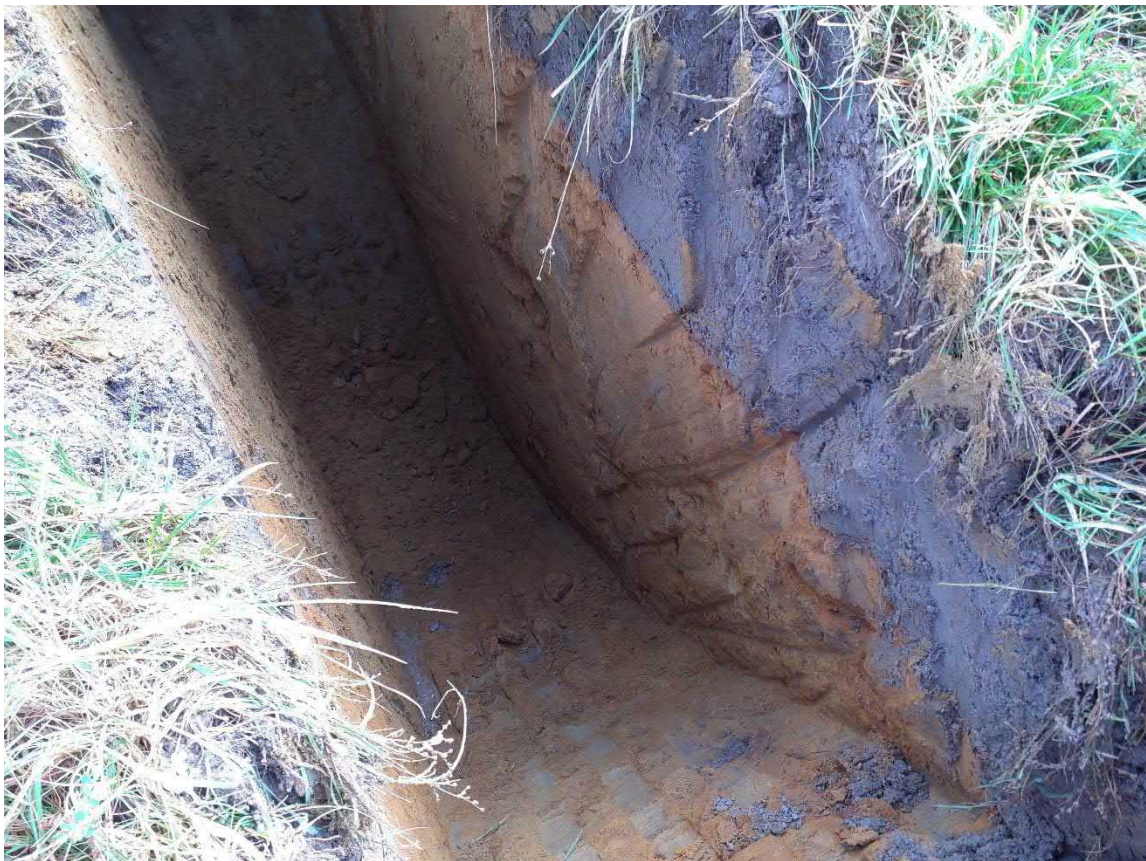
**Figure 8. Dense sand encountered in area B.**

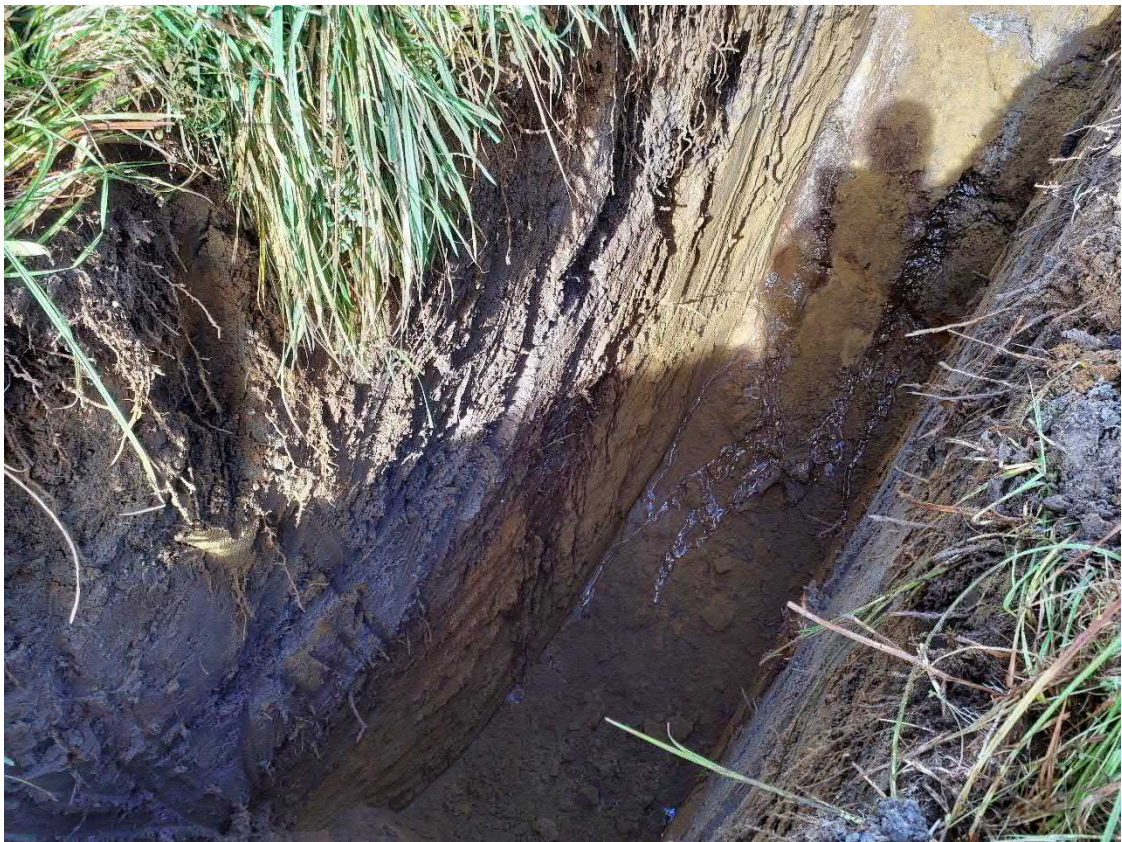
Uncertified fill was encountered in two areas investigated: areas E and K. Area E is located around halfway along the boundary adjacent to Wilsons Lead Road. The test pit in this area, at test location 07, encountered around 1.2m of fill over iron pan. This test area was next to an existing accessway from Wilsons Lead Road into the site, and it appears the uncertified fill may be overlying soft silt which was removed in the construction of the accessway.

Figure 10. Test pit in area E

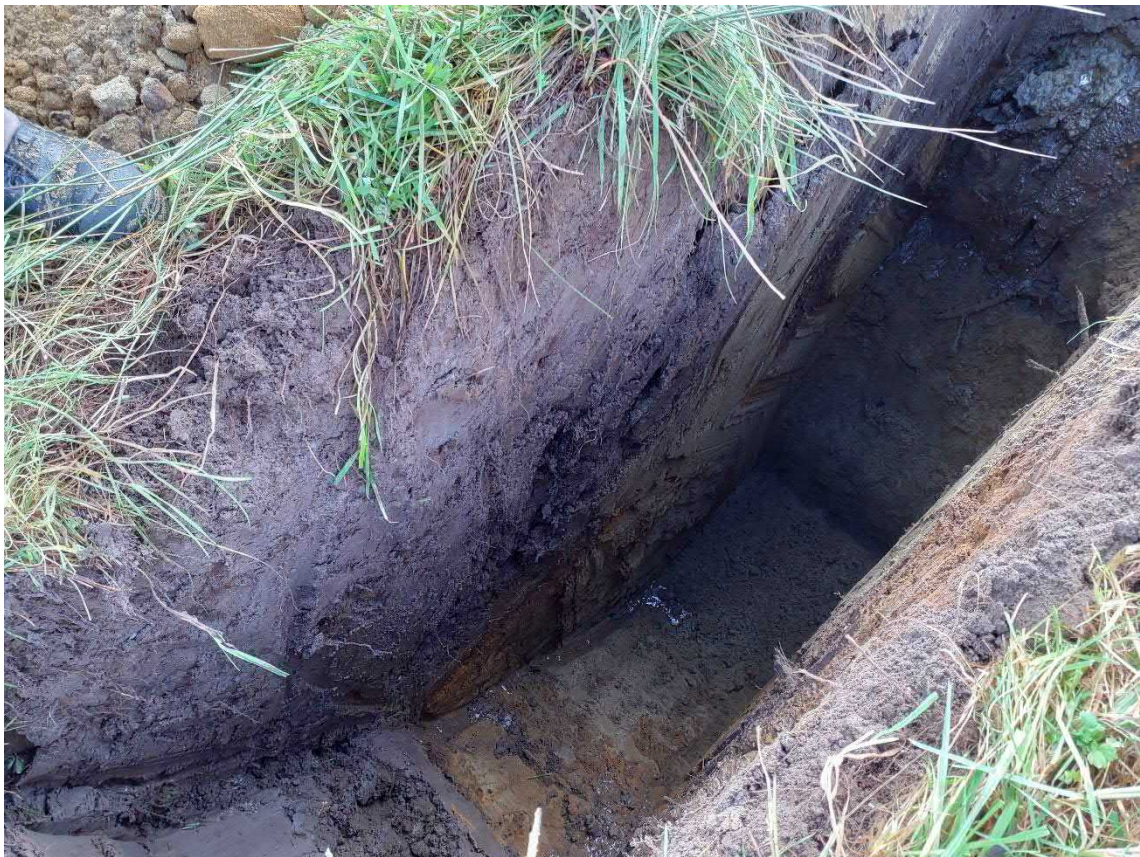
Figure 14. Test pit in area J
