Punakaiki Wild, West Coast

Ecological Effects Assessment

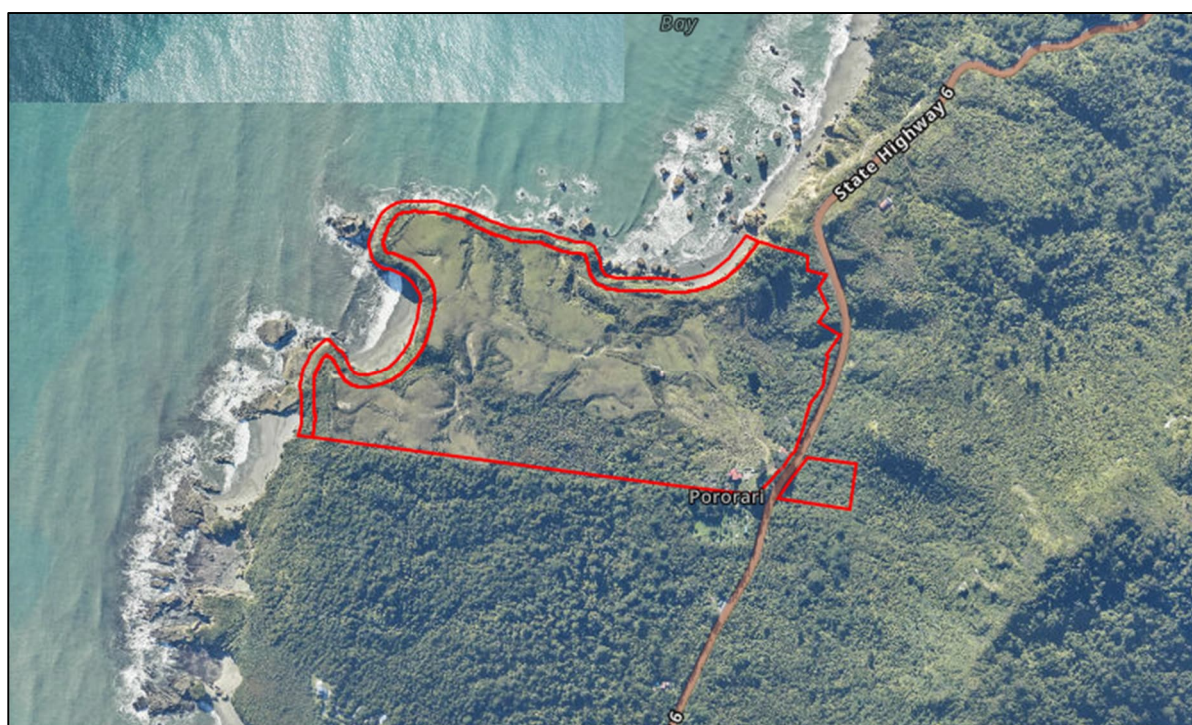
Figure 1: Site boundary as outlined in red. This is the investigation area that is the subject of this report.

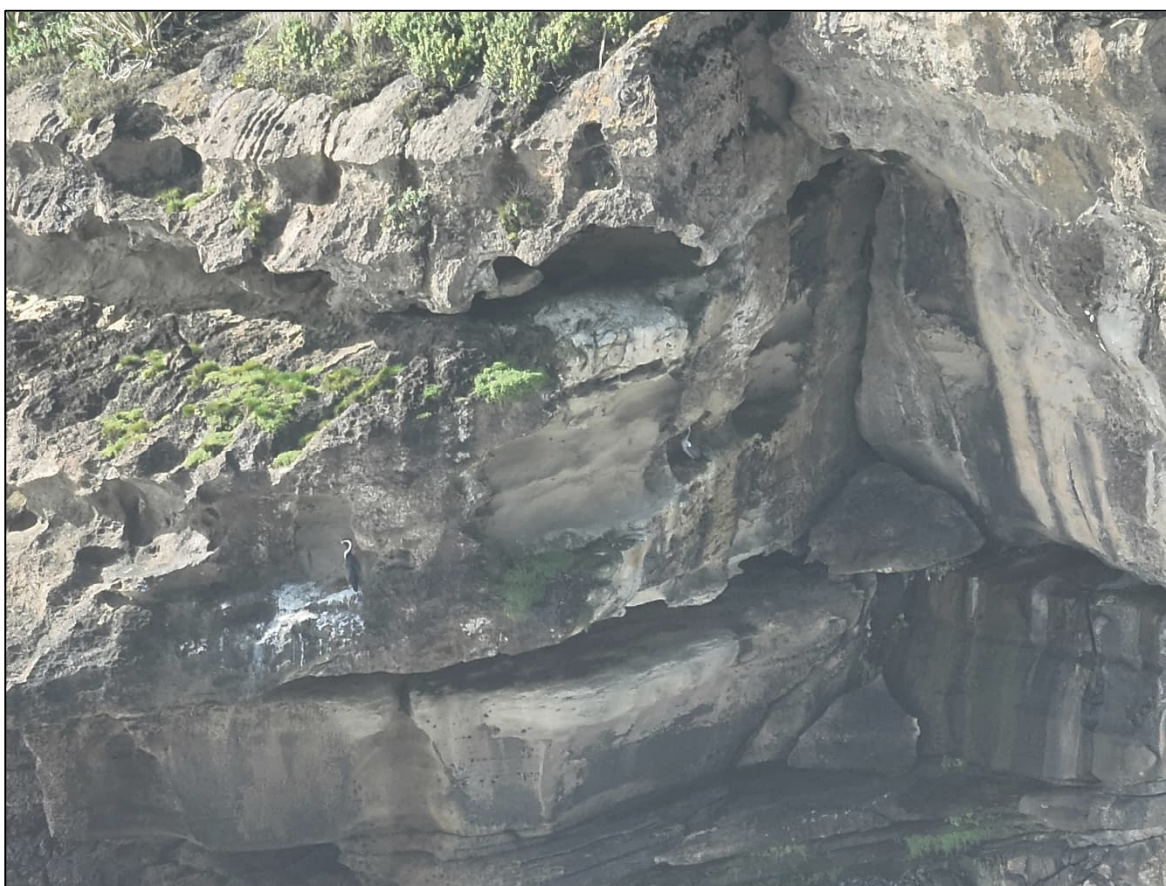
Plate 3: Drone imagery of the spotted shag roost and possible nest at the northern end of the horseshoe-shaped bay at the western edge of the site. Three adult birds were resting here when observed through binoculars, prior to capturing the drone imagery.

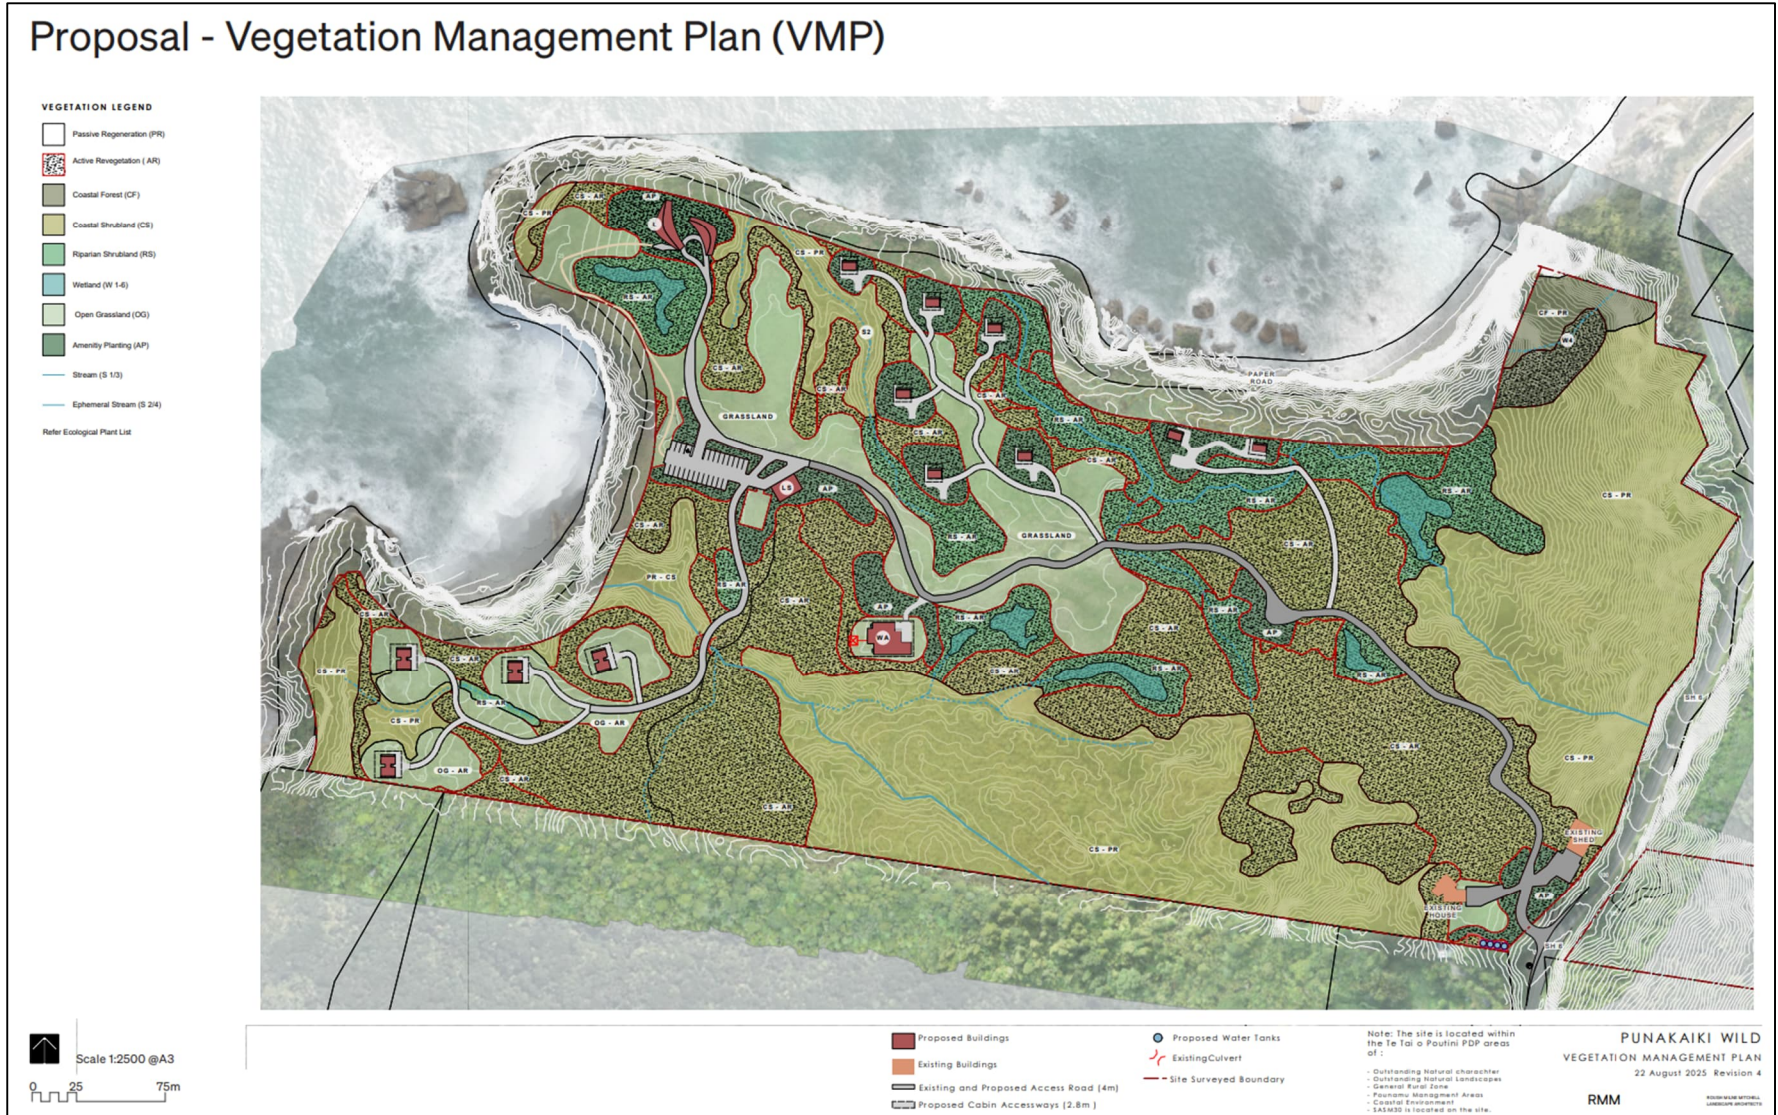
Figure 9: Plan of the proposed vegetation units following completion of the project. This shows substantial areas that are currently in pasture that will be actively revegetated or assisted back to native-dominated shrubland and native forest.
