Punakaiki Wild, West Coast

Ecological Effects Assessment

2431

February 2025

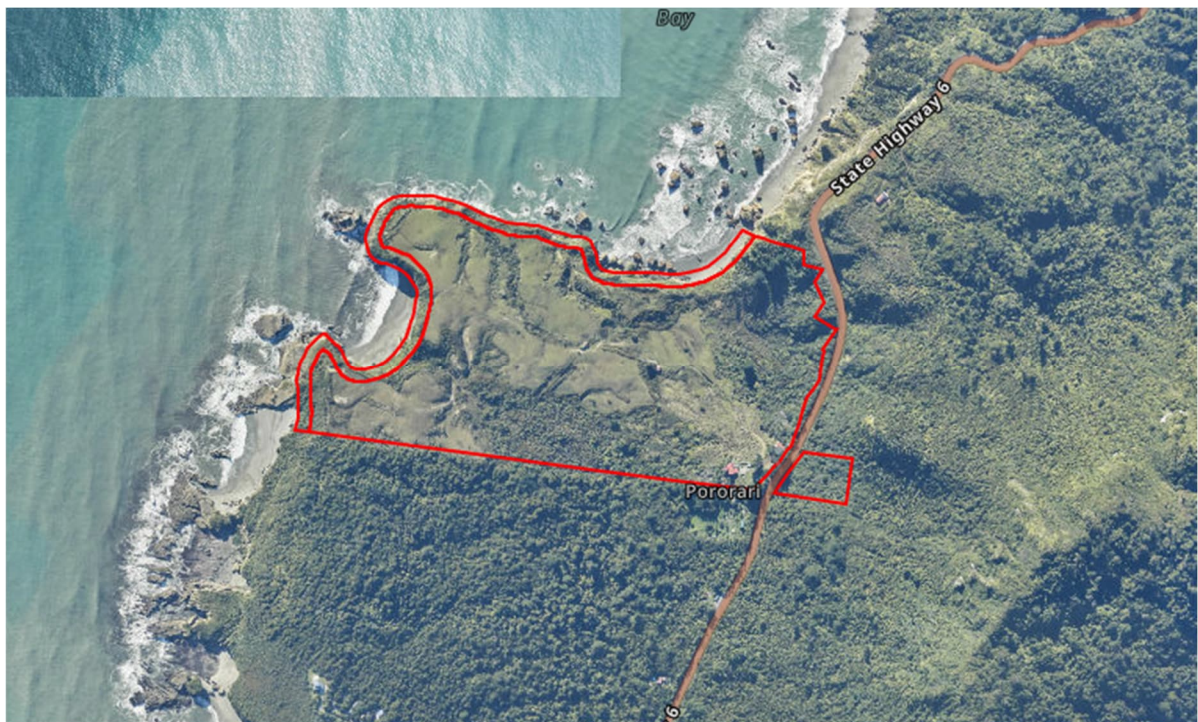
Figure 1. Site boundary as outlined in red. This is the investigation area that is the subject of this report.

This report provides an assessment of the ecological values of the property at 4663 State Highway 6, Te Miko, West Coast, legal description Part Section 1 Block IX Brighton SD, hereafter 'the site' (Figure 1), and an assessment of the ecological effects of a proposal to develop the site for luxury eco accommodation.

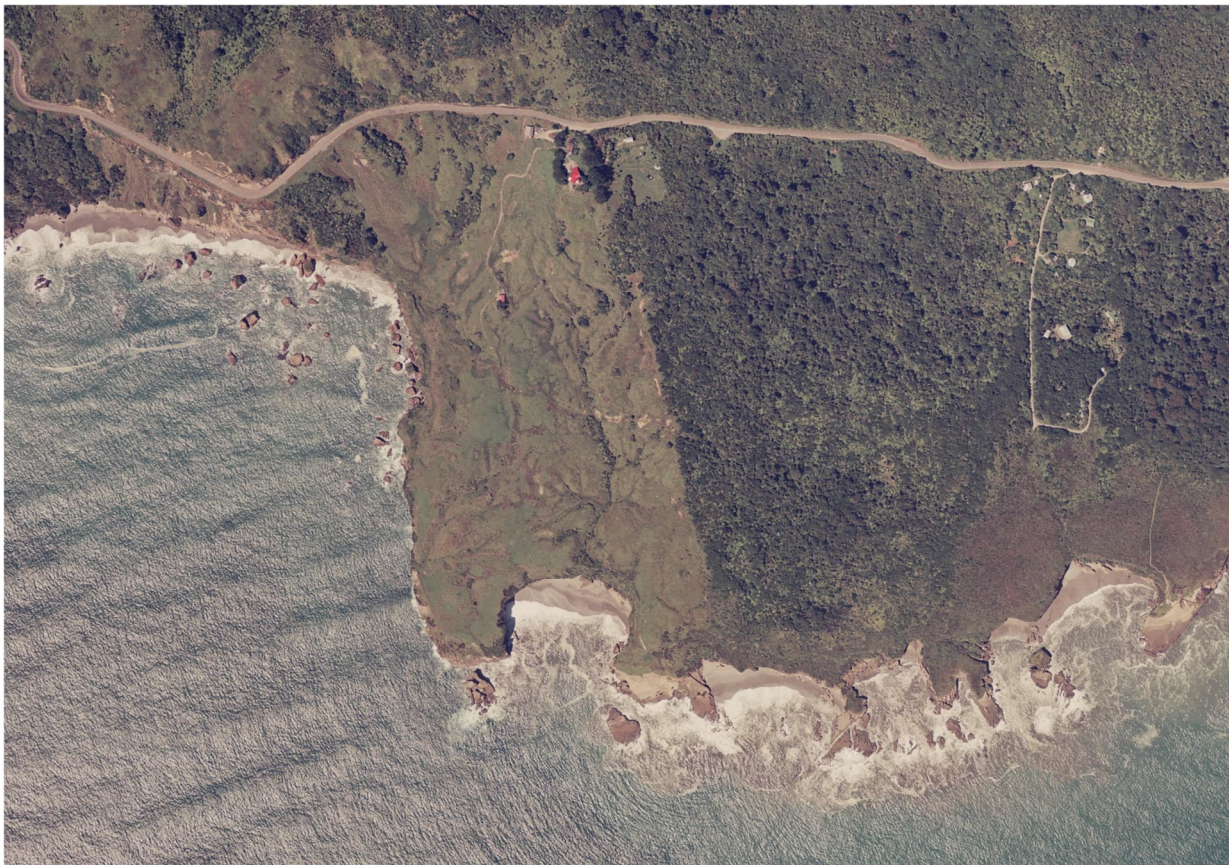
Figure 2. Historic aerial photograph depicting the vegetation cover from 1988 across the site, with the DOC forested land to the south (right of the lighter green grazed pasture on the site). Sourced from Retrolens.

LCDB v5.0 provides an indication of current land use, and land use change since its inception in 1996. The LCDB shows that the site has been used as 'high producing exotic grassland', 'indigenous forest', and 'broadleaved indigenous hardwoods' since at least 1996.

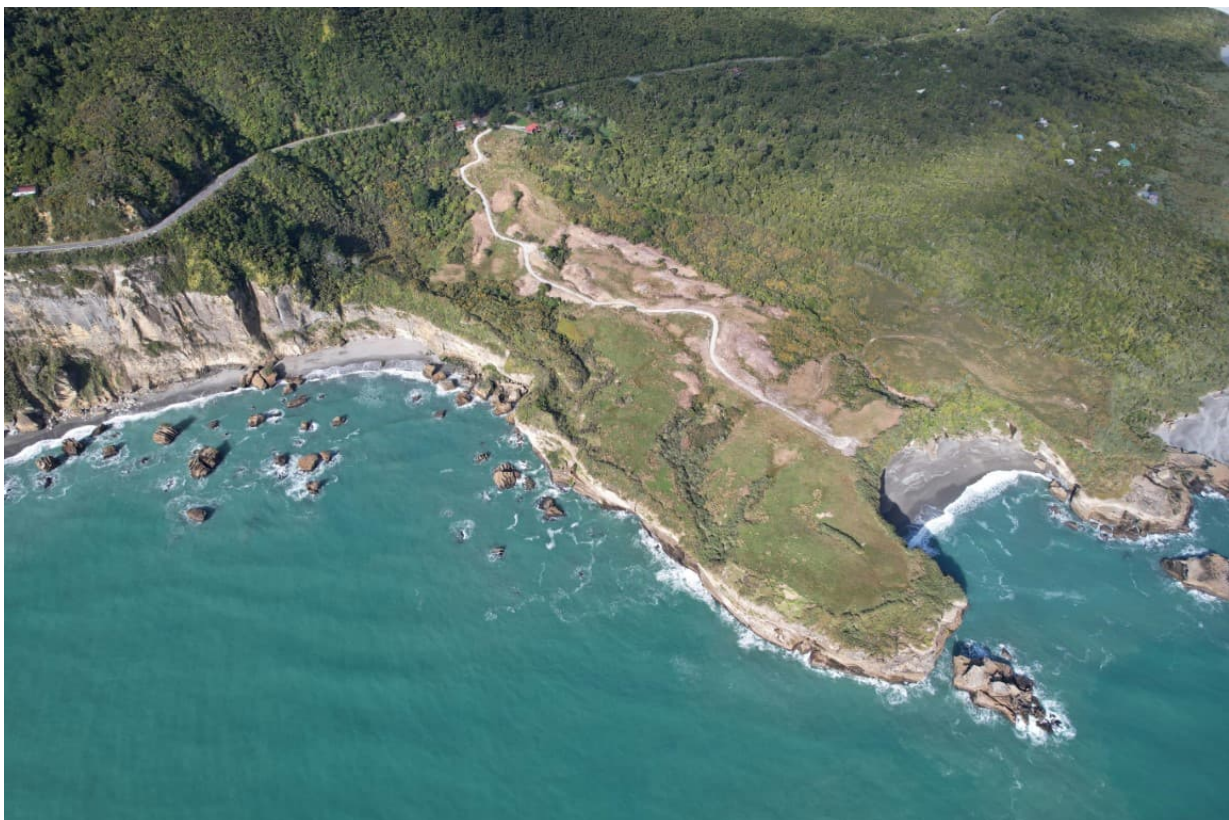
Plate 1. Aerial photograph depicting the current vegetation cover across the site as of July 2024, with the existing farm access track that was recently resurfaced / maintained (white line) that bisects the site through its length from the main highway.

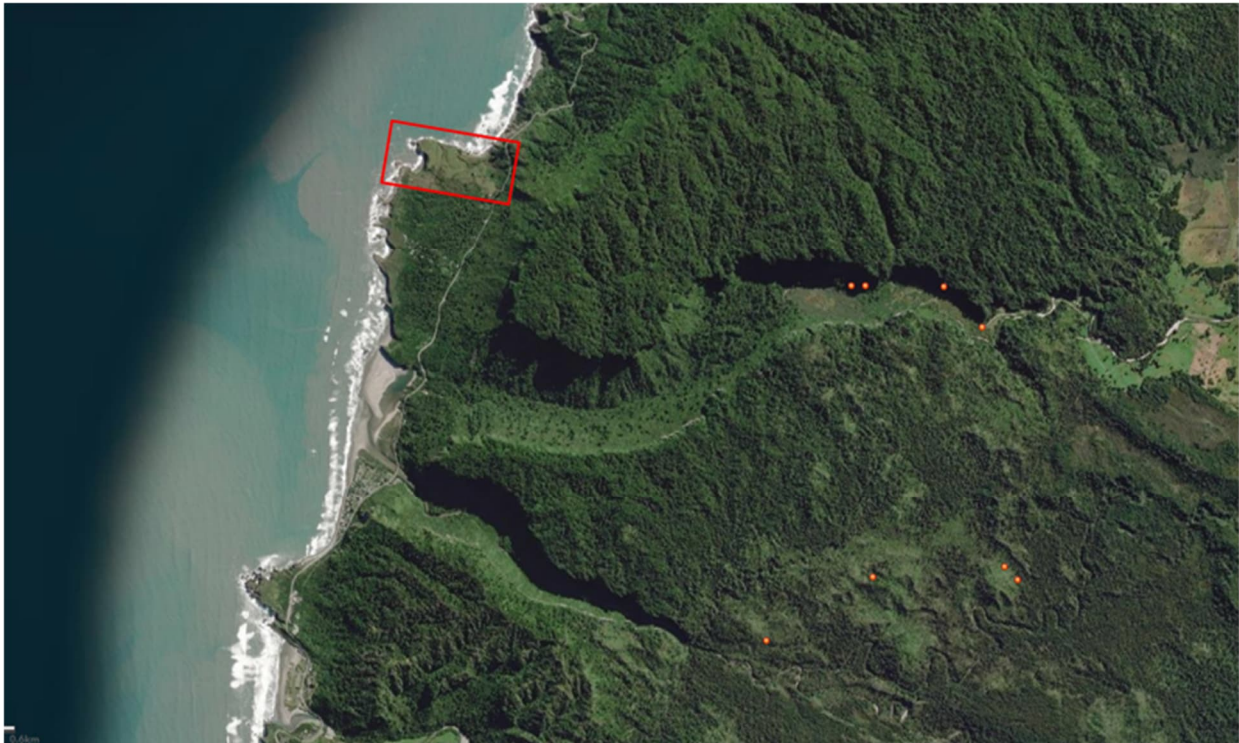
Figure 6. Historic records from 1997 and 1998 of lesser short-tailed bats (orange dots) in relation to the project site (red rectangle).

There is low – moderate quality bat habitat at the site in the mature exotic trees and the mature coastal forest. Individual trees were too dangerous to access at the time of the site visit to assess if they contain good bat habitat features. Aerial imagery shows that the trees are tightly compacted and windswept, with no linear pattern.

Although there are historic bat records in close proximity to the site, it is unlikely that bats occur on the site or transit through the site due to lack of viable habitat for roosting, foraging, or transiting through the site.

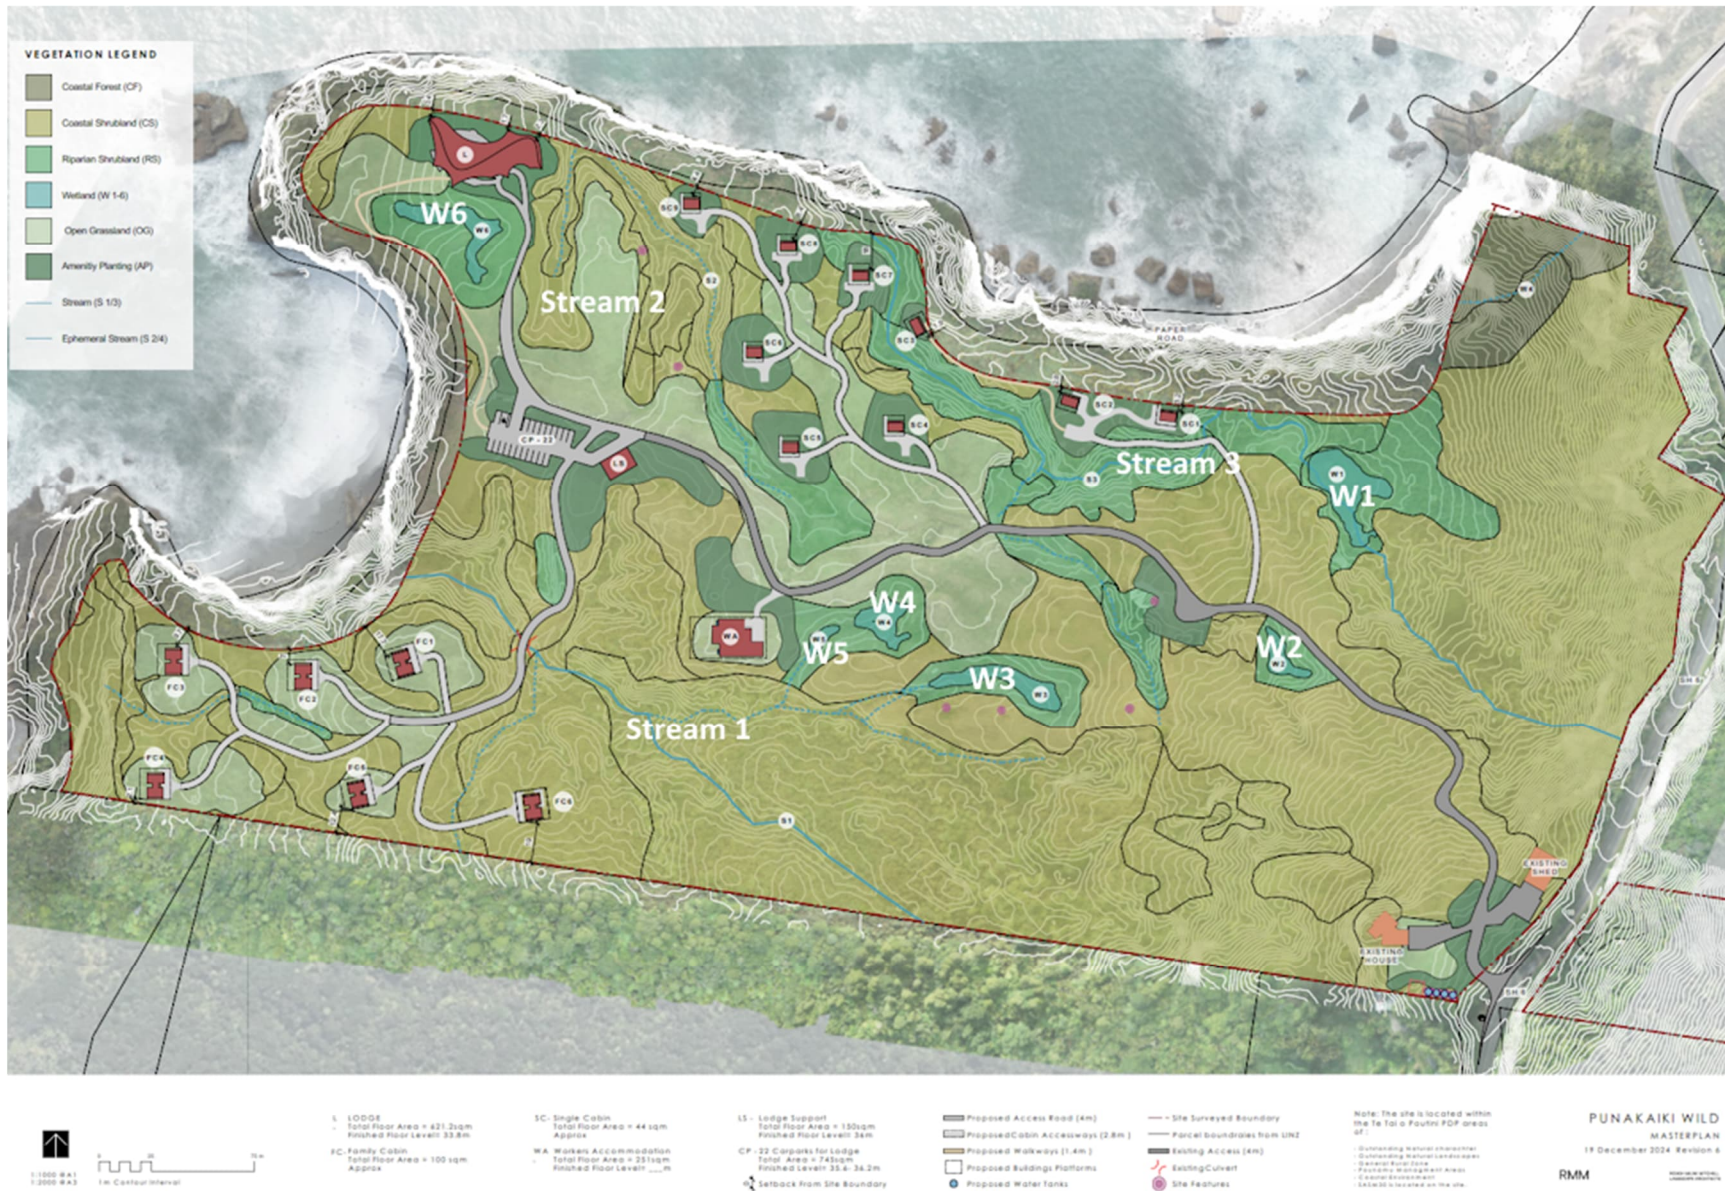
Figure 7. Plan of proposed development at the site. Wetlands are labelled W1-W6. Streams 1-3 are also shown (Stream 4 not shown as it is outside of the development area).

Two culverts are currently present at the site and will be retained for access to accommodation cabins at site. One of those existing culverts will be retained in the current state over stream 1 (Figure 7). The second culvert is damaged and will be removed and replaced with a new culvert in a different location on Stream 3. The culverts over these two streams will be designed in accordance with good practice fish passage design requirements to allow for passage of native fish as a precautionary measure (as no fish were detected in streams and natural barriers to migration or

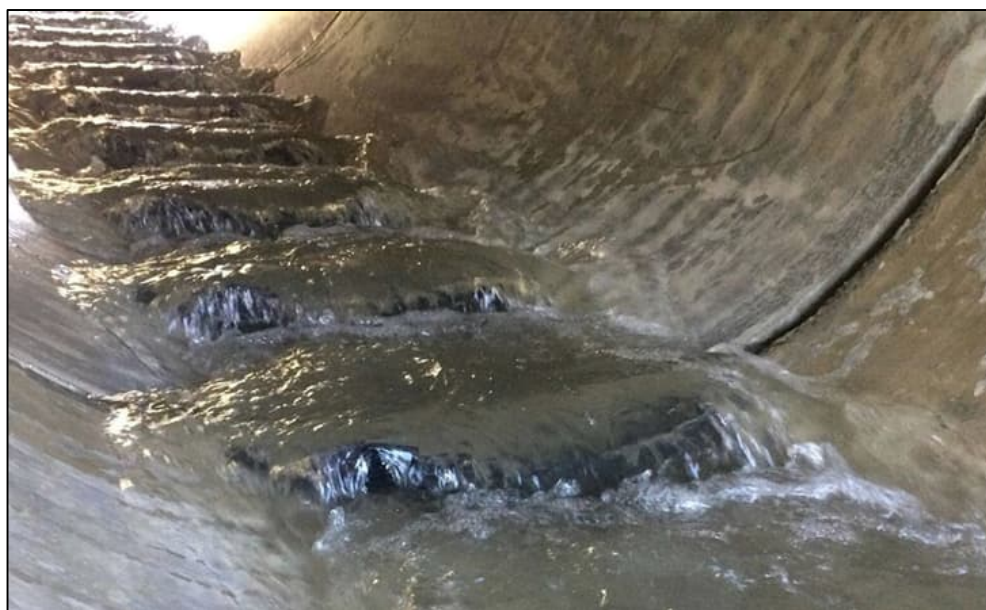
Plate 2: Multiple *Flexi-Baffles* are placed in a culvert to alter the flow while providing rest areas for species travelling upstream. (Source: <https://www.ats-environmental.com/solutions/culvert-baffles/>)

Alternative designs to allow for fish passage, particularly if the size of the culvert required cannot meet the specifications in 2 (d) and (e), must include the installation of flexible baffles (Plate 2), that alter the flow of water through the culvert and provide rest areas for fish.

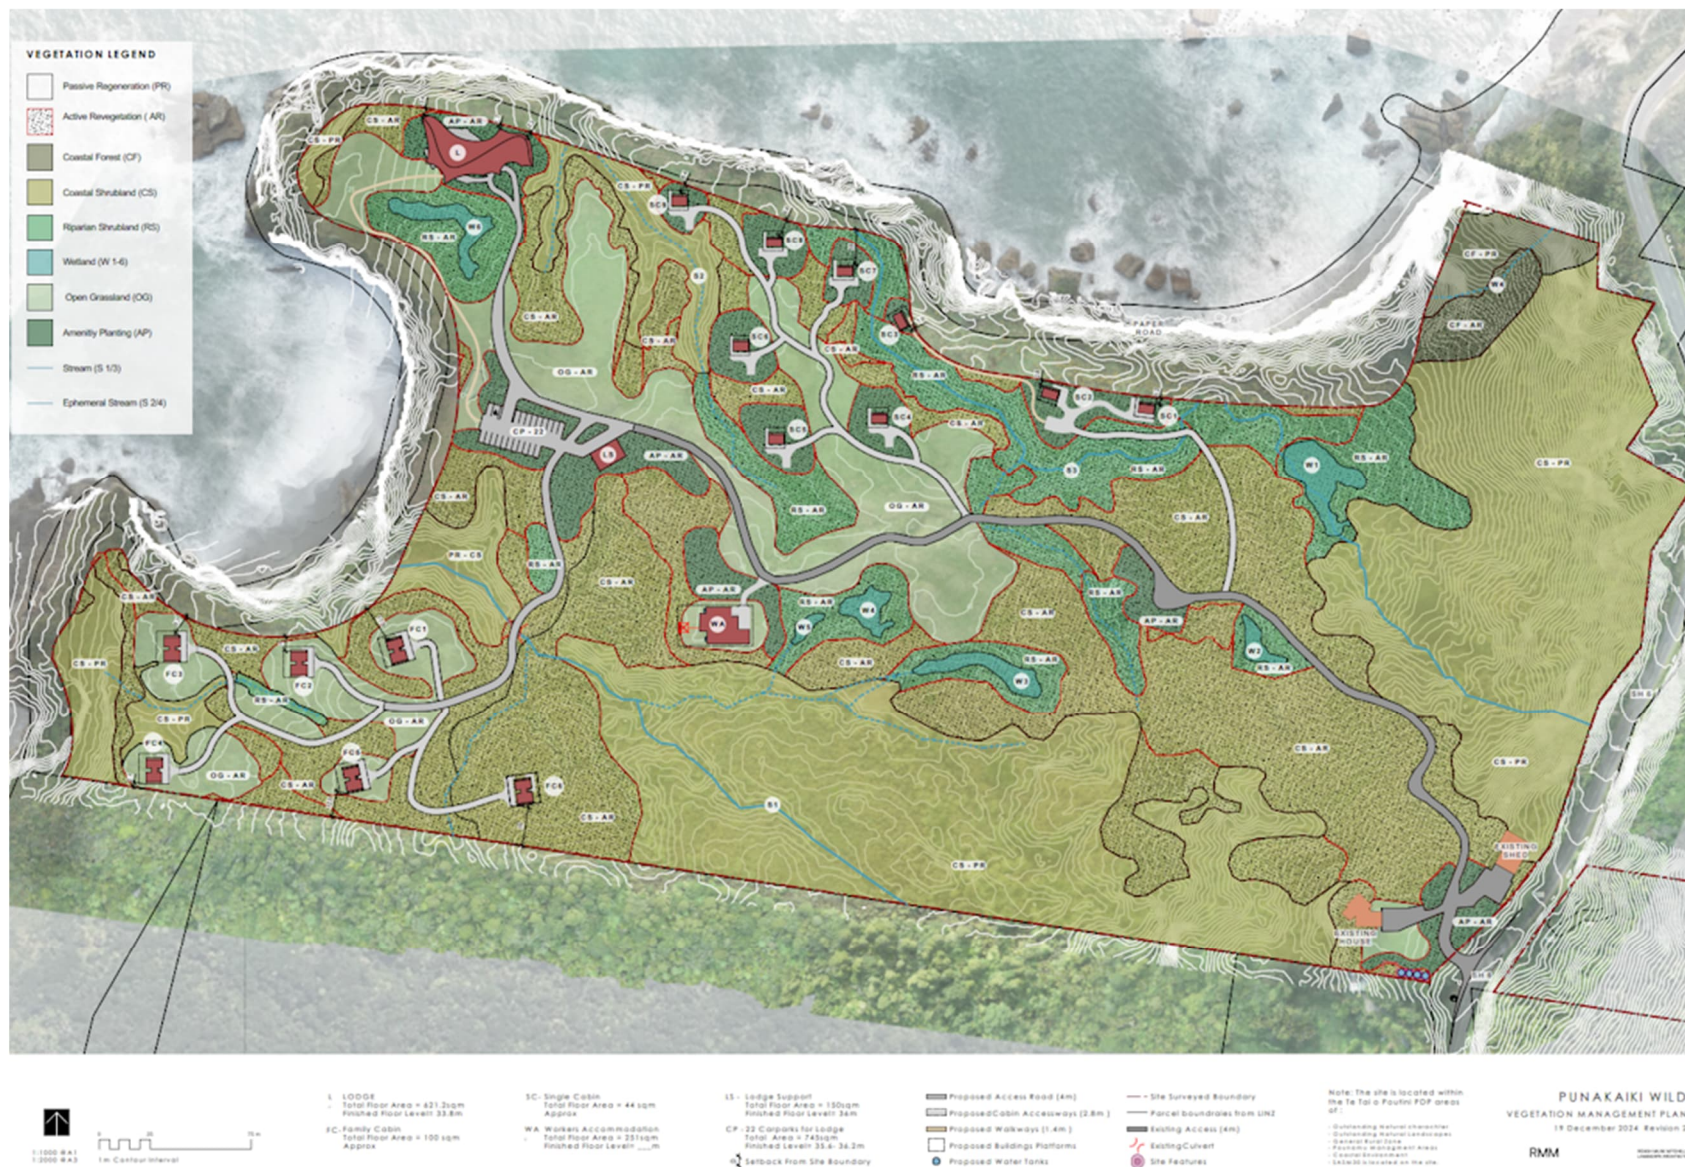
Figure 8. Plan of the proposed vegetation units following completion of the project. This shows substantial areas currently in pasture and weedland that will be revegetated or assisted back to native dominated shrubland and native forest.

The ecological restoration works will be described in a Vegetation Management Plan for the site, which we understand will form one of the proffered conditions of consent.
