# Preliminary Site Investigation

**Sec 41 Tauranga Bay Road**

Prepared for Tauranga Bay Holdings Ltd  
510322

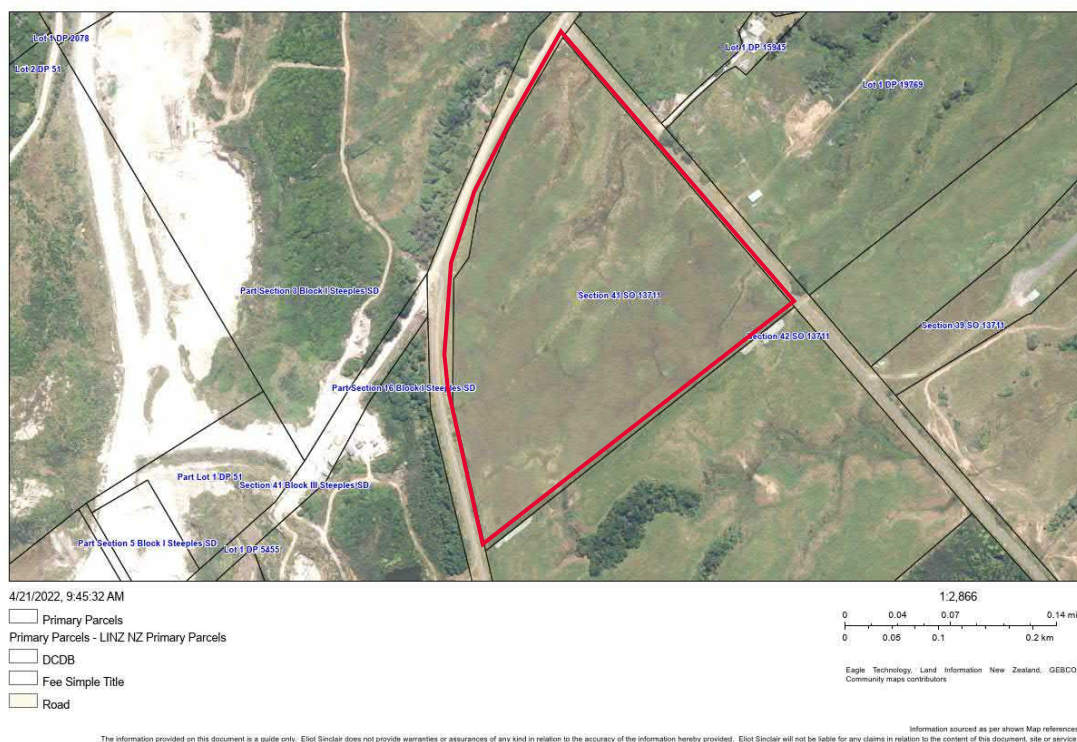
Figure 1. Site plan. Sourced from WestMaps (May, 2022).

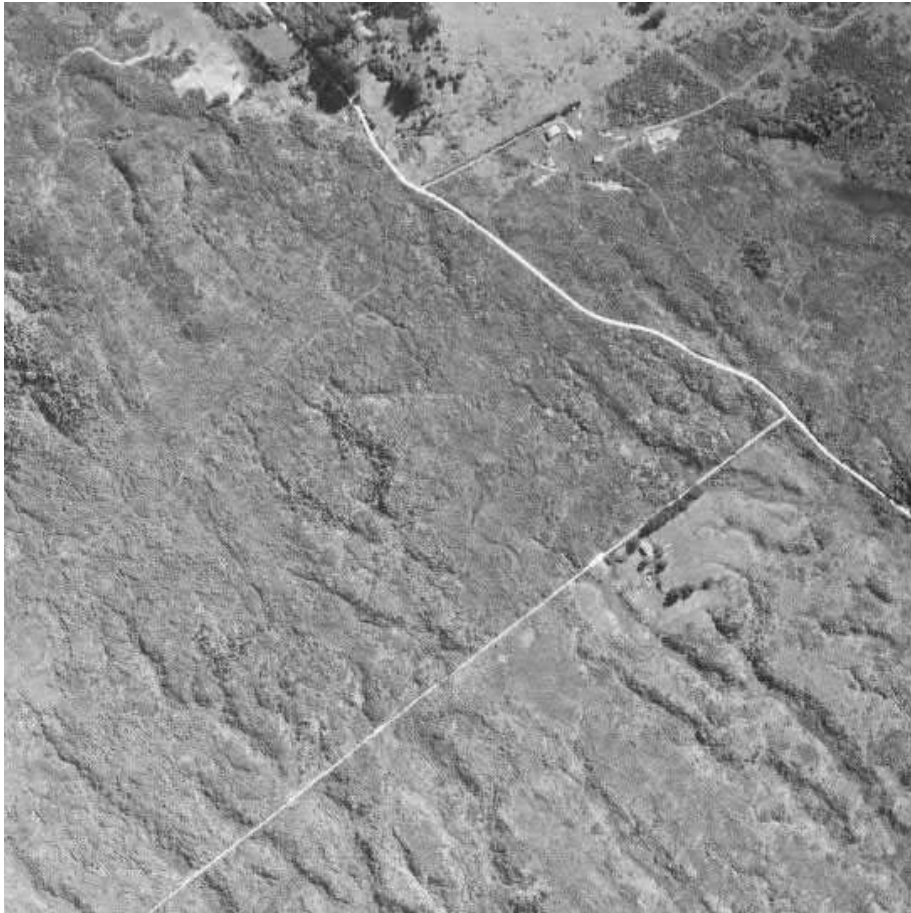
Figure 1. 1951

Date of photograph	Land use, site features, identified HAIL area(s)
1951- 1988 (Retrolens)	Vacant land. No HAIL activities identified
2003 – 2021 (Google Earth)	No change to site.
