The following is in response to the Section 92 further information request letter dated 21 February 2025 for the subdivision being undertaken by John Raymond McLaughlin at State Highway 6, Addisons/ Virgin Flat.

**Proposed Subdivision of  
Lot 3 DP360520 & easement  
over Lot 2 DP360520**

Detailed Site Investigation

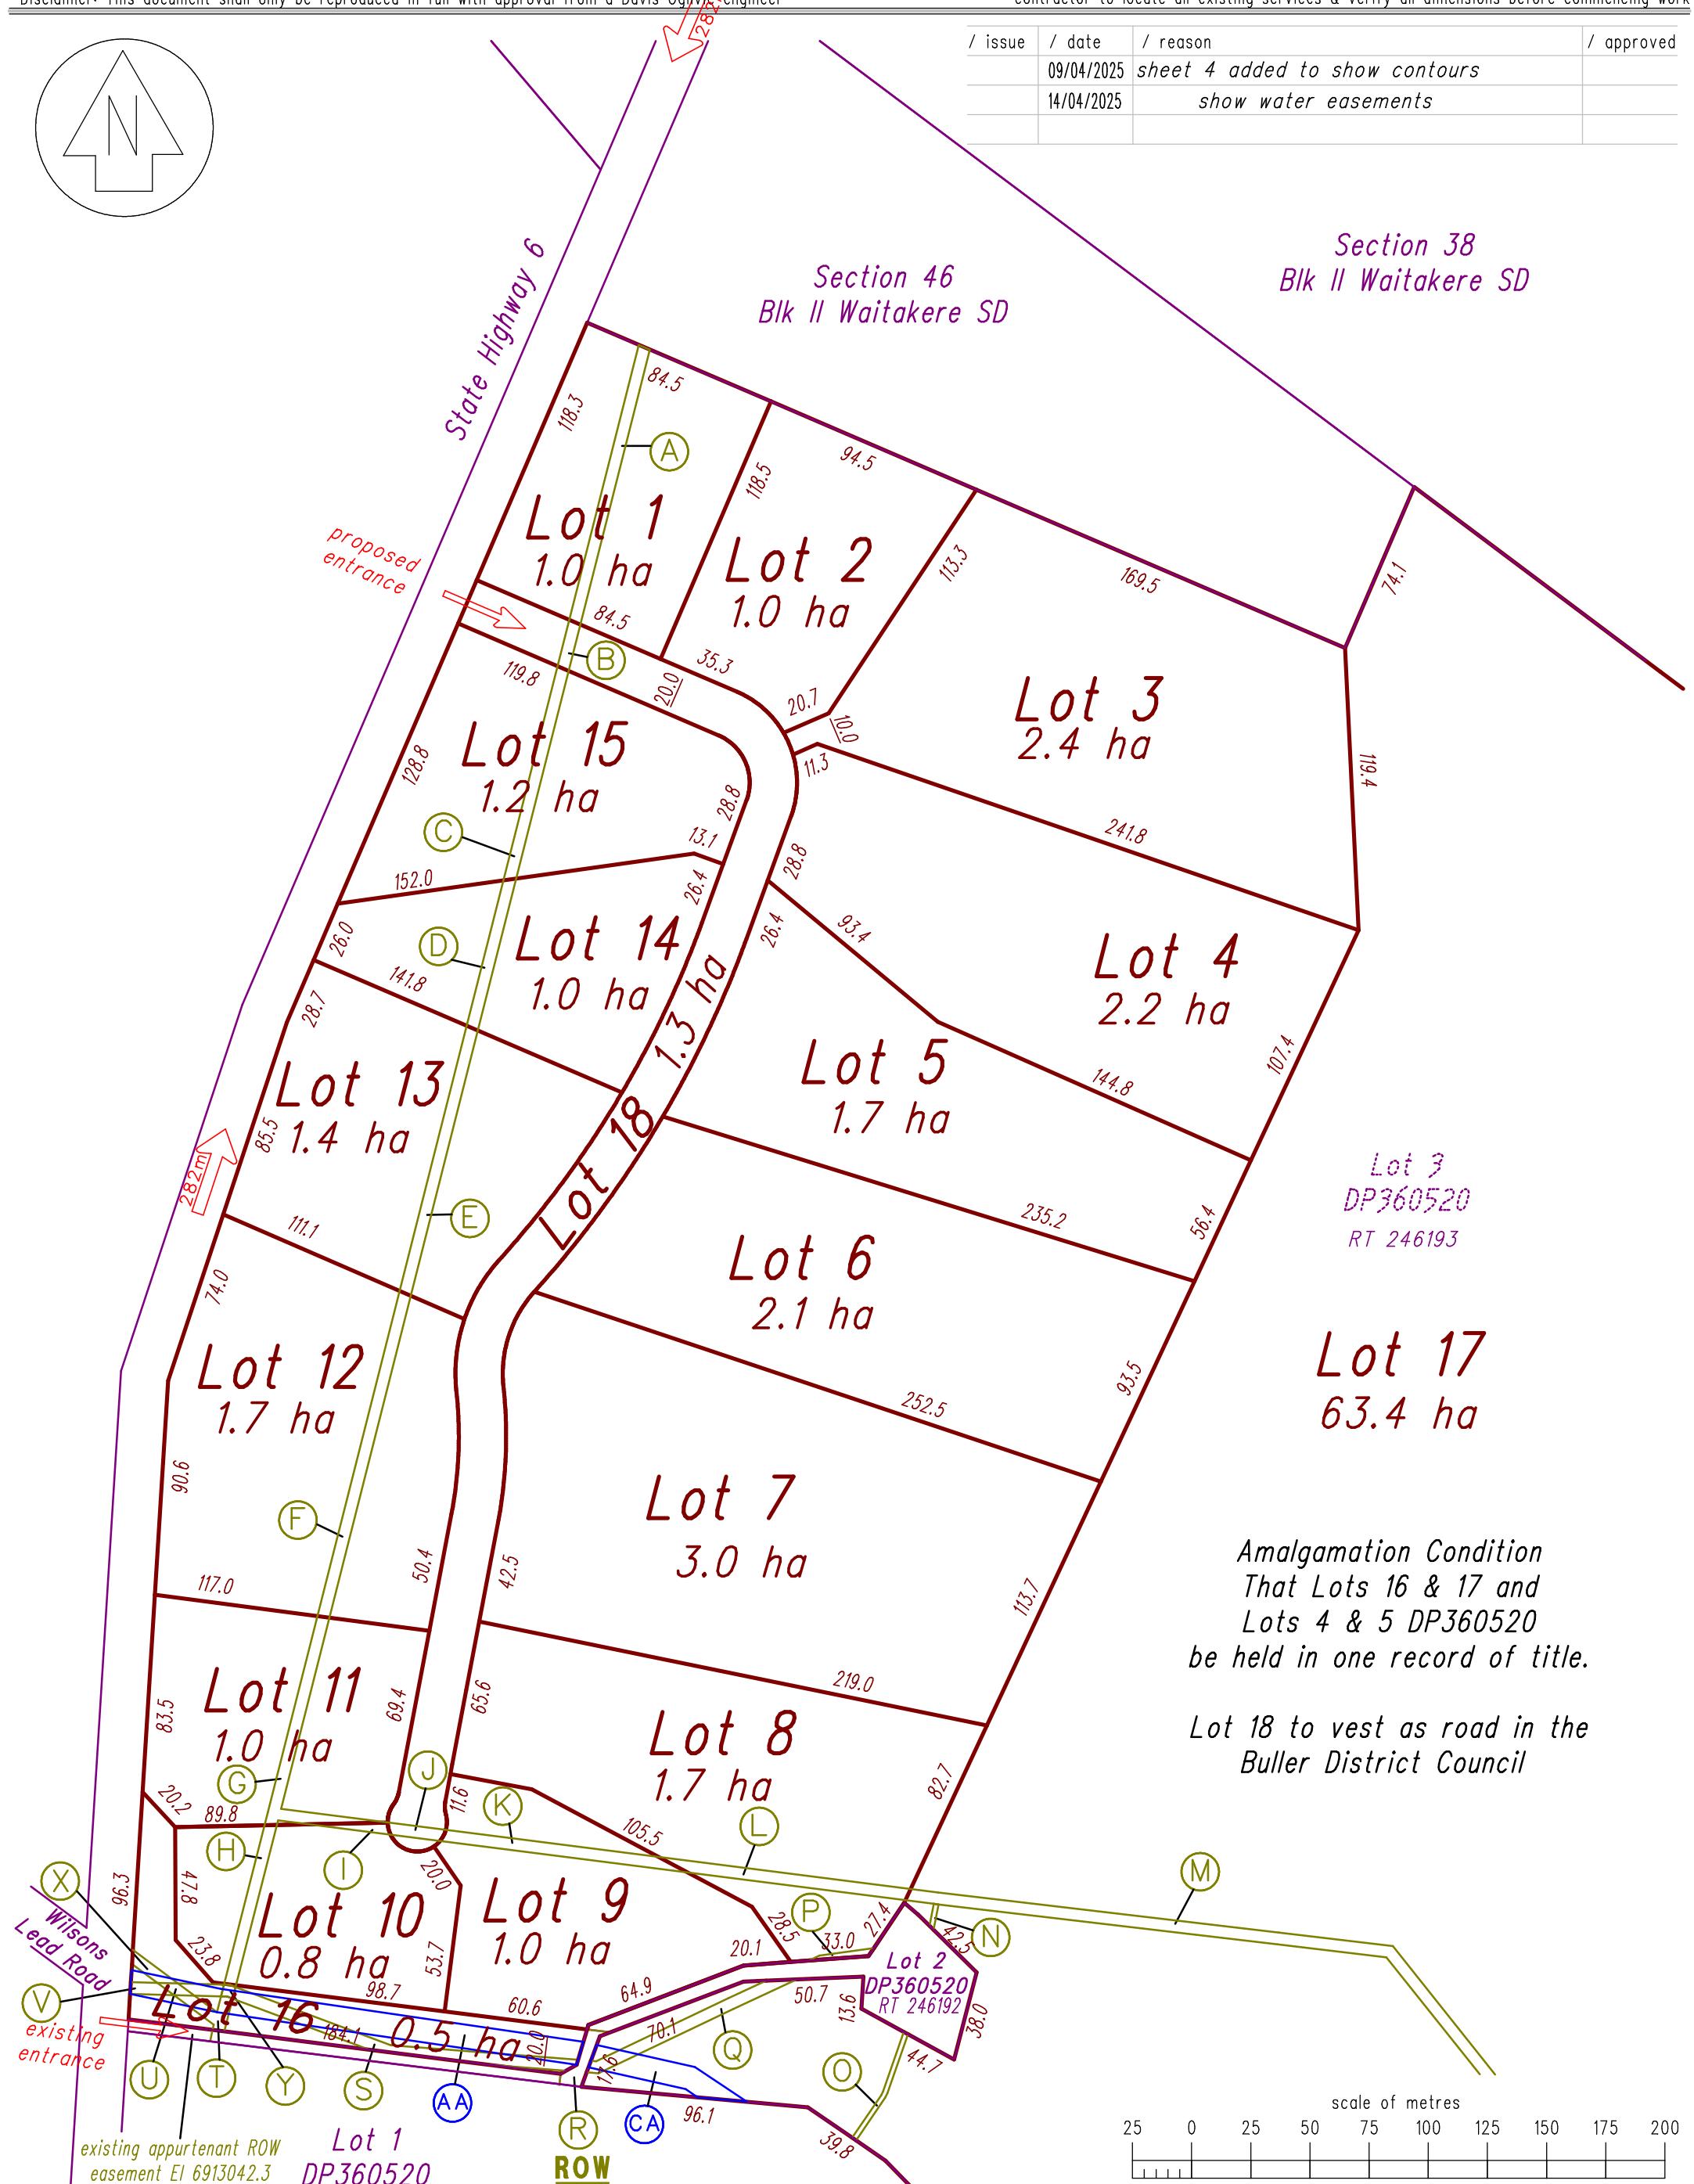
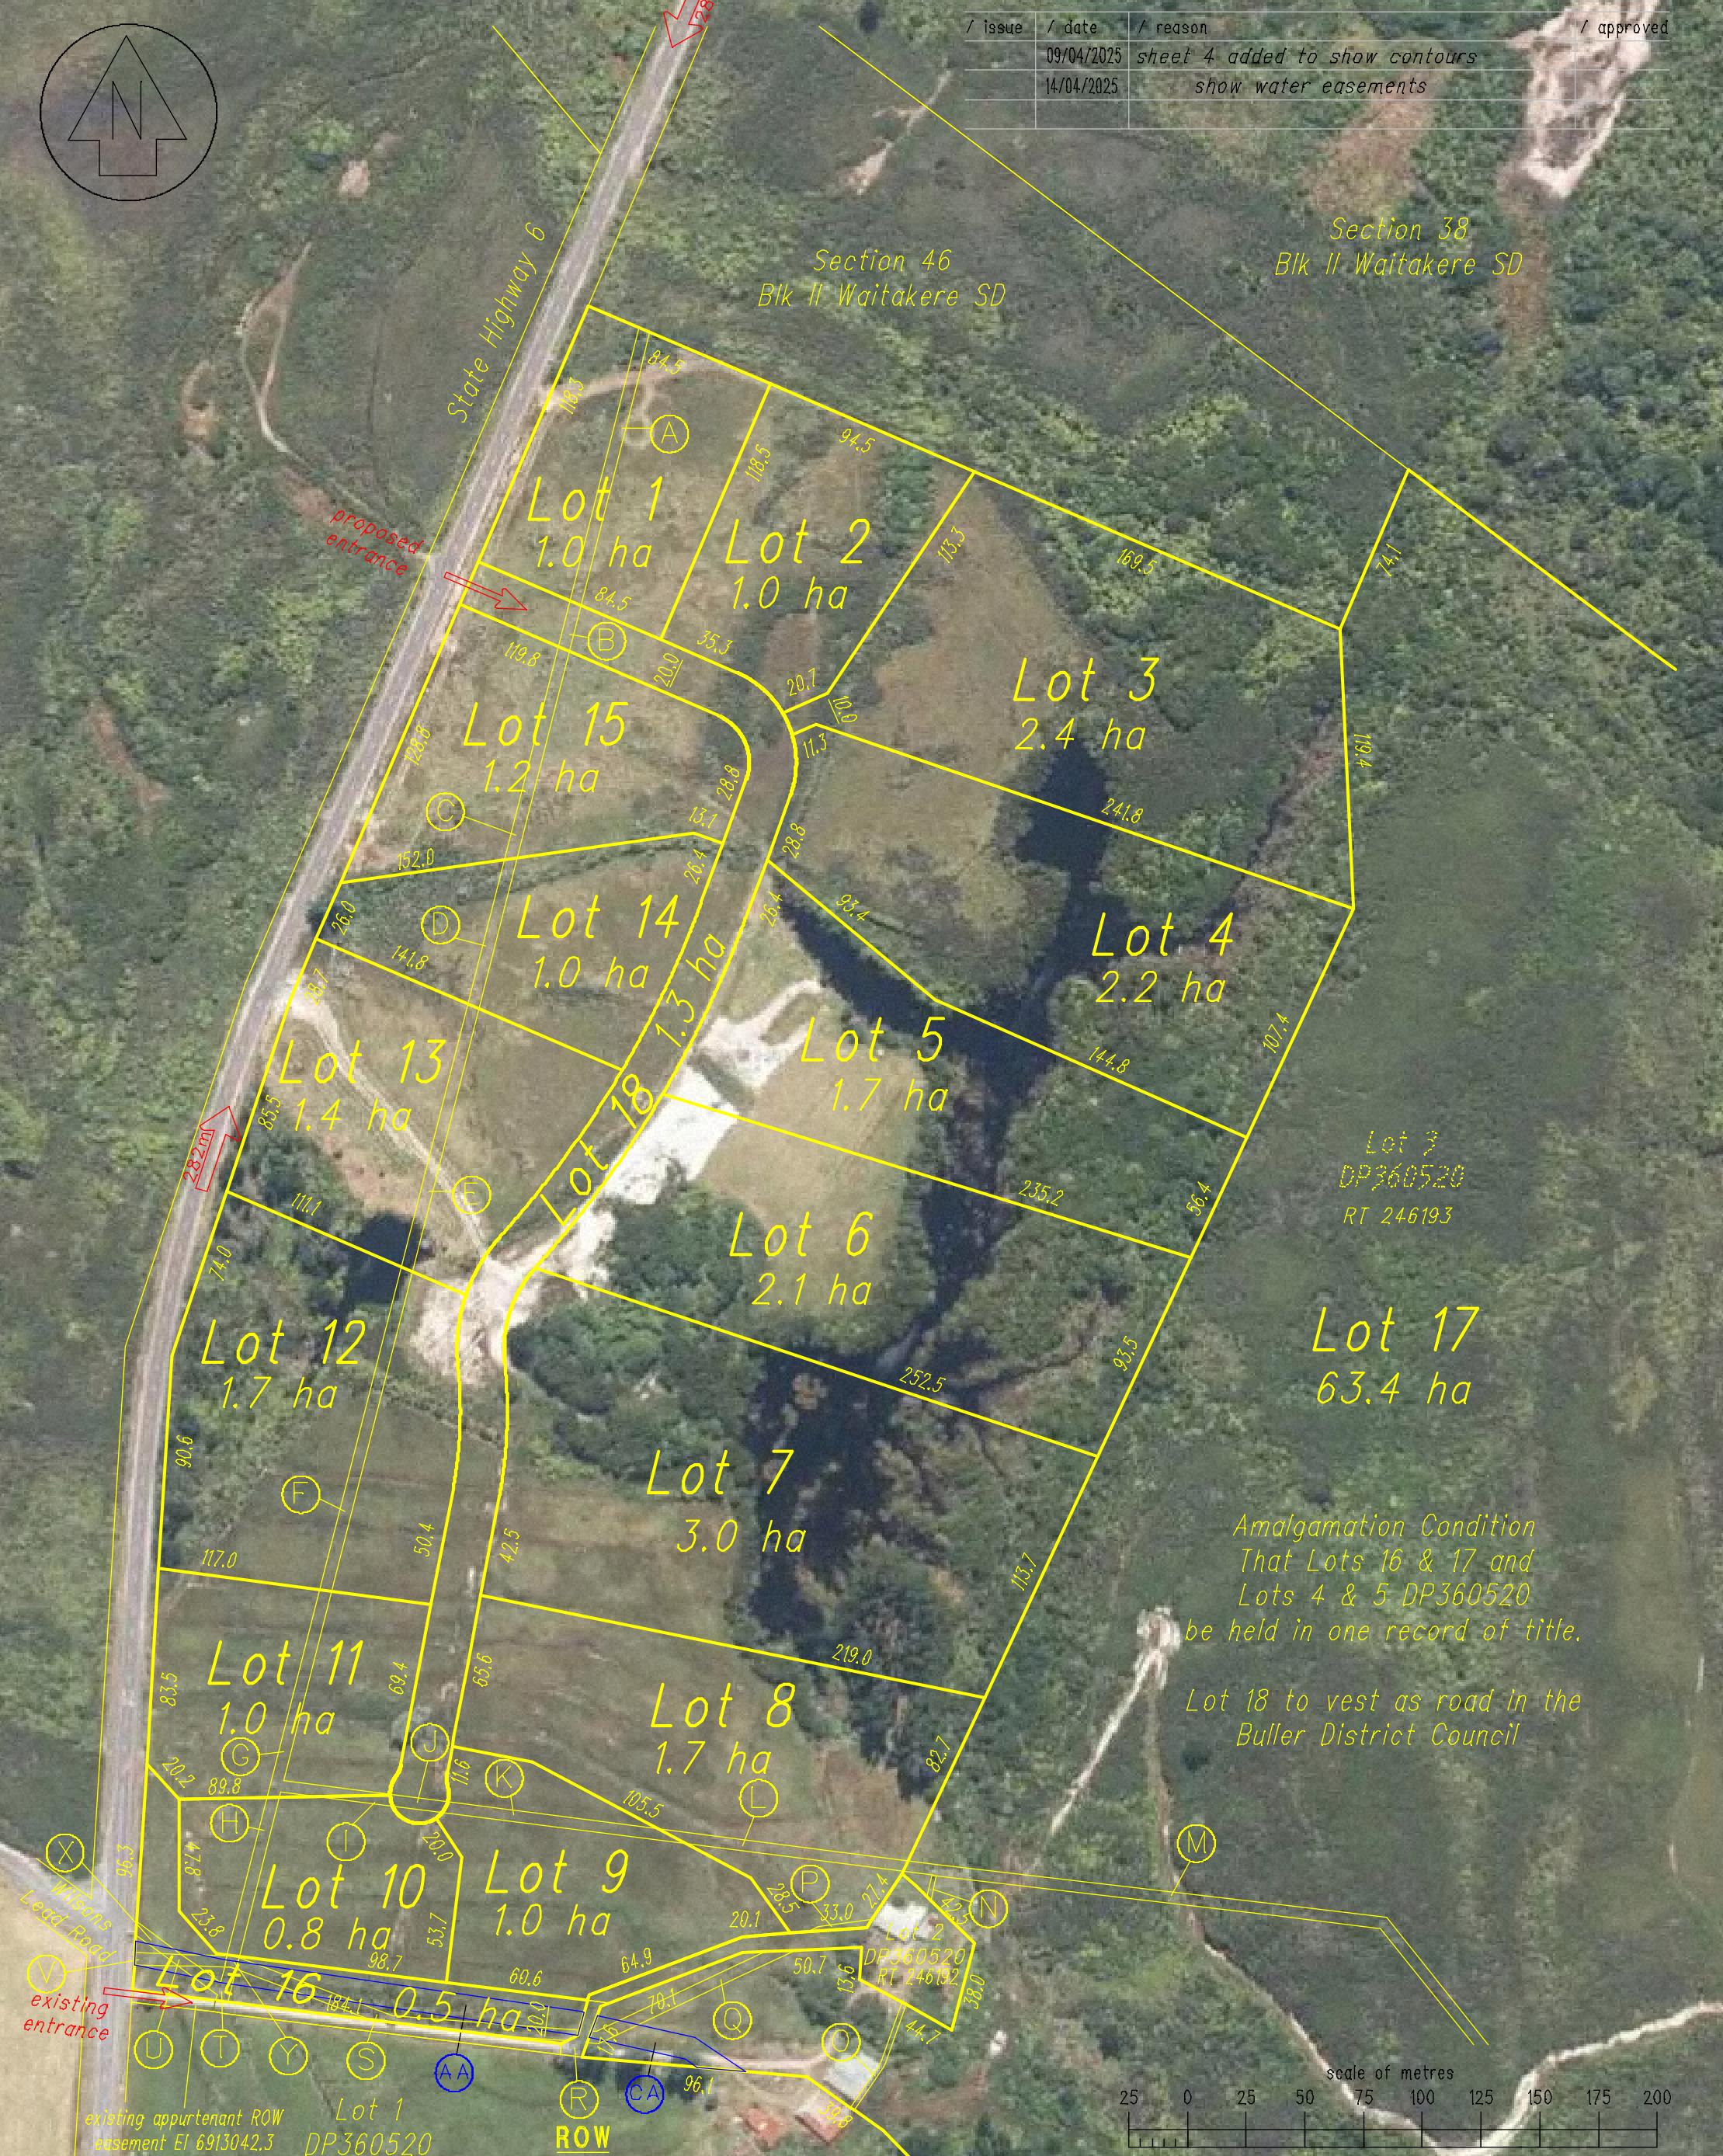
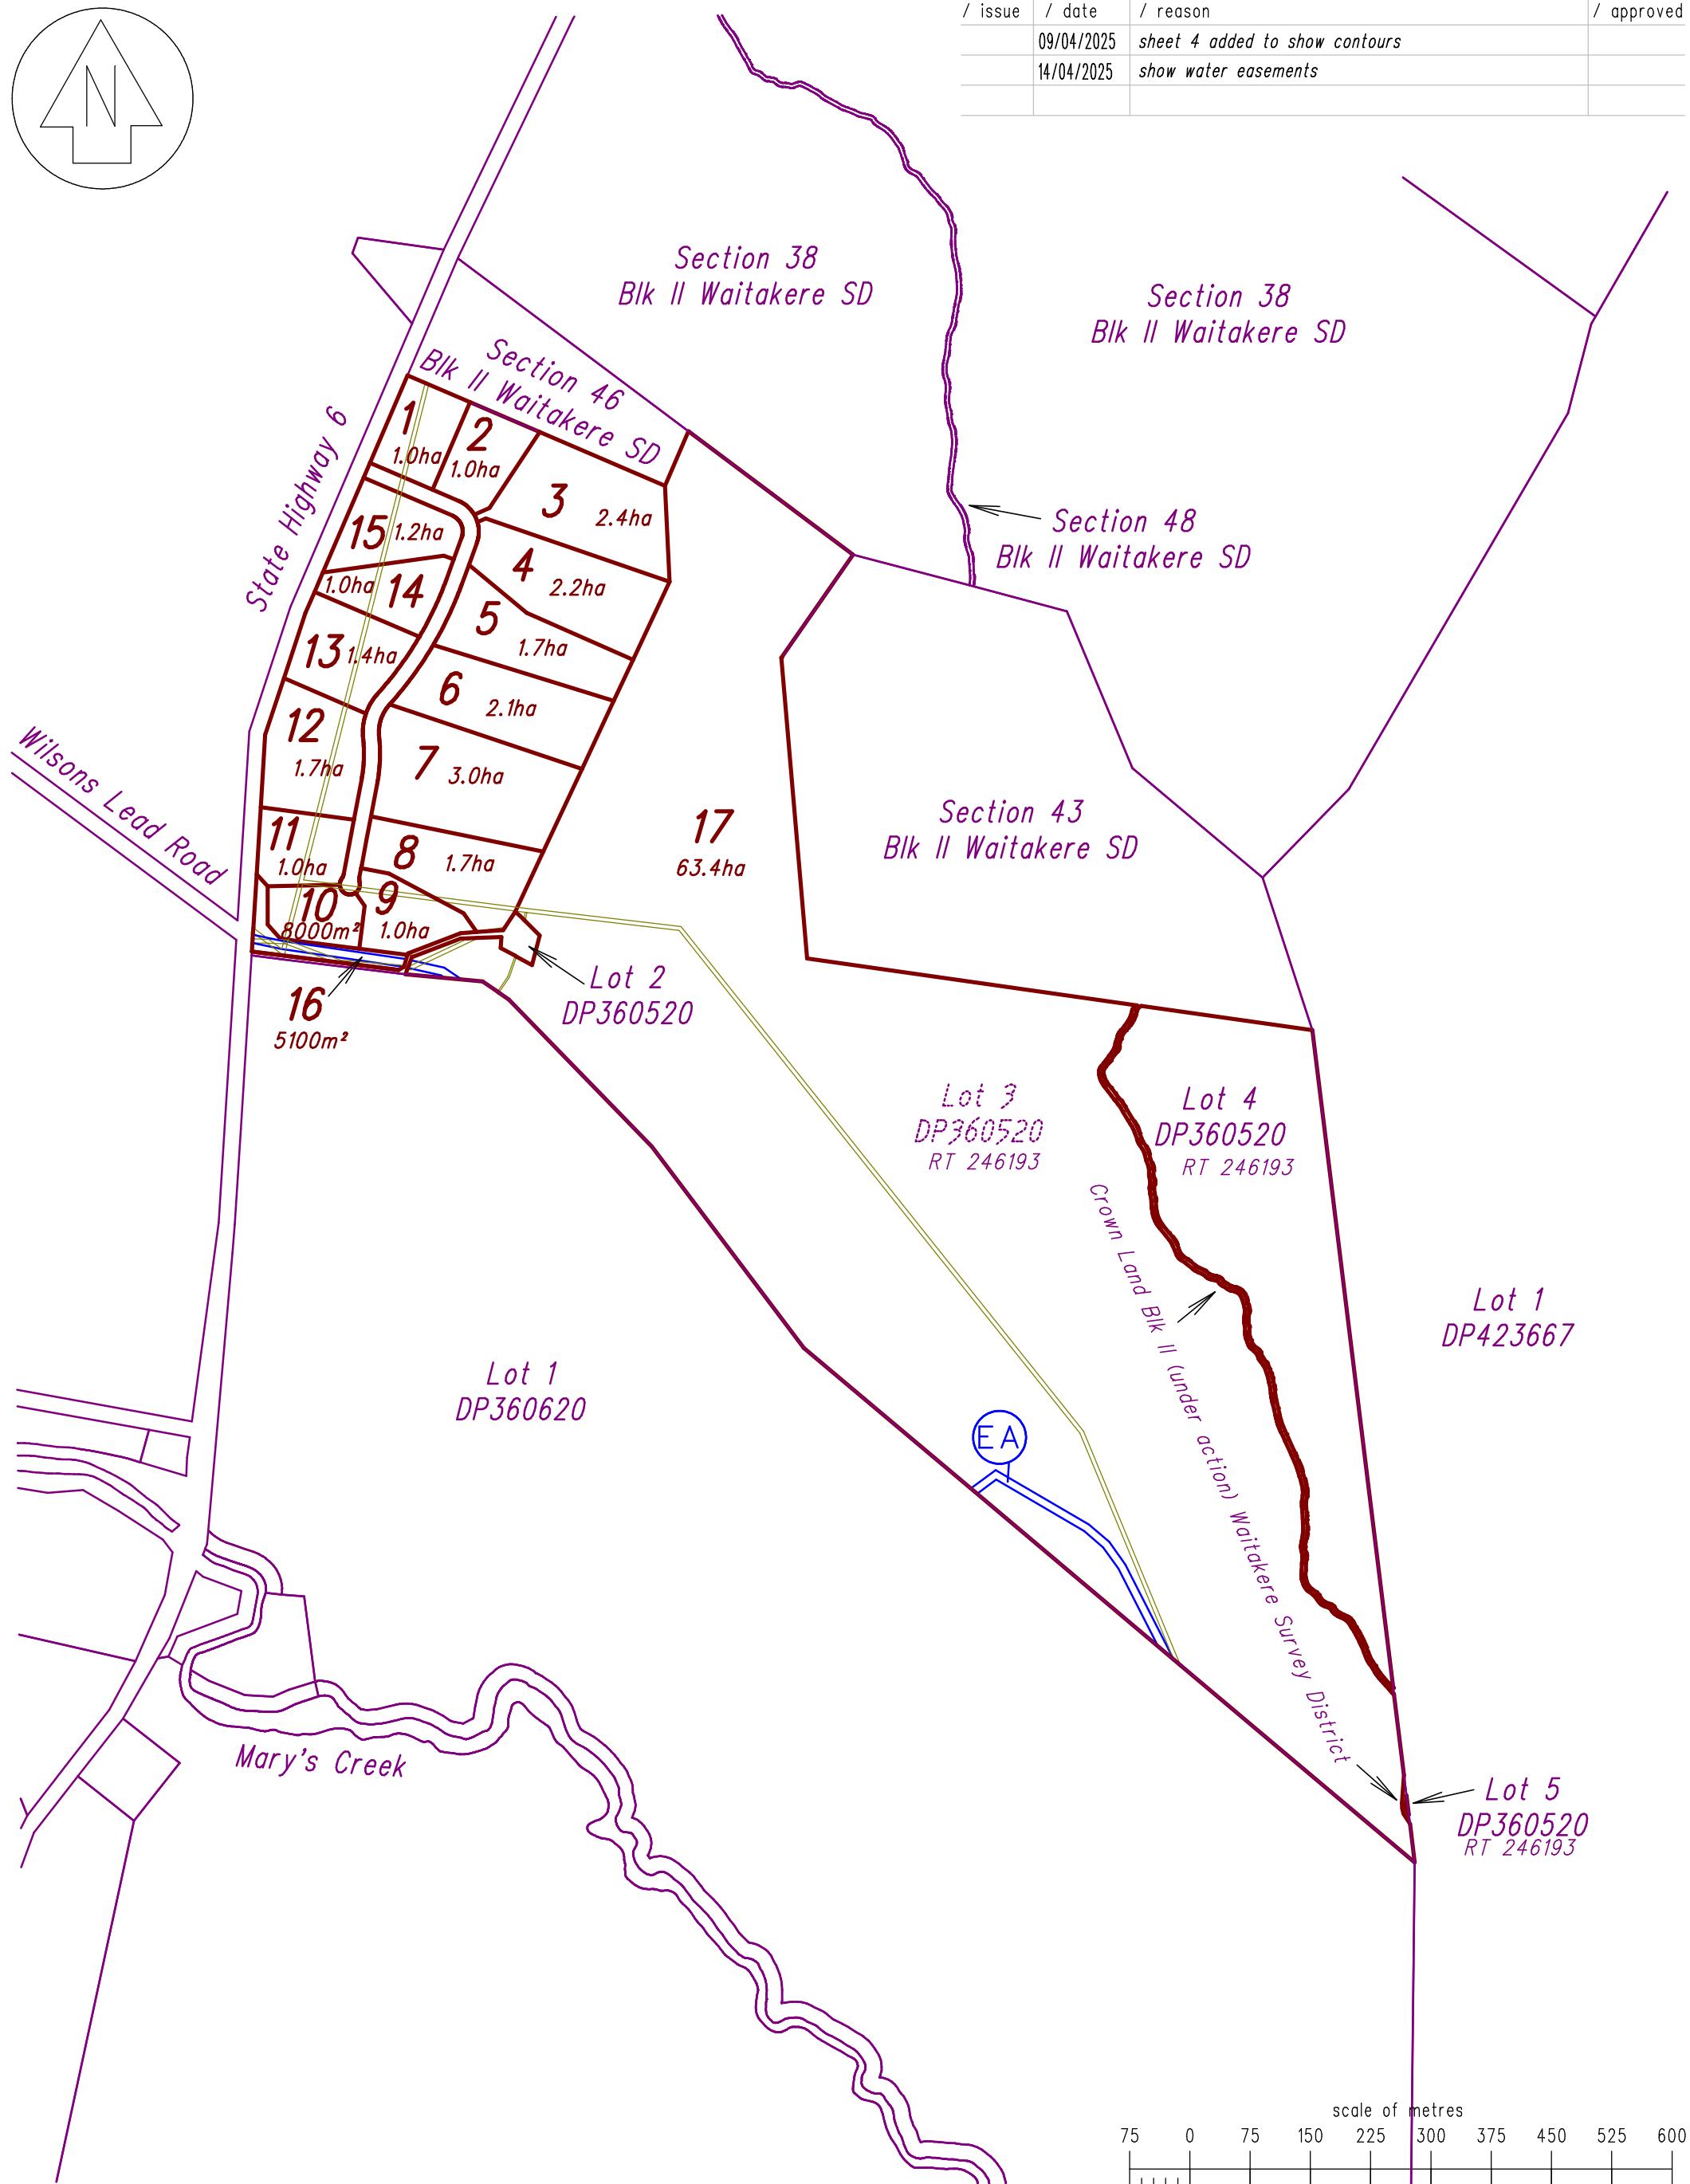
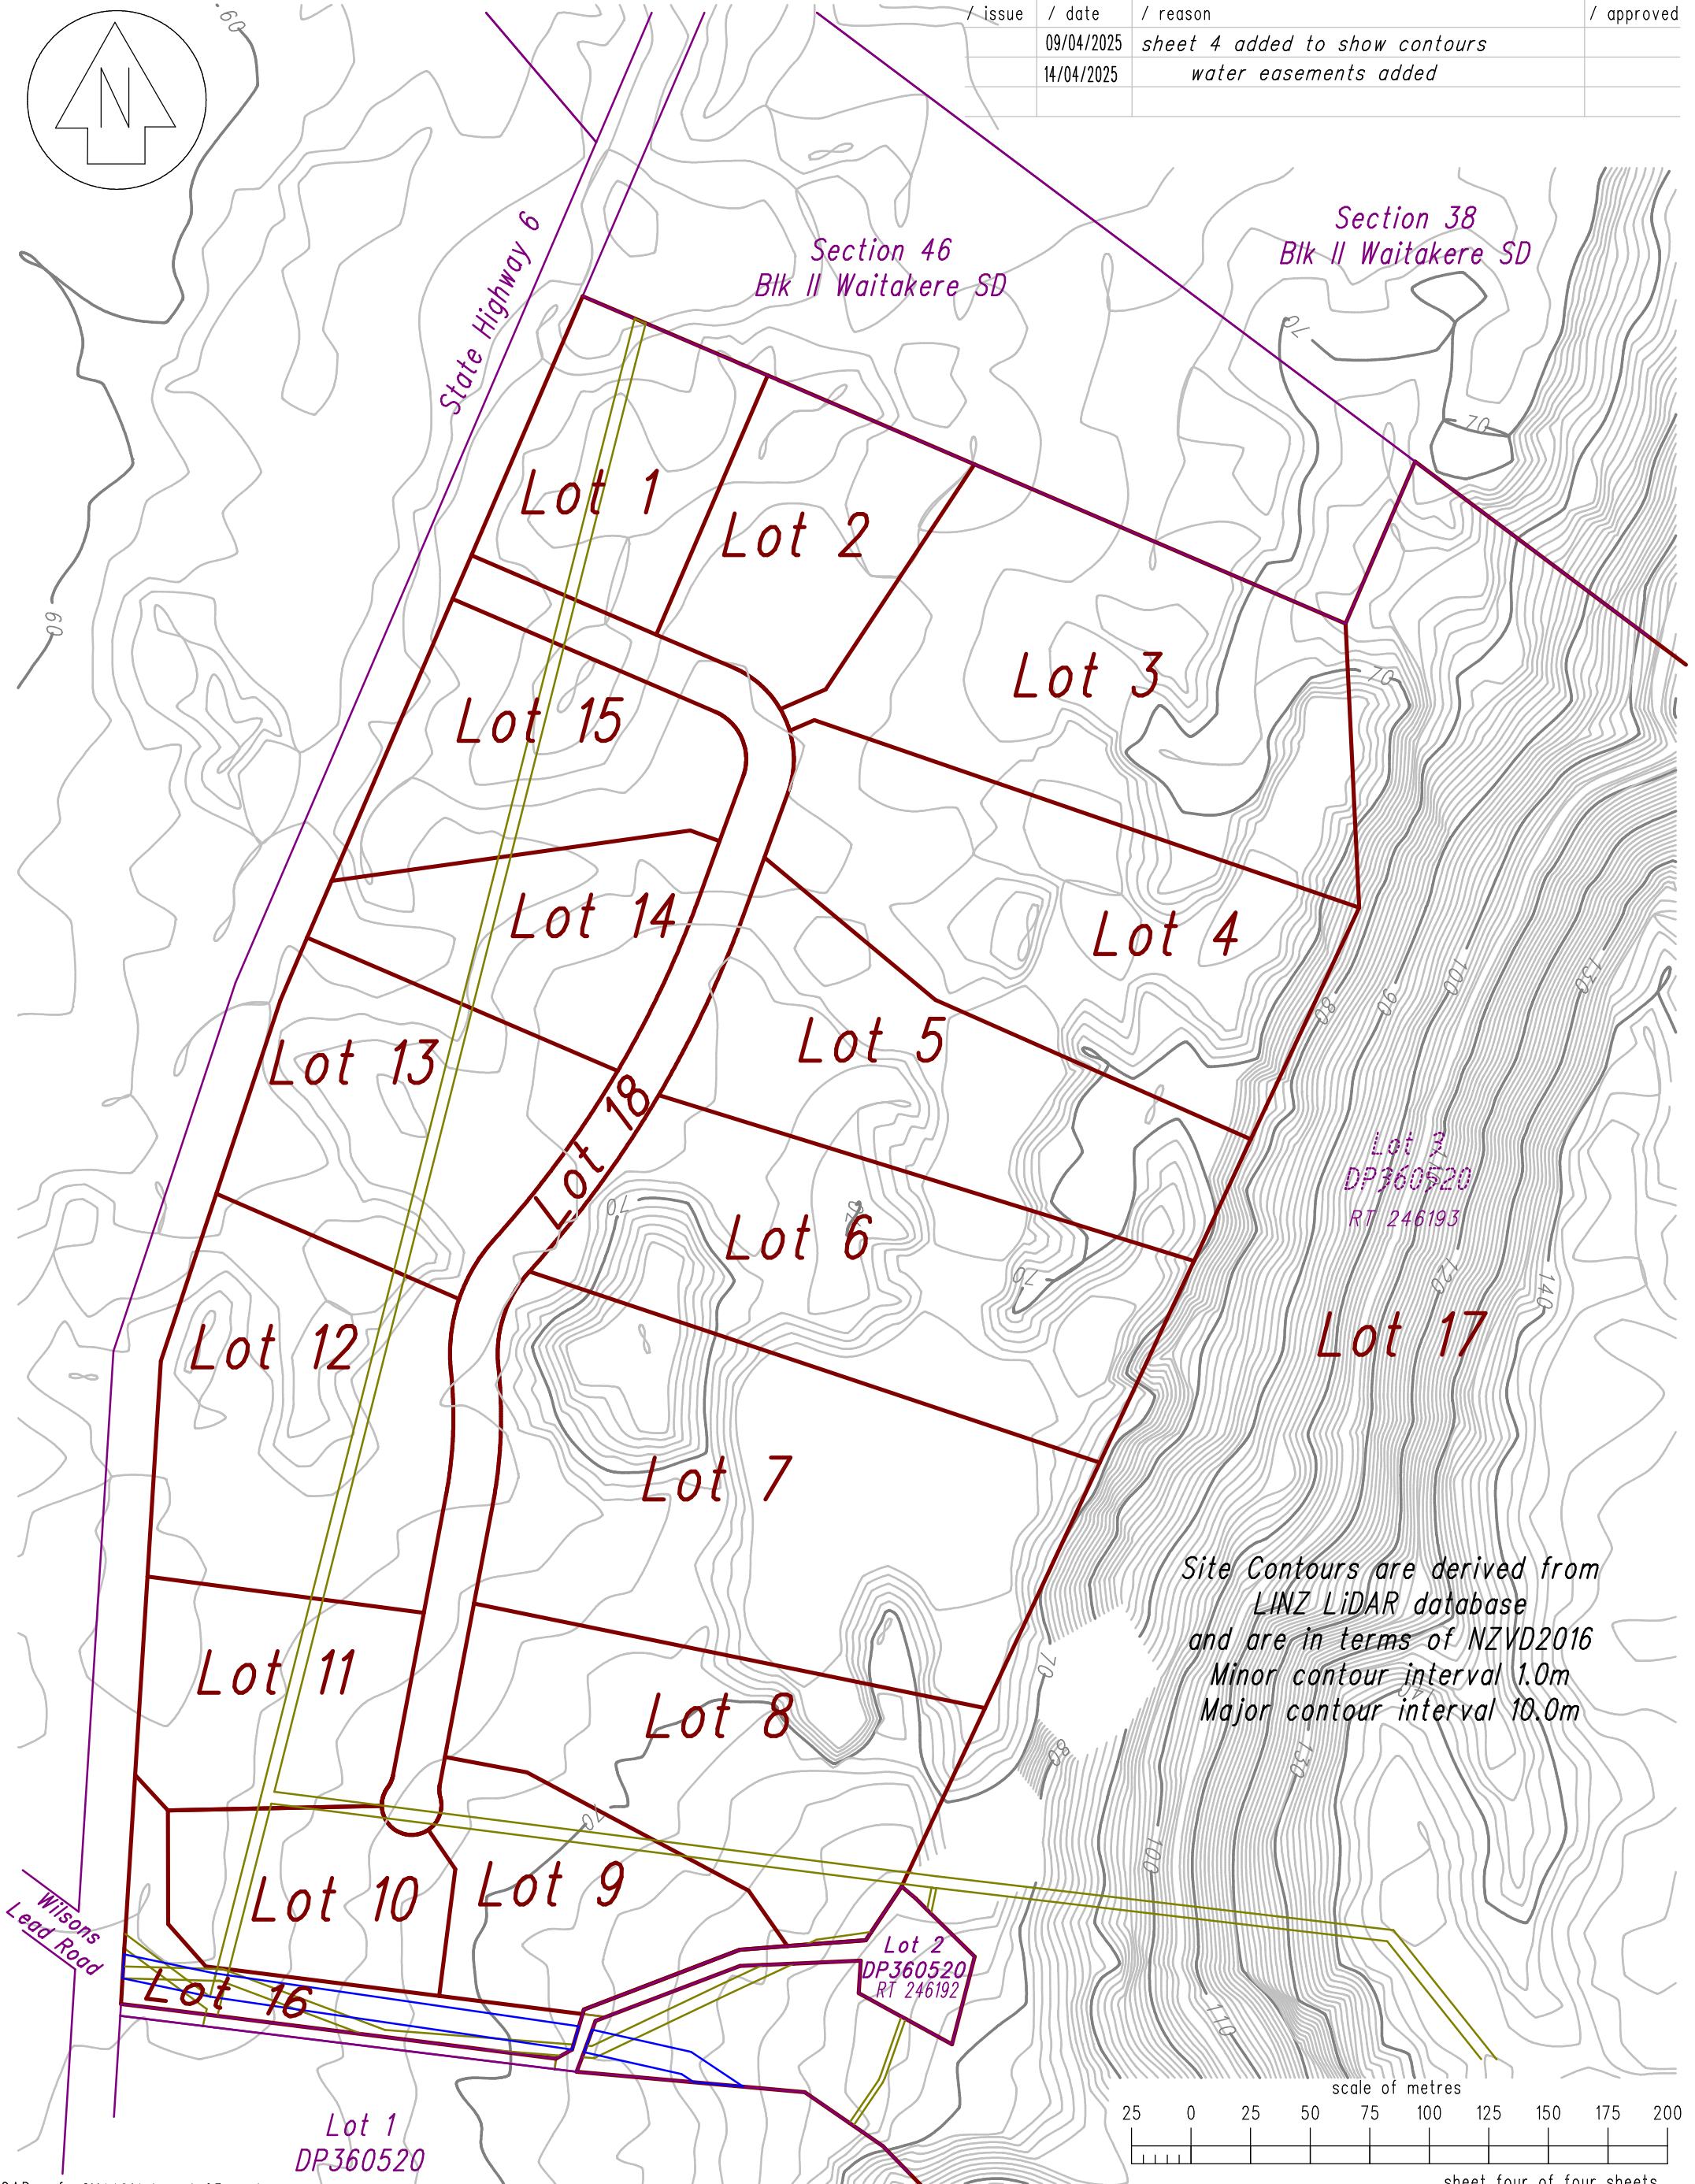
/ issue	/ date	/ reason	/ approved
	09/04/2025	sheet 4 added to show contours	
	14/04/2025	show water easements

The Scheme Plan attached as **Appendix A** includes a plan showing the contours of the site. The contours are based on NZVD 2016.

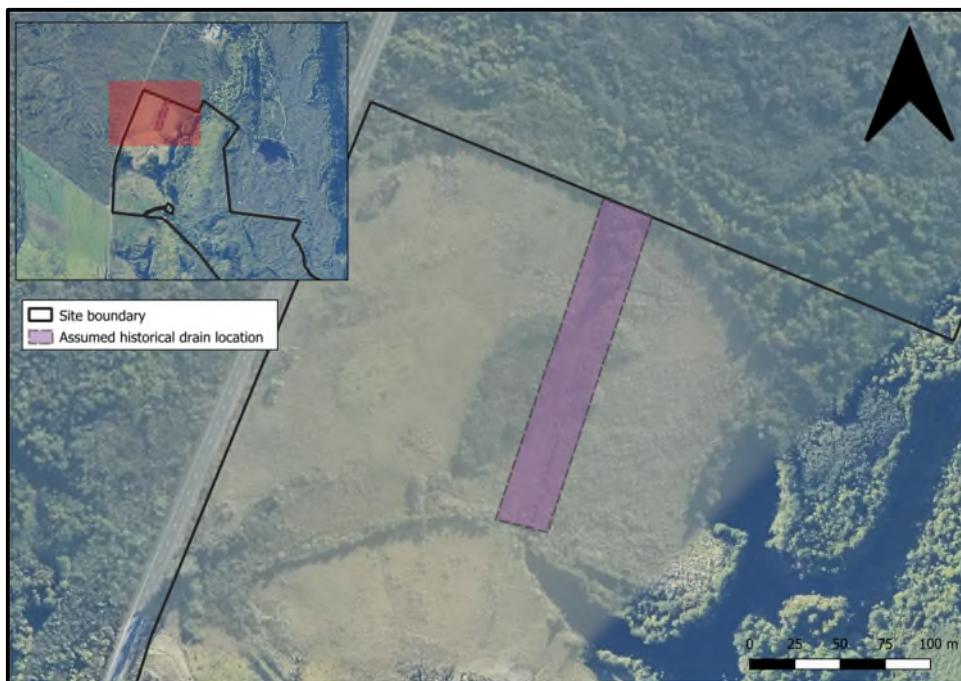
**Figure 5: Approximate Location of Vegetated Drain.**

- An area extending north to south in the north of the site (Refer to **Figure 5**) that is densely vegetated is understood to be a drain dug over 30 years ago. This area is now being revegetated with it being wet during winter months.

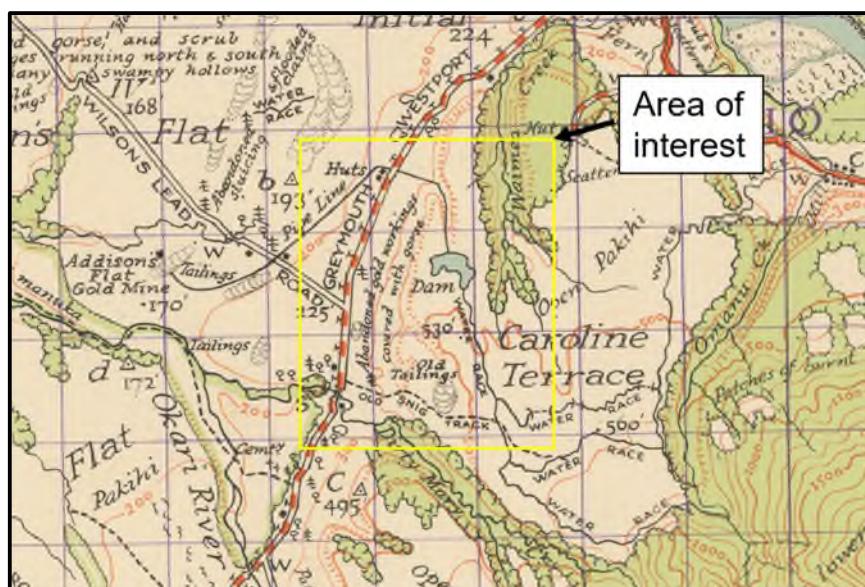
Figure 6: 1944 Topographic Map with Yellow Box Identifying Approximate Site Location.

Within the 1944 topographic map (see excerpt below) the site is labelled as being 'Abandoned gold workings covered with gorse'. Additionally, below the dam is a dashed line labelled as being 'Old Tailings'. Tailings are a byproduct of a gold mining process common in the late 1800s and early 1900s within New Zealand<sup>9</sup>. These are typically deposits of sand and silt and often found in large piles at the site of old mines.

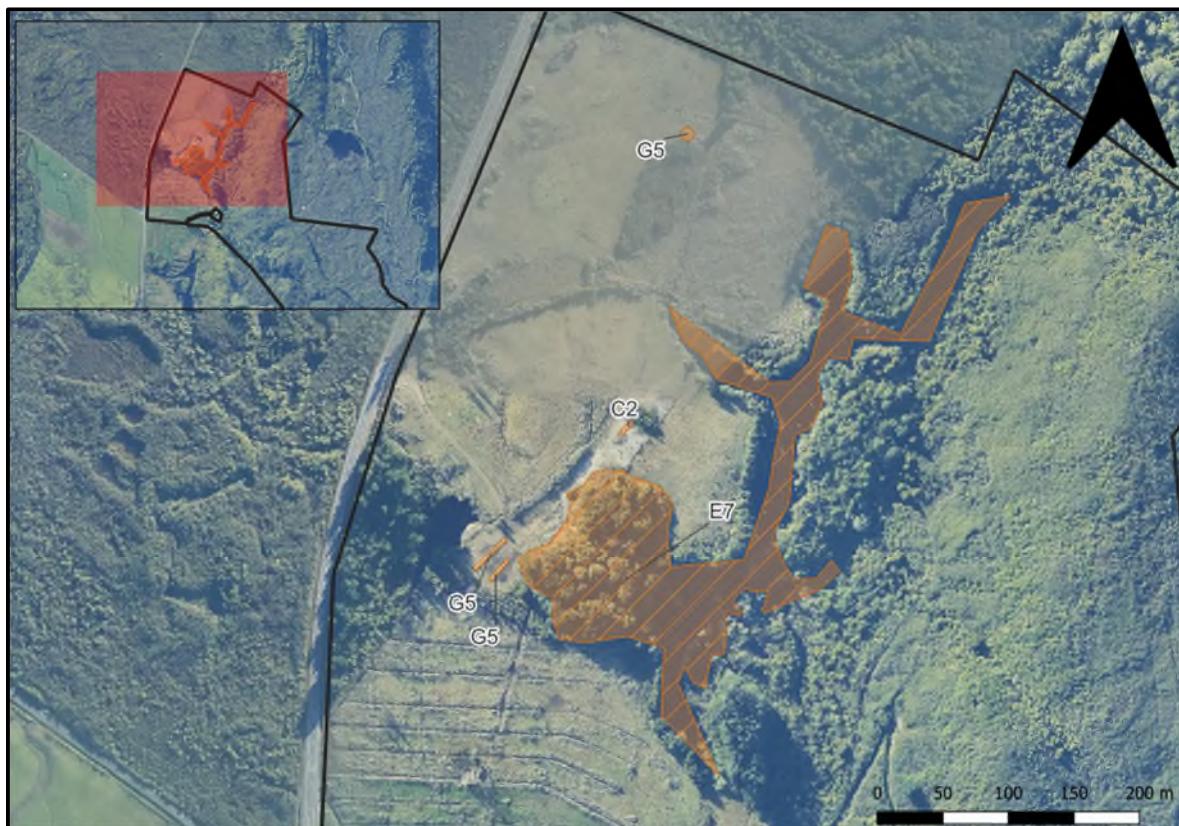
**Figure 7: Identified HAIL on the site during April site visit.**

- C2: Gun clubs or rifle ranges, including clay targets clubs that use lead munitions outdoors.
- E7: Mining industries (excluding gravel extraction) including exposure of faces or release of groundwater containing hazardous contaminants, or the storage of hazardous wastes including waste dumps or dam tailings.
- G3: Landfill Sites.
  - From identified mounding of material in centre of site creating two bunds and small disposal area within the north.

Locations are detailed in **Table 4** and **Figure 7** below.

Potential Sources	HAIL ID	Contaminants of Concern	Exposure Route and Pathways	Investigation location
Shooting range ammunition – relatively central to site	C2: Gun clubs or rifle ranges, including clay targets clubs that use lead munitions outdoors	Heavy metals (lead, antimony, copper, zinc, tin, and nickel)		Locations were chosen to assess the likely source and distribution of bullet contamination.
Historic gold mining activities	E7: Mining industries (excluding gravel extraction) including exposure of faces or release of groundwater containing hazardous contaminants, or the storage of hazardous wastes including waste dumps or dam tailings.	Arsenic, mercury, cyanides, sulphides, and metals and hydrocarbons associated with fuel storage	<p>Site Visitors, Future Site Staff, Site Inhabitants:</p> <ul style="list-style-type: none"> <li>• Inhalation of dust</li> <li>• Ingestion of soil</li> <li>• Ingestion of produce grown in contaminated soils</li> <li>• Dermal</li> </ul> <p>Transport by overland flow (rainwater or seasonal water flow) and / or advection / dispersion / dissolution</p> <p>Potential ecological receptors (including but not limited to: terrestrial vegetation, wildlife)</p>	Relatively central to site within vegetated mound
