Westport No.1 Water Tunnel Repairs Option 2d (Stabilising + Piping)

Feasibility Study

October 2017

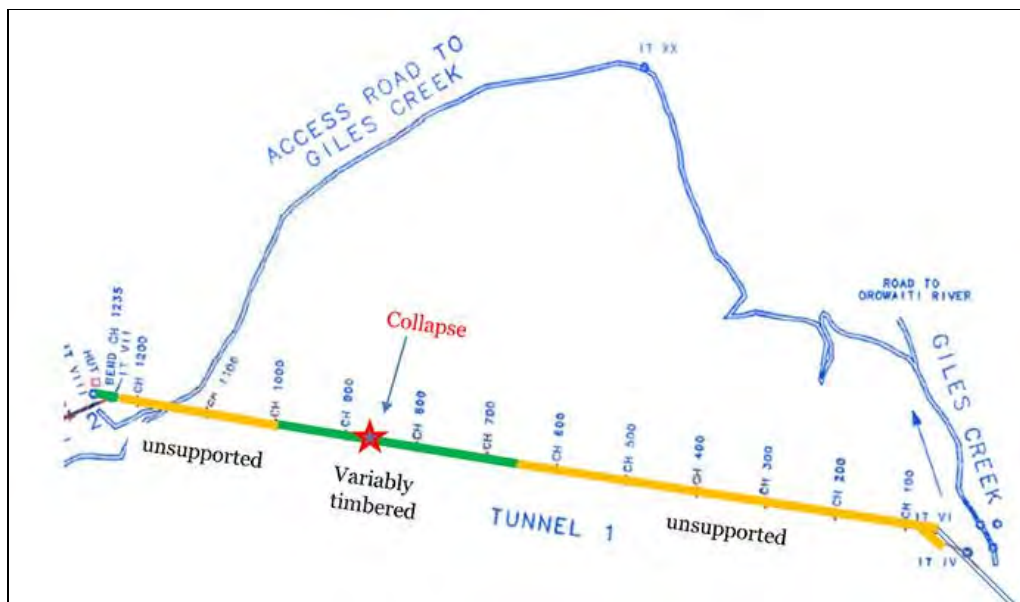
Figure 4-1: No. 1 Tunnel Schematic

The (Extended) suffix denotes an increase in length from the originally scoped 450m for Option 3a, up to approximately 660m in order to clear the worst tunnel sections (refer Figure 4-1 below). This improves the reliability of the option significantly, as the remaining 500m of tunnel is in relatively sound condition, i.e. virtually unchanged since 1903. Refer to the appendices for a full report of the Options Workshop.

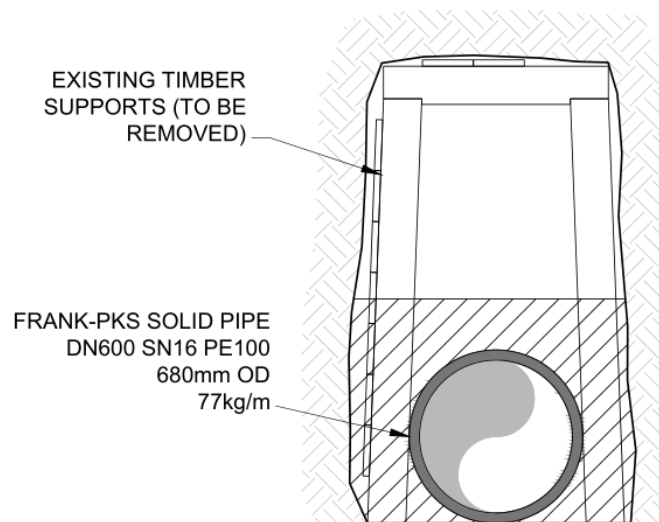
Figure 10-1: Indicative Piped Cross Section

We believe that the risk of future damage and deformation of the pipeline can be mitigated by backfilling the pipe to a level of approximately 200mm above the crown of the pipe. This can be effected by blowing dry material in using a shotcrete technique, provided the aggregate size does not exceed about 8mm. It would also be worth adding cement to the mixture to give a low-strength (*ca.* 5-10 MPa) dry mix concrete that will give additional security against collapse and damage. The dry mix will slowly set with atmospheric moisture which avoids creating significant heat of hydration which may weaken the pipe.

This backfill will protect the pipe from puncture damage, and reduce the risk of crushing/deformation failure as the sidewalls will be supported. It will still leave sufficient room for a person to crawl along the space above the pipe if this were ever necessary in future to undertake further repairs. An indicative section for the solid-wall pipe option is shown below.

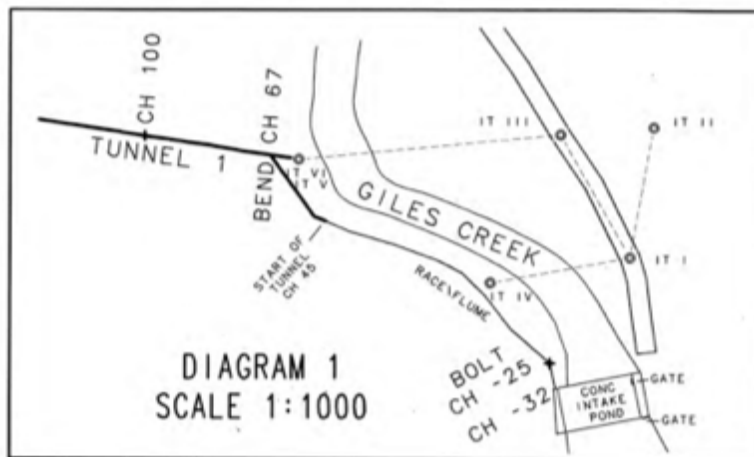
Figure 8. Diagram showing location of ventilation fan and brattice stopping.

Air flow would be achieved by the installation of a fan at chainage 45, and brattice stopping at IT VI. Brattice stoppings will be established each 200m to be deployed should there be an out-bye fire. The brattice would be rolled out and secured, and compressed air lines turned on in-bye of the stopping to assist with pressurising the area where the men are located. In effect, in-bye of the stopping would become a refuge chamber. Caches in sealed 20litre buckets will be out in the tunnel for use should the men be trapped in the unlikely event of a catastrophic roof fall. Caches will contain clean water, food, space blankets and additional lighting. They will be installed on first entry into the tunnels at two locations, nominally 200m and 400m in from the outlet portal.

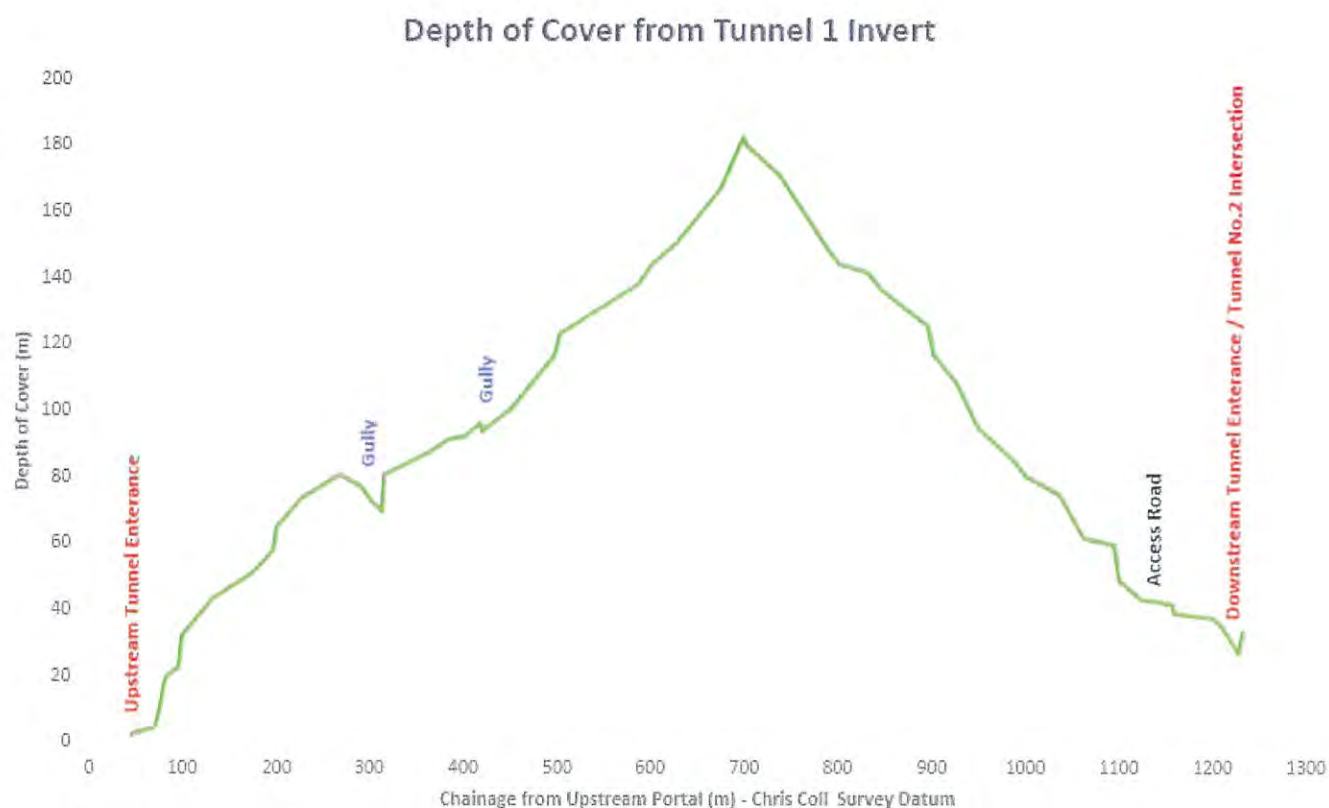
Tunnel No.1 has been excavated to a narrow-arched profile with nominal dimensions of about 0.8m wide and 1.8m high. Depth of cover over the tunnel varies as a function of surface topography (the tunnel gradient being less than 1:1000) and ranges from 10m at the upstream portal to 180m under the topographic high on the ridgeline at chainage 700m (Figure 6).

Figure 6 - Depth of Cover along the Tunnel No. 1 alignment

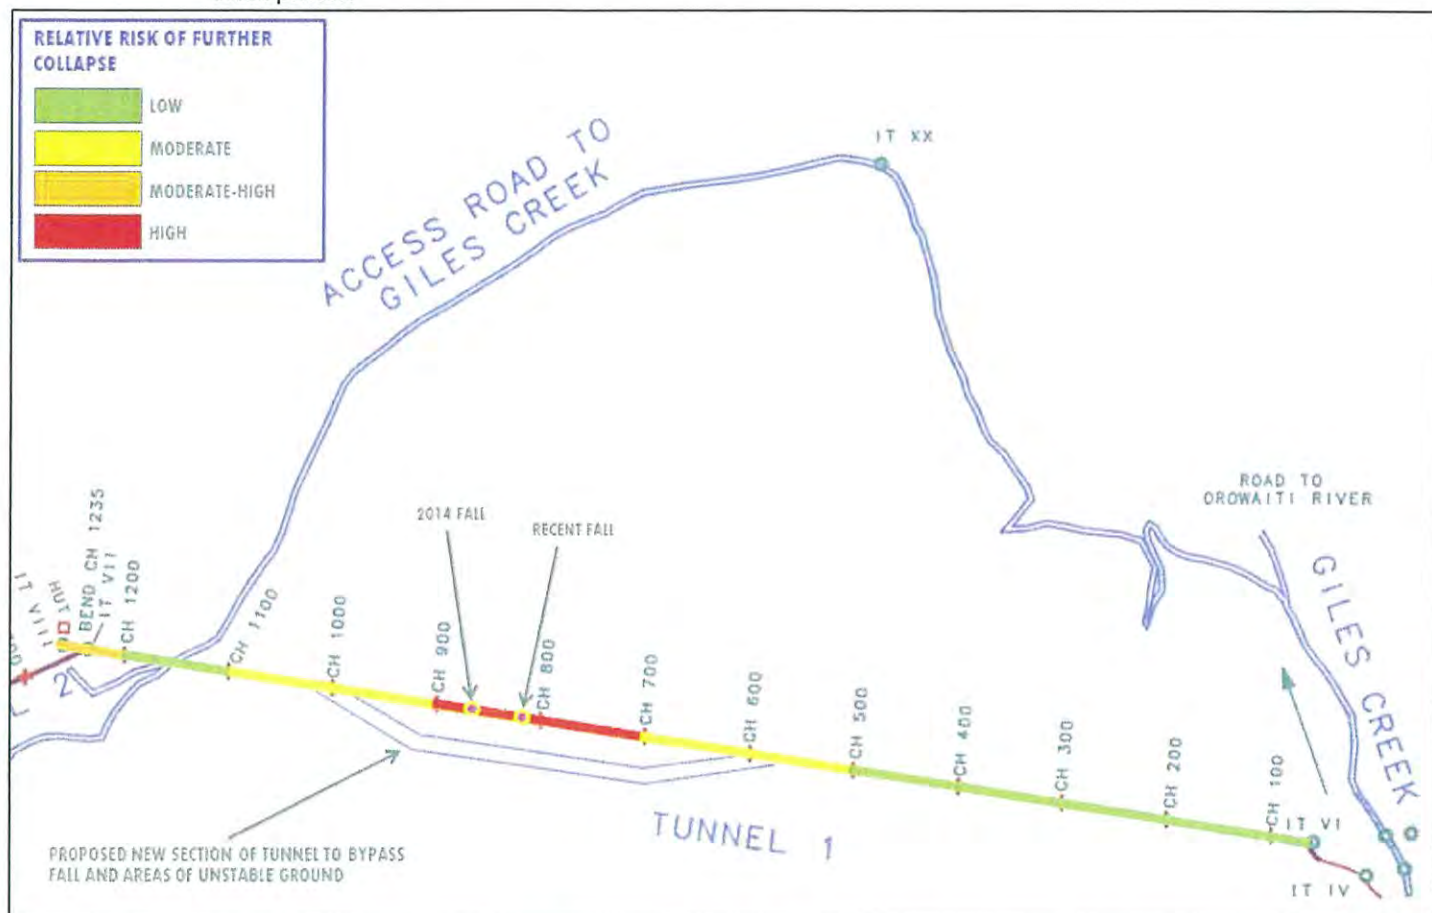
Given the ground and timber support conditions within the tunnel the preferred, lower risk, option would be to develop a new section of tunnel around the fall and associated poor ground linking in at the upstream tunnel end at approximately 600m chainage as displayed in Figure 9. This strategy reduces risk by “engineering out” as much of possible the strata instability hazards associated with people removing supports in unstable ground, whilst also placing the tunnel in virgin ground that hasn’t been weakened by previous deformation and that can be adequately supported immediately after excavation. It is likely that tunnel advance rates would be similar if not quicker in virgin ground with potential for cost savings. The key disadvantages of the method are:

Figure 9 – Plan showing relative geotechnical risk and proposed bypass of fall and areas of high instability

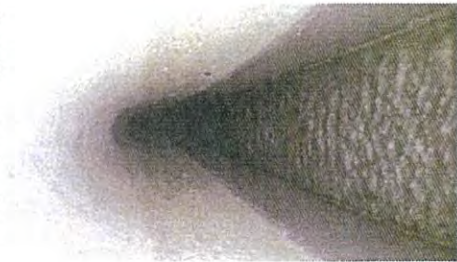
Tunnel ~100m showing very good Ground & thin conglomerate band

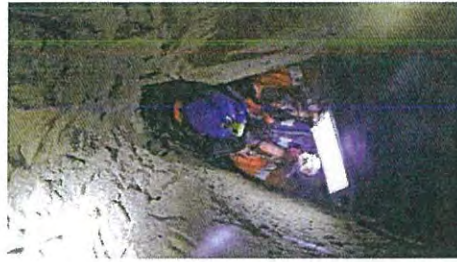
Tunnel at ~550m showing blocky roof

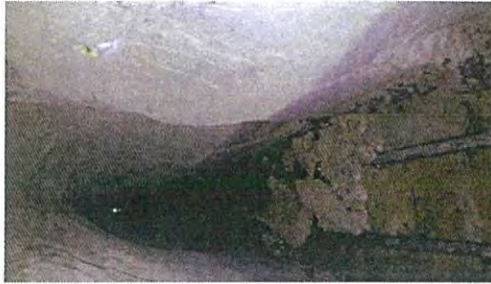
Tunnel at 1000m showing recent roof fall material on tunnel invert
