Perpendicular Point

Natural Hazard
Desktop Assessment
Version 2

24 March 2025

ACG Properties Limited

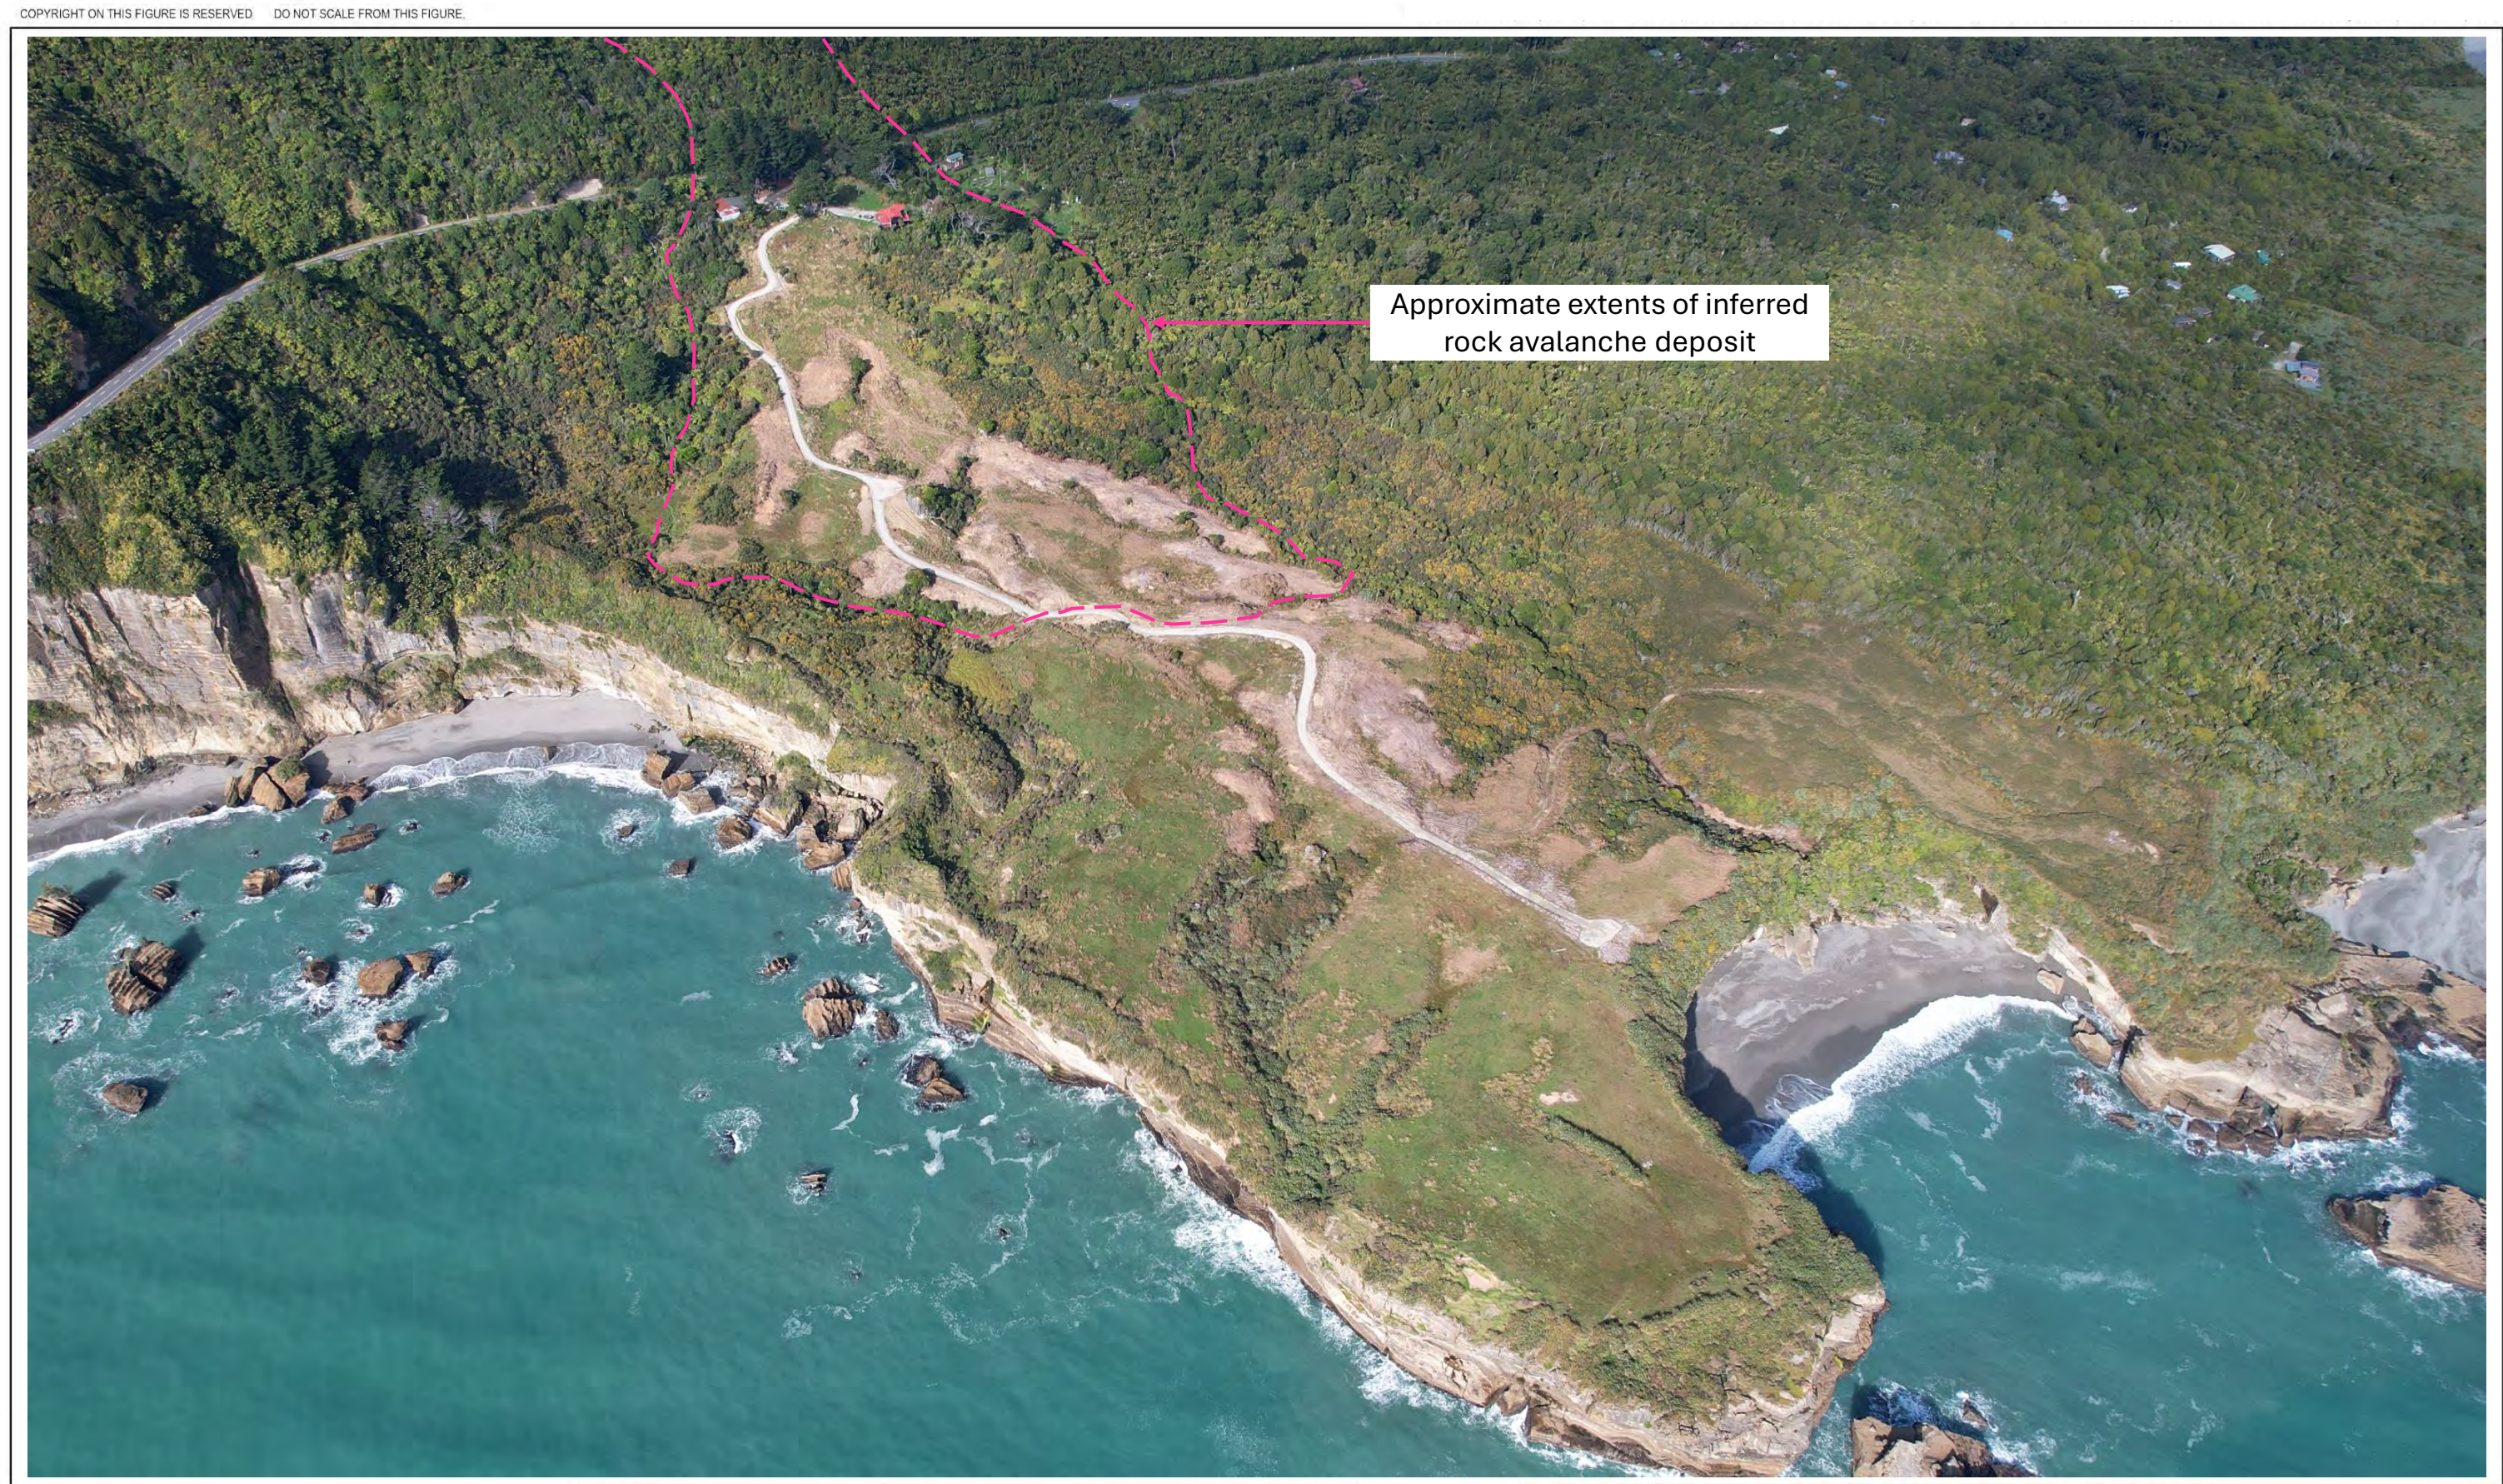
The steep hillside and escarpment east of the site presents several significant falling debris hazards. There is evidence of historic instability of this slope affecting the site, including:

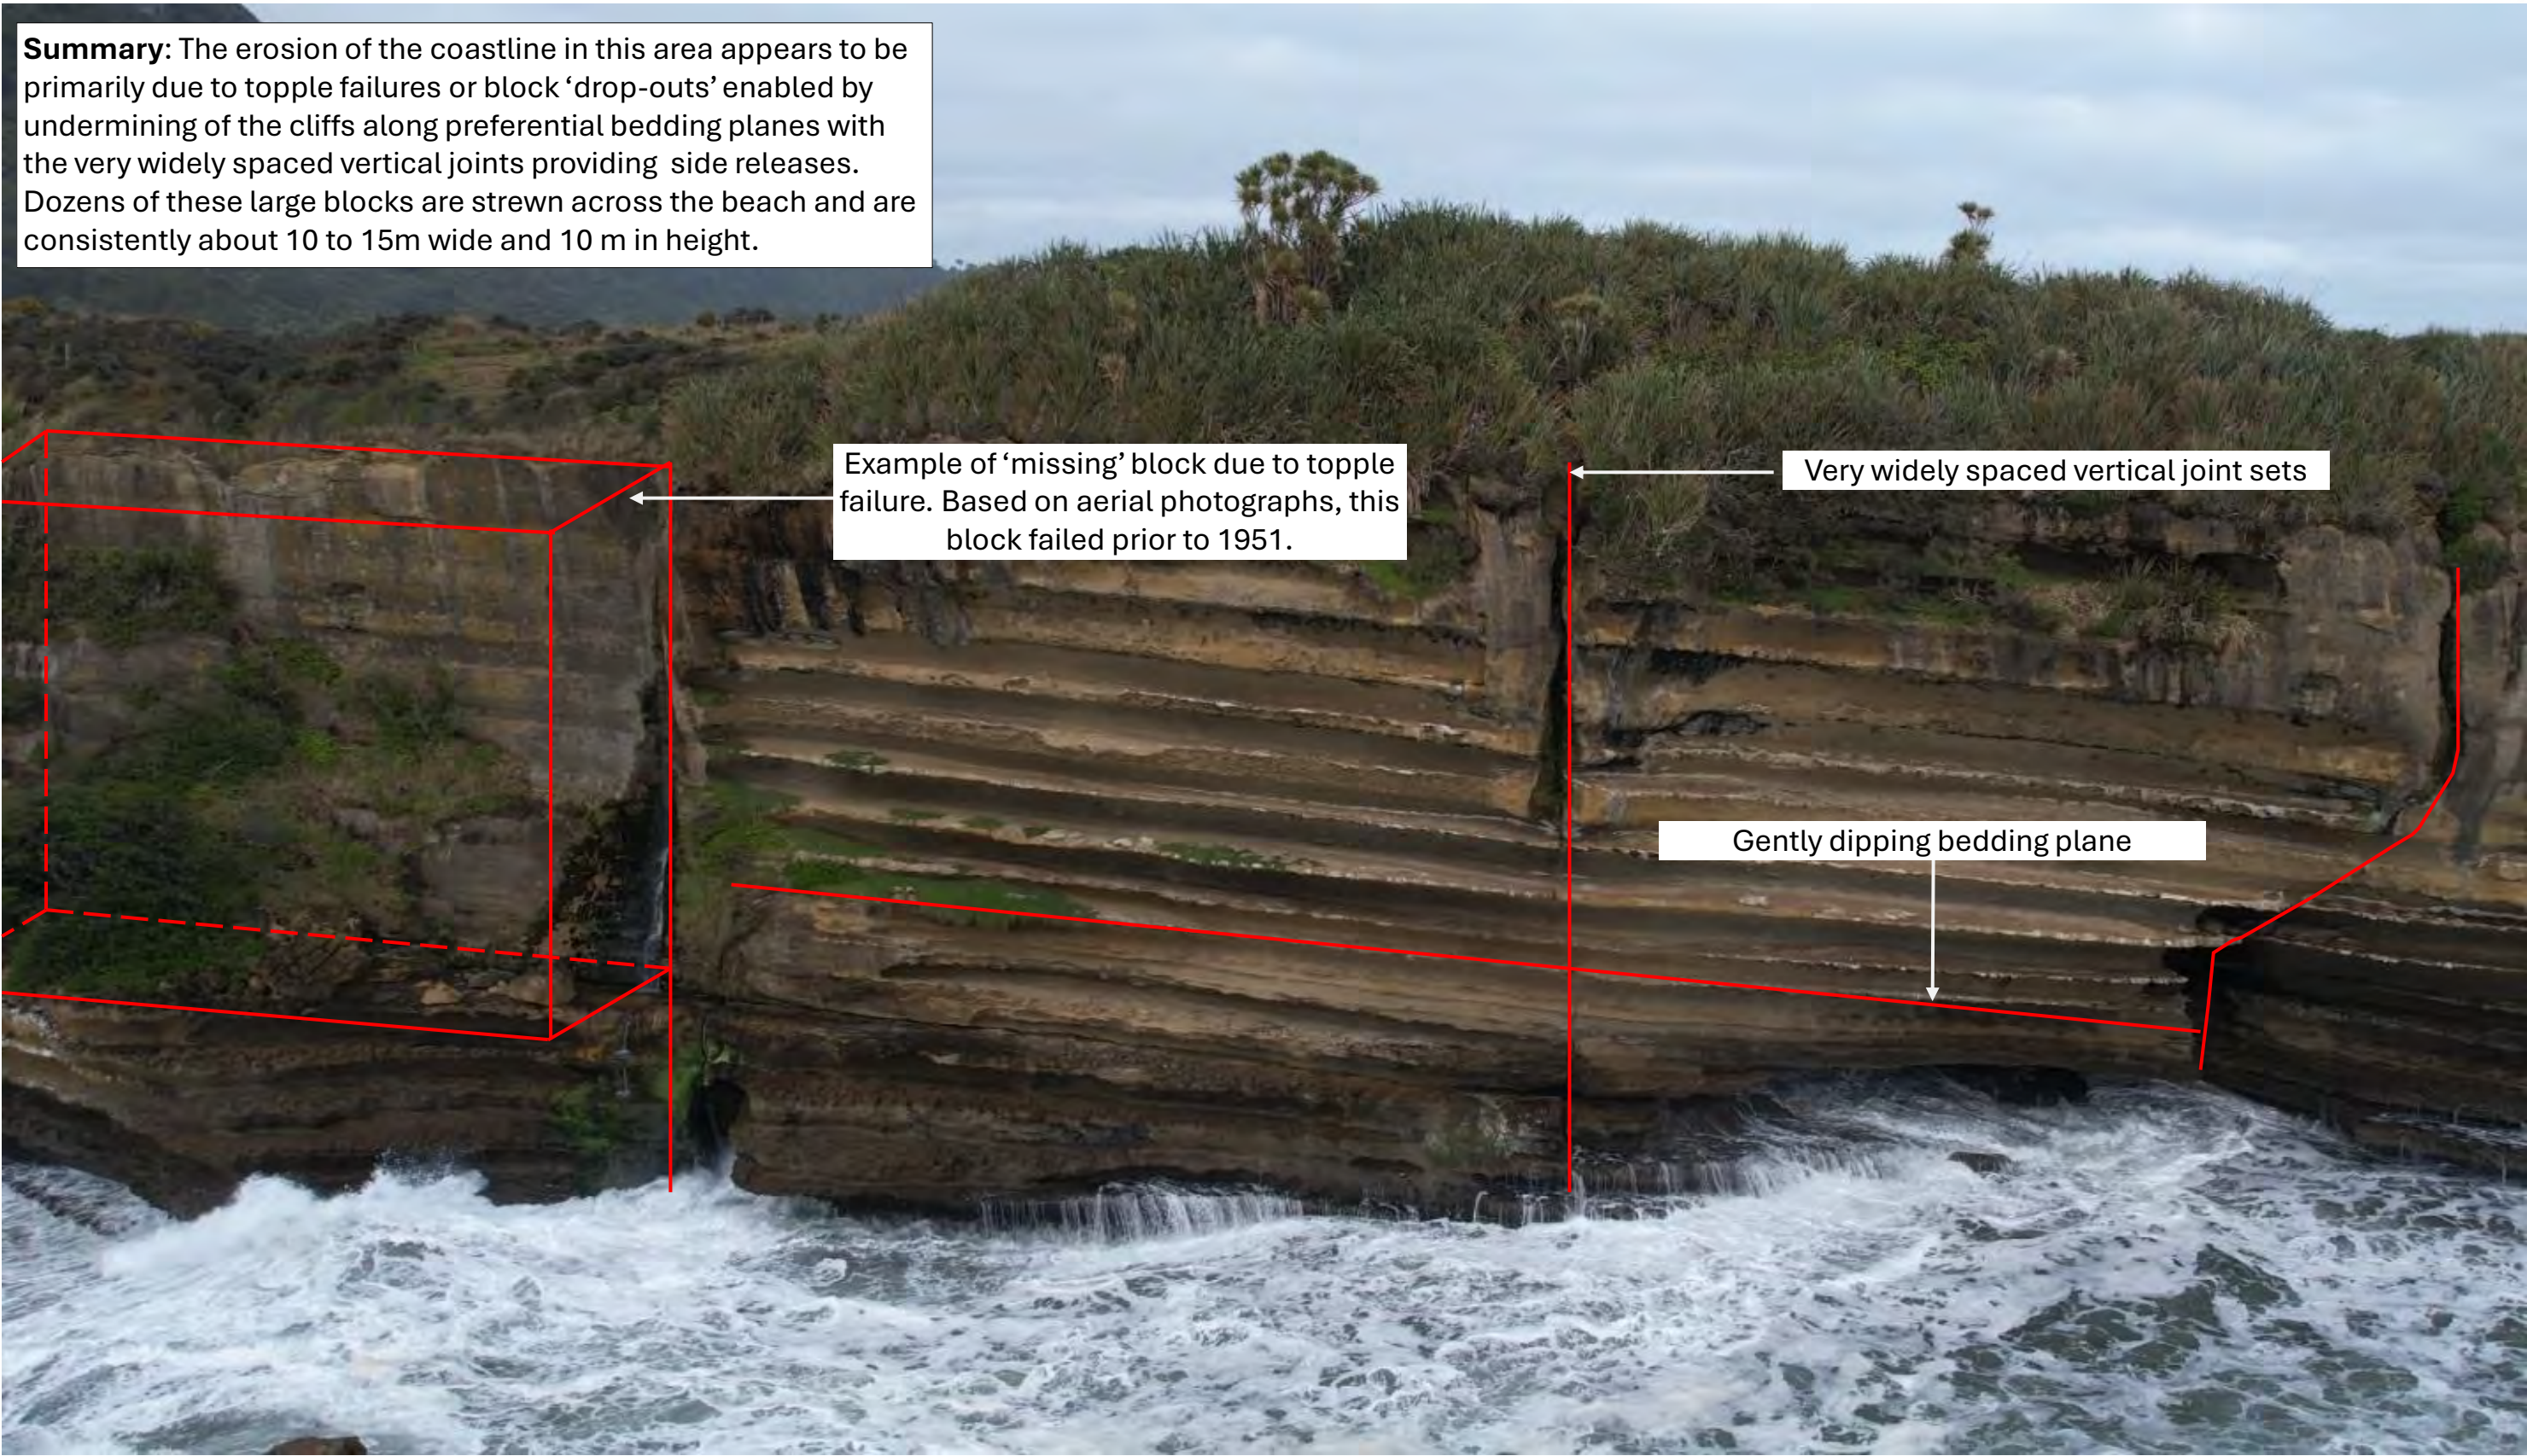
The erosion of the coastline appears to be primarily due to topple failures or block ‘drop-outs’ enabled by undermining of the cliffs along preferential bedding planes with the very widely spaced vertical joints providing side releases. Dozens of these large blocks are strewn across the beach and are consistently about 10 to 15m wide and 10 m in height. There is limited observations of block failures occurring between 1951 and present.

The coastal hazards in the Te Tai o Poutini Plan (TTPP) have recently been mapped and are in the process of being updated to become operative. Submissions close on 30 August 2024. Development coastward of this line will likely require detailed assessment and interaction with West Coast Regional Council.
