# Subdivision Suitability Report

**Section 41 SO 13711**

Prepared for Tauranga Bay Holdings Ltd  
510322

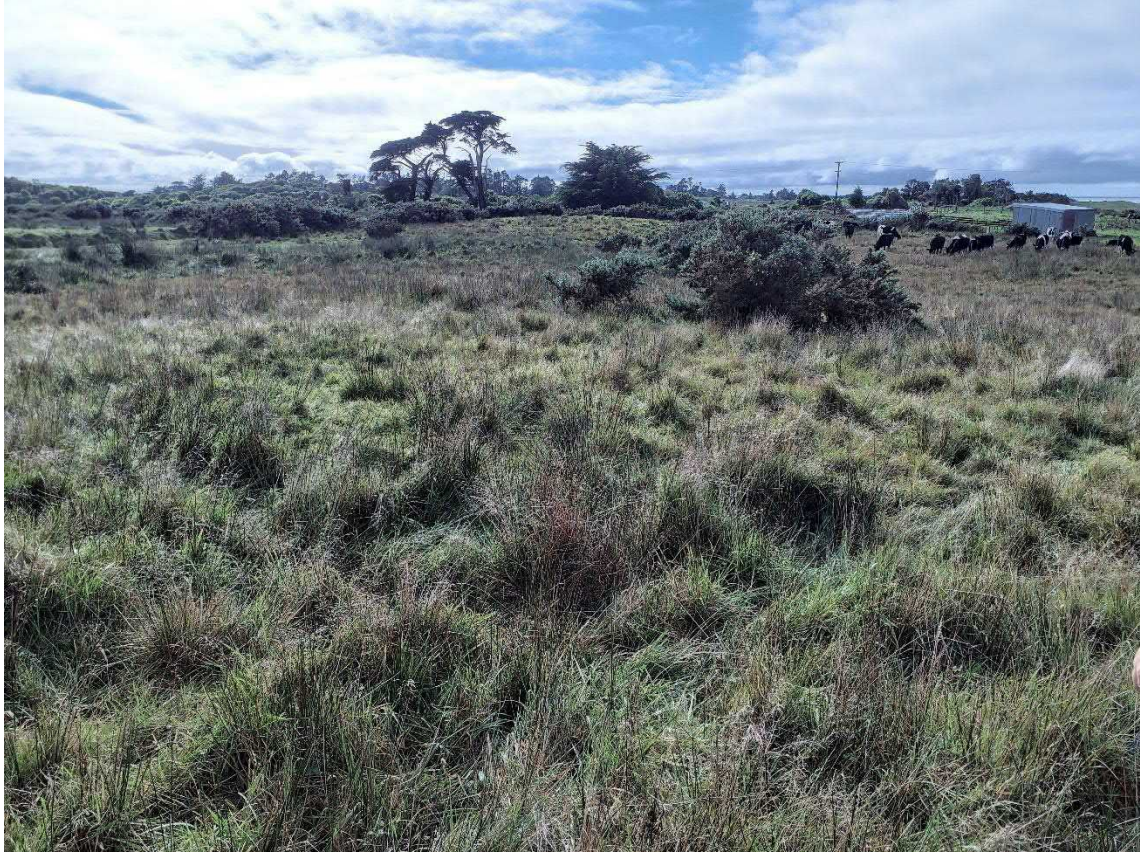
**Figure 1. Facing north-east across from area C.**

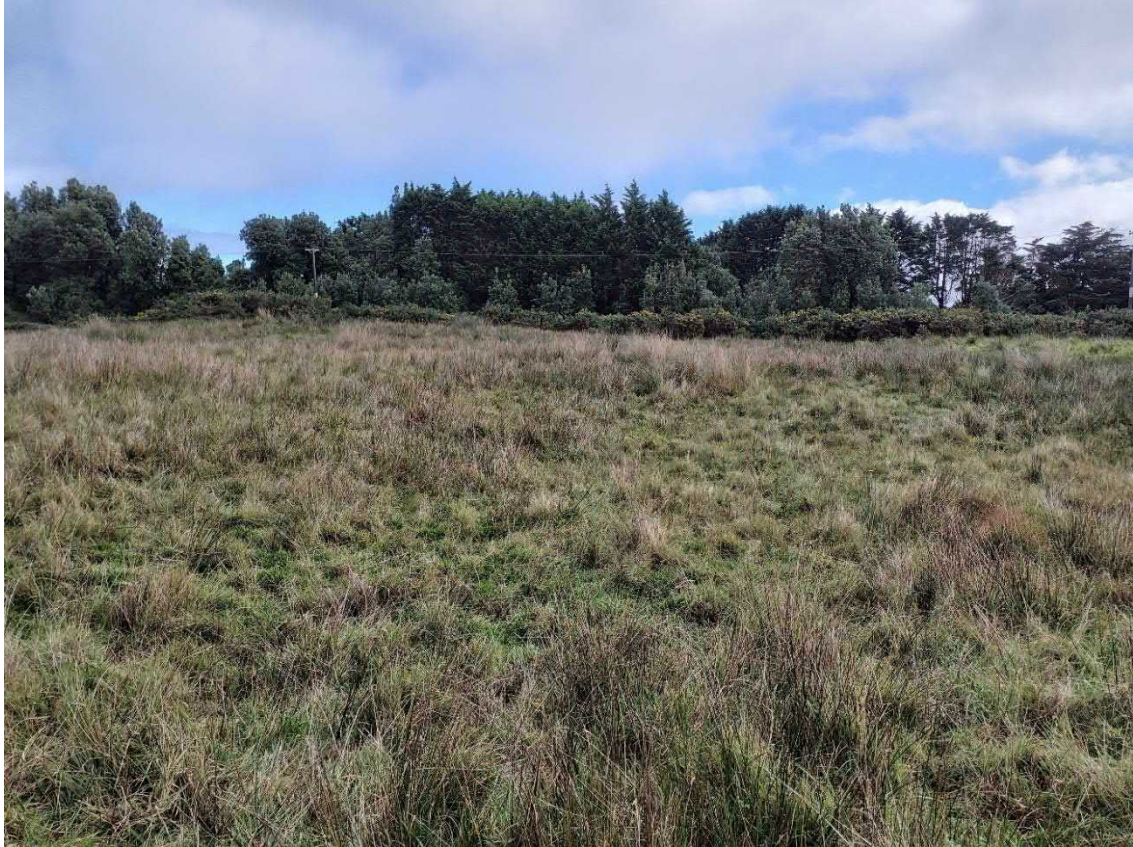
**Figure 3. Facing north-west towards Tauranga Bay by area I.**

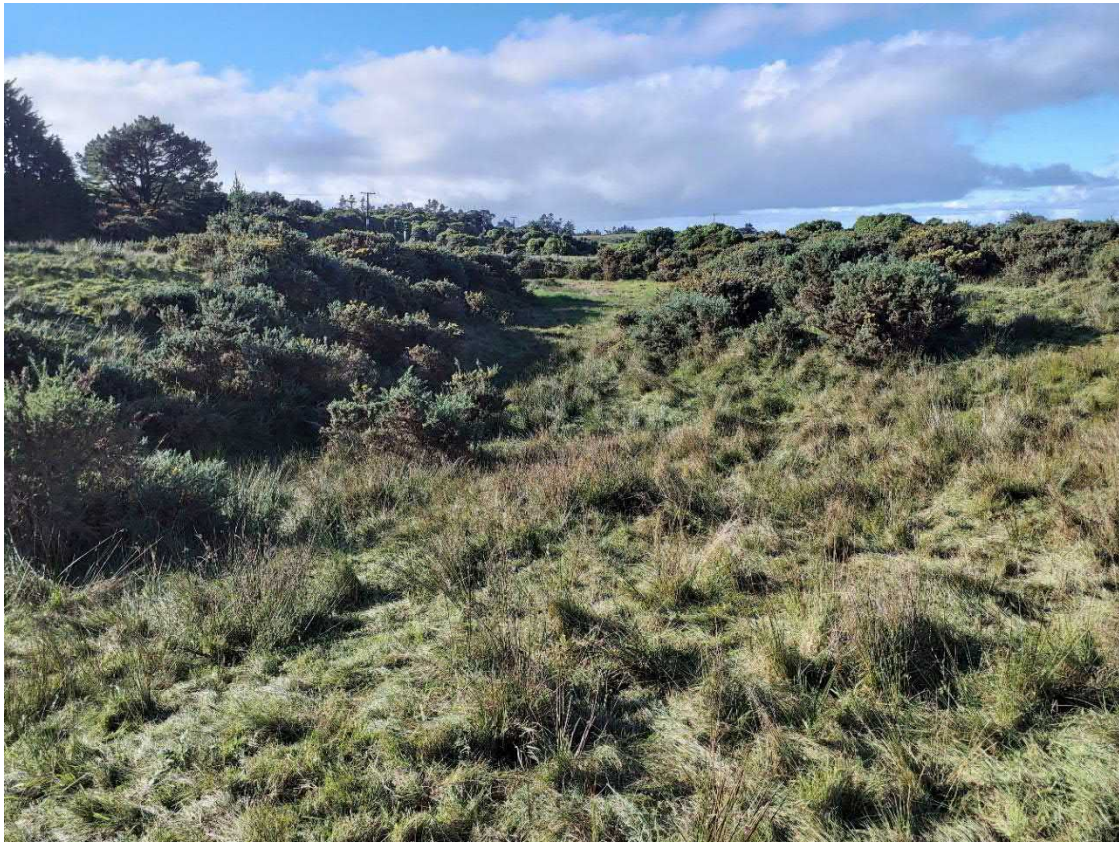
**Figure 6. Facing north from area N across a gully towards the Wilson Lead Road and Tauranga Bay Rd intersection.**

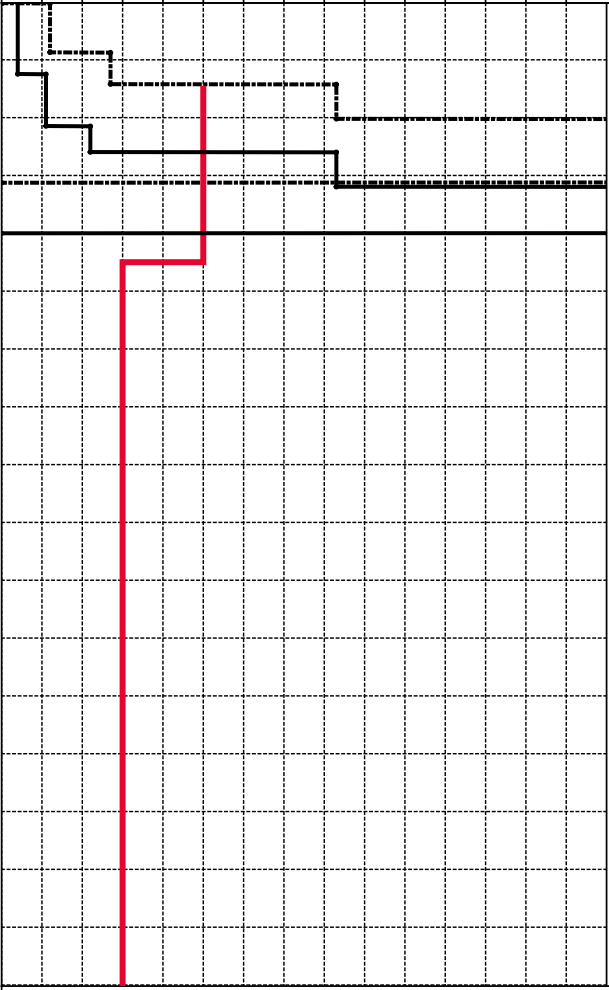
0.2	TOPSOIL & SILT, with some sand; brown.	Groundwater Not Encountered
															0.4		
															0.6	SAND; orange. Iron pan. SAND; orange brown.	
															0.8		
															1.0		
															1.2		
															1.4		
															1.6		
															1.8		
															2.0		
															2.2		
															2.4	EOH: 2.4m	
															2.6		
															2.8		
															3.0		
															3.2

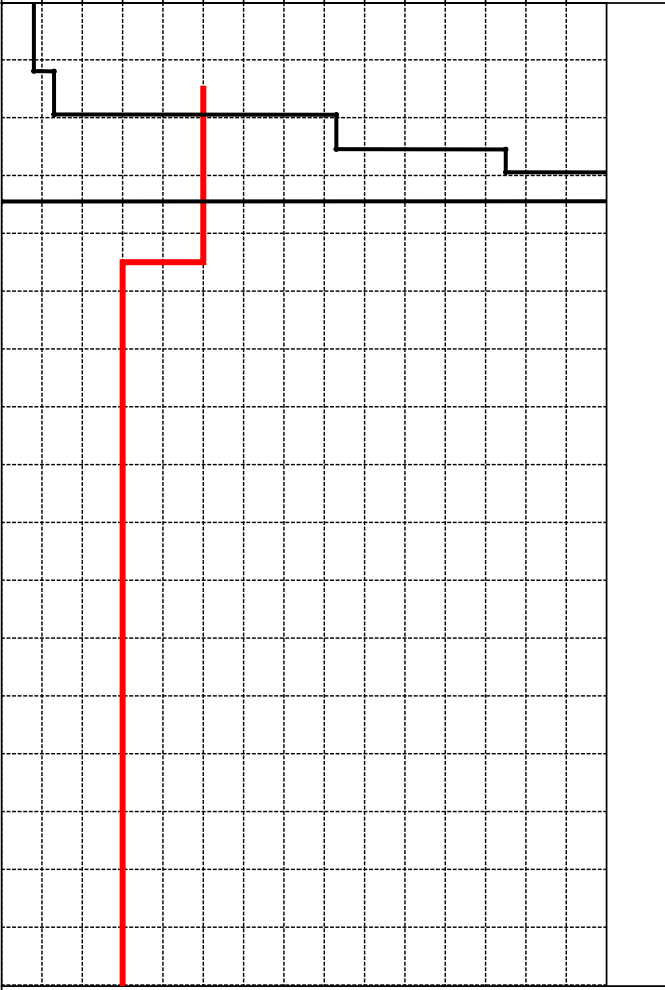
0.2	TS	TOPSOIL & SILT, with some sand; brown.	Groundwater Not Encountered
															0.4		SAND; orange. Iron pan. SAND; orange brown.	
															0.6			
															0.8		SAND; greyish brown.	
															1.0			
															1.2			
															1.4			
															1.6			
															1.8			
															2.0		EOH: 2m - Target Depth.	
															2.2			
															2.4			
															2.6			
															2.8			
															3.0			
															3.2

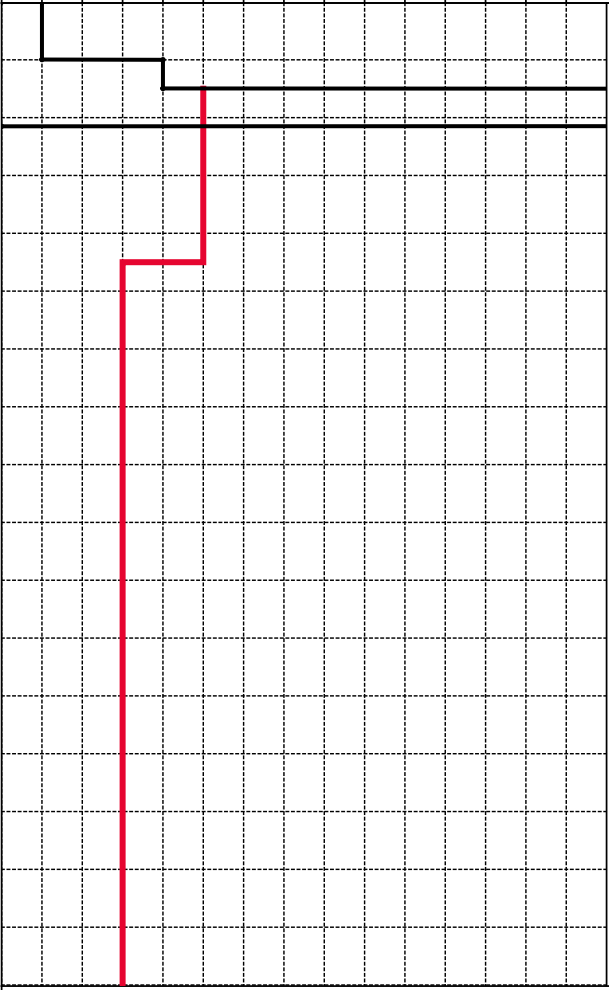
0.2	TOPSOIL & SILT, with minor sand; brown.	
															0.4	SAND; orange. Iron pan. SAND; orange brownish. Firm.	
															0.6		
															0.8		
															1.0		
															1.2		
															1.4		
															1.6		
															1.8		
															2.0		
															2.2	EOH: 2.2m - Target Depth.	
															2.4		
															2.6		
															2.8		
															3.0		
															3.2
